Urban Expansion and Erosion Processes in an Area of Environmental Protection in Nova Lima, Minas Gerais State, Brazil

Rafael Falci Ercoli, Vandeir Robson da Silva Matias and Valéria Cristina Palmeira Zago*

Federal Center for Technological Education of Minas Gerais, Belo Horizonte, Brazil

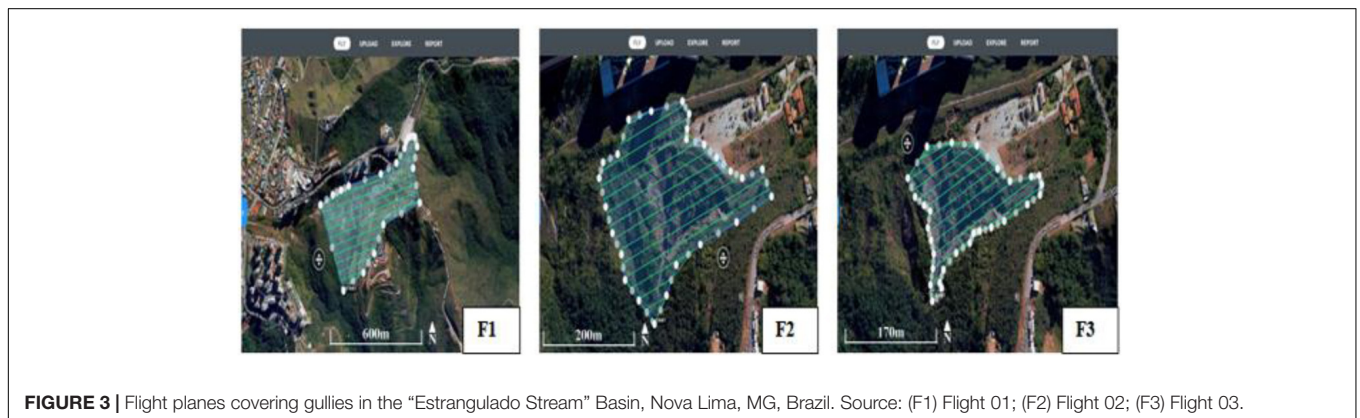
FIGURE 3 | Flight planes covering gullies in the “Estrangulado Stream” Basin, Nova Lima, MG, Brazil. Source: (F1) Flight 01; (F2) Flight 02; (F3) Flight 03.

The speed of the three flights was 15 m/s, recommended by DroneDeploy software for terrain mappings with 70% front and side overlap. Flight 01 was conducted at an altitude of 90 m, direction -13° , and 13:35 min of duration, covering an area of 22 hectares and capturing 209 images.

Flight 02 was performed at an altitude of 35 m, direction -19° , and lasted 13:55 min, covering an area of 2 hectares and capturing 287 images. Finally, Flight 03 was performed at an altitude of 30 m, the direction of -23° and duration of 13:55 min, covering an area of 4 hectares and capturing 235 images (Figure 3).

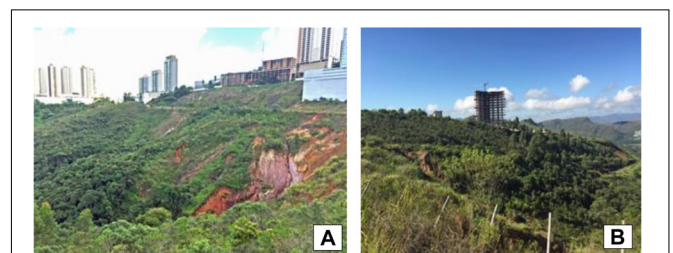
FIGURE 5 | Study area – gullies between Belvedere and Jardim da Torre neighborhoods. (A) Lateral view of erosive processes and buildings in the Belvedere neighborhood in the background, in Belo Horizonte; (B) another angle of the gully and view of a new residential real estate development in the neighborhood of “Jardim da Torre neighborhood,” Nova Lima. Source: Authors’ personal archives.

The “Belvedere” neighborhood, part of the municipality of Belo Horizonte, is a consolidated neighborhood, with little space for new buildings and the “Jardim da Torre” neighborhood (municipality of Nova Lima), is still little inhabited. However, it still has large areas of environmental preservation, which have been degraded due to the removal of the original vegetation to obtain raw materials (stones, gravel, sand, gravel) and by disposal of construction waste (Figures 5A,B).

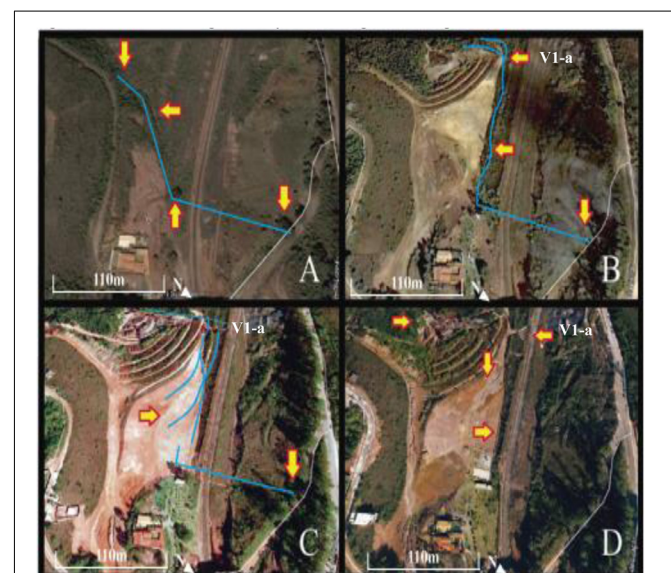
FIGURE 8 | Satellite image history indicating the emergence of the V1-a incision. **(A)** Arrows show the drainage channel in 2002 **(B)** arrows show channel reconfigured due to the construction of the waste landfill in 2008. **(C)** Presence of water traces on the surface of the waste landfill plateau indicating the direction of the water flow in 2009. **(D)** Intensification of the erosion processes in 2011. Source: Adapted from Google Earth, 2002–2019.

In the satellite images, it is possible to verify different modifications of the pre-existing water drainage structures. In the 2002 image, there is a canal built with the probable intention of directing the excess of water from the highest parts to the floor of the valley, where the bed of the “Estrangulado” stream is located (Figure 8A). Due to the construction waste landfill at the site, the water flow from the highest parts of the slope started to be

directed to one side of the landfill, contributing to the emergence of a new ravine, identified here as V1-a (Figures 8B–D).

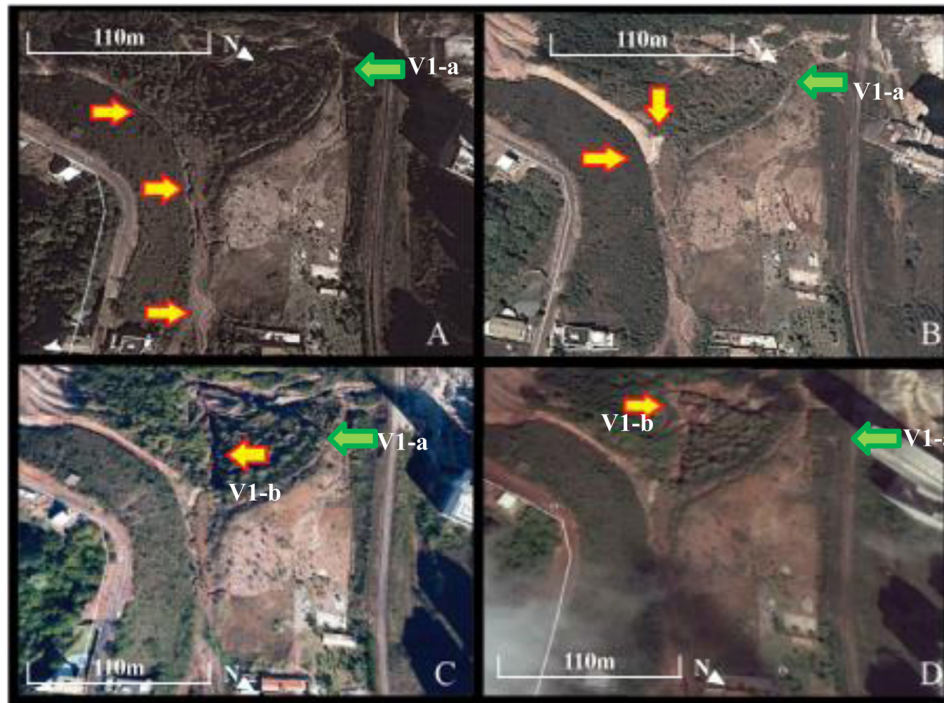
FIGURE 10 | Satellite image history indicating the emergence of incision V1-b. Yellow arrows represent V1-b and green arrows a V1-a. **(A)** Presence of ravines in the abandoned road in 2013. **(B)** Recovery of the abandoned road in rehabilitation works of “Jardim da Torre” neighborhood in 2014. **(C)** Appearance of incision V1-b in 2015. **(D)** Intensification of the erosive process in 2019. Source: Adapted from Google Earth, 2002–2019.

Regarding V1-b, besides being also originated by the construction of the waste landfill, it can also be attributed to the presence of an abandoned urban road, coming from a subdivision of the “Jardim da Torre” neighborhood. The historical series of satellite imagery shows that this road was abandoned until 2004 (Figure 10A). However, it was reopened and used as a way to access the construction waste dump trucks on site between 2004 and 2008, which exposed the soil and contributed to the instability of the embankment slope (Figure 10B).

These changes in the original configuration of the area led to the intensification of erosive processes at the site through runoff, creating ravines along the entire road (Figure 10C). By 2019, the V1-b incision was already connected to the V1-a incision at the floor of the valley, forming a forked gully (Figure 10D).

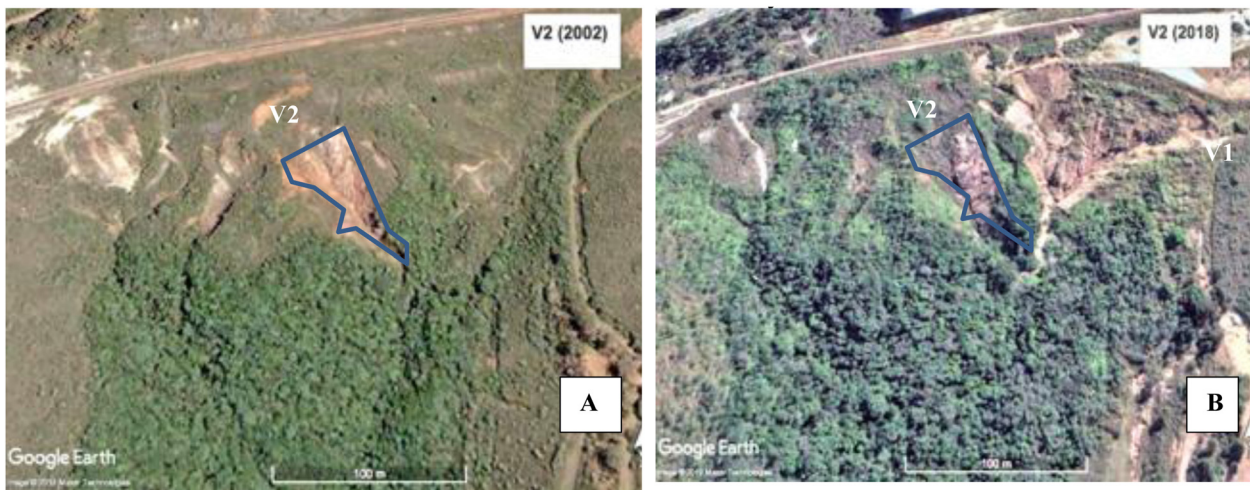
FIGURE 11 | Evolution of Gully V2. **(A)** Incision of V2 gully in 2002 and **(B)** V2 in 2018, with V1 on its right side; gully V2 - delimited in blue. Source: Adapted from Google Earth, 2002–2019.

There are no image records of the emergence of V2 gully. In the first available satellite image of Google Earth (2002–2019), their existence is already verified. From its position on the ground, it can be inferred that there was slipping of the topsoil due to reduced vegetation cover previously removed from the site (**Figure 11A**).

In the most recent available image of gully V2 (2018), it is clear that there was no significant evolution in its dimensions. However, native vegetation did not regenerate at the site (**Figure 11B**).

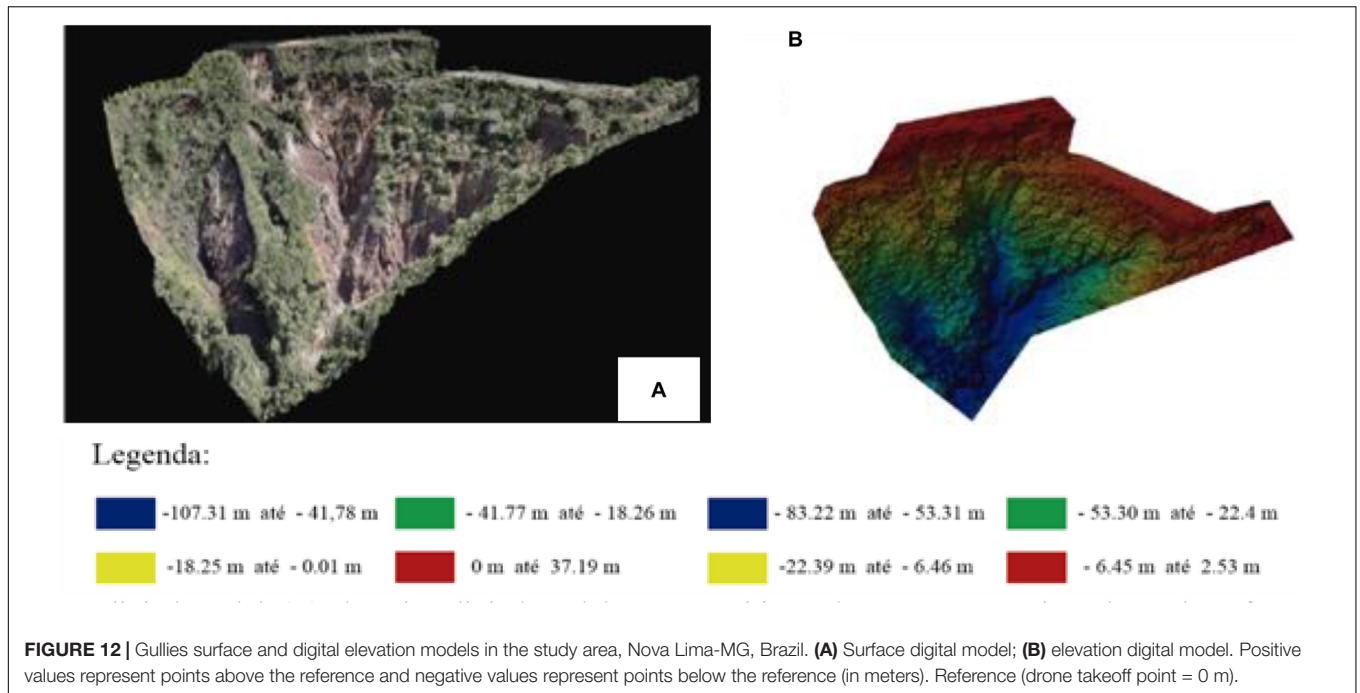
With the MDE of the area surrounding the gullies, it was found that the land has an elevation difference of 144.5 m, from the lowest point to the highest point of the slope. The head of the V1 gully was used as a takeoff point for the drone. It was possible to verify an average difference in elevation of the gullies of 84.75 m, considering the distance between the head of the gully (surface to be the drone takeoff location) and its lowest point on the slope (**Figure 12**).

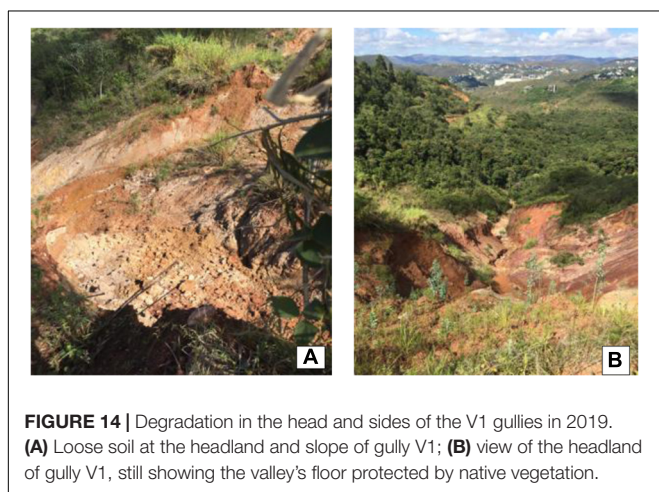
In the present work, measurements were taken of the satellite image of the gully obtained from Google Earth, and it was estimated that in 2014, the area of the gully V1 was approximately 1.2 hectares. In the current study conducted in 2019, it was estimated for the same gully (V1), an area of 1.52 ha, an expansion of 26% compared to 2014. Regardless of the estimated area and volume values, the progress of erosion processes is visible from satellite images, from images also obtained by the drone and visually at the site. The increase in the area of the V1 gully found over the years is also associated with the low percentage of soil cover, and the flow of rainwater directed to it (**Figure 14**).
