Corrosion Fatigue Studies on a Bulk Glassy Zr-Based Alloy under Three-Point Bending

Daniel Grell^{1*}, Yannic Wilkin¹, Petre F. Gostin², Annett Gebert² and Eberhard Kerscher¹

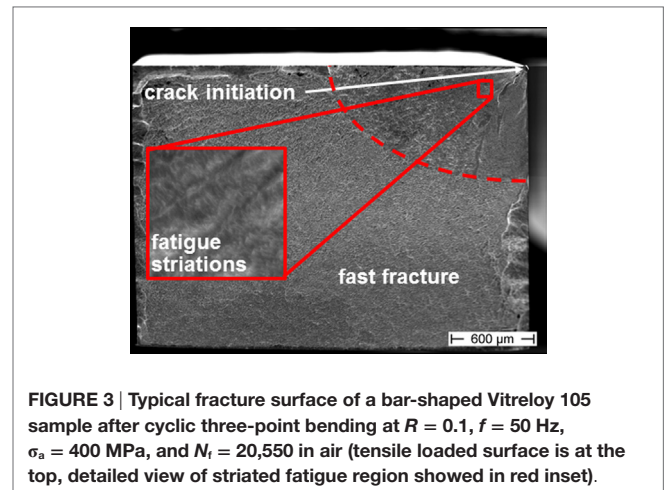
Fractographic analysis of samples fractured in air revealed characteristic features of Zr-based BMG fracture surfaces as also detected in Hess et al. (2006) and Morrison et al. (2007b). **Figure 3** shows a representative fracture surface of the three-point bending fatigue samples. Cracks were found to initiate at the tensile stressed surface, especially at sample edges starting from small surface defects or sometimes at near-surface micropores that act as supplementary stress concentrators (not shown here). Stable crack growth occurred in the quarter-elliptical fatigue region that is characterized by fine striations (see red inset in **Figure 3**) that result from stepwise crack propagation along small shear bands arising in the plastic zone in front of the crack tip. However, crack propagation could not be correlated directly to striation spacing, which suggests that there is an accumulation of damage over several loading cycles as also reported by Liu et al. (2015). The area of fatigue crack growth covered between 6 and 35% of the whole fracture surface in the present study. After passing a sharp transition region, the crack propagates much faster until final fracture occurs. The resulting fast fracture region has a characteristic vein-like morphology, which is commonly observed in BMGs.

explained by a varying sample quality. Fracture can be influenced by micropores with sizes up to $50 \mu\text{m}$ as well as by other material imperfections (e.g., unmolten particles). The formation of such defects during the suction casting process could not be avoided completely. Both features led to a shifting of the crack initiation site from the tensile-stressed surface to inner regions in some cases, and this could also be detected on the fracture surface.

Besides the bending fatigue samples tested in air, which showed the characteristic features on their fracture surfaces (see **Figure 3**), the polarized samples have also been investigated by SEM. The observed fractographic characteristics are presented exemplarily in **Figure 7** on a CF sample tested at $\sigma_a = 388$ MPa and an anodic potential of 0 mV vs. SCE.
