Fire resistance of composite shear walls filled with demolished concrete lumps and self-compacting concrete

composite shear walls, fire performance, demolished concrete lumps, self-compacting concrete, experimental study

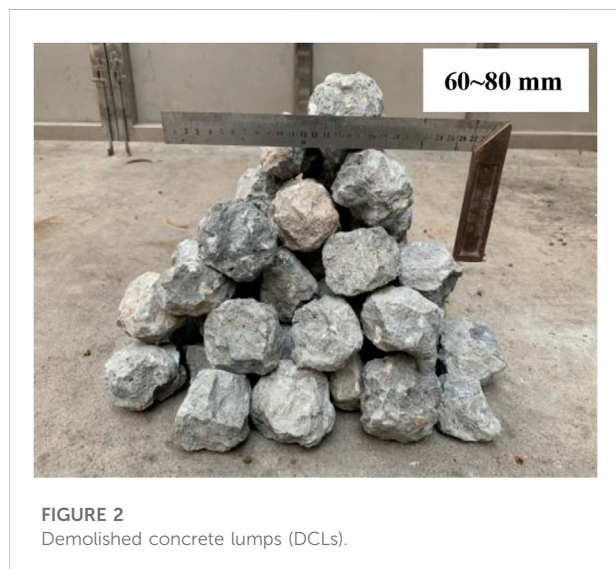
FIGURE 2
Demolished concrete lumps (DCLs).

39.7 MPa according to Technical Specification for Testing Concrete Strength with Drilled Core. As is shown in Figure 2, the waste concrete was manually crushed into concrete blocks with characteristic dimensions of 60–80 mm.

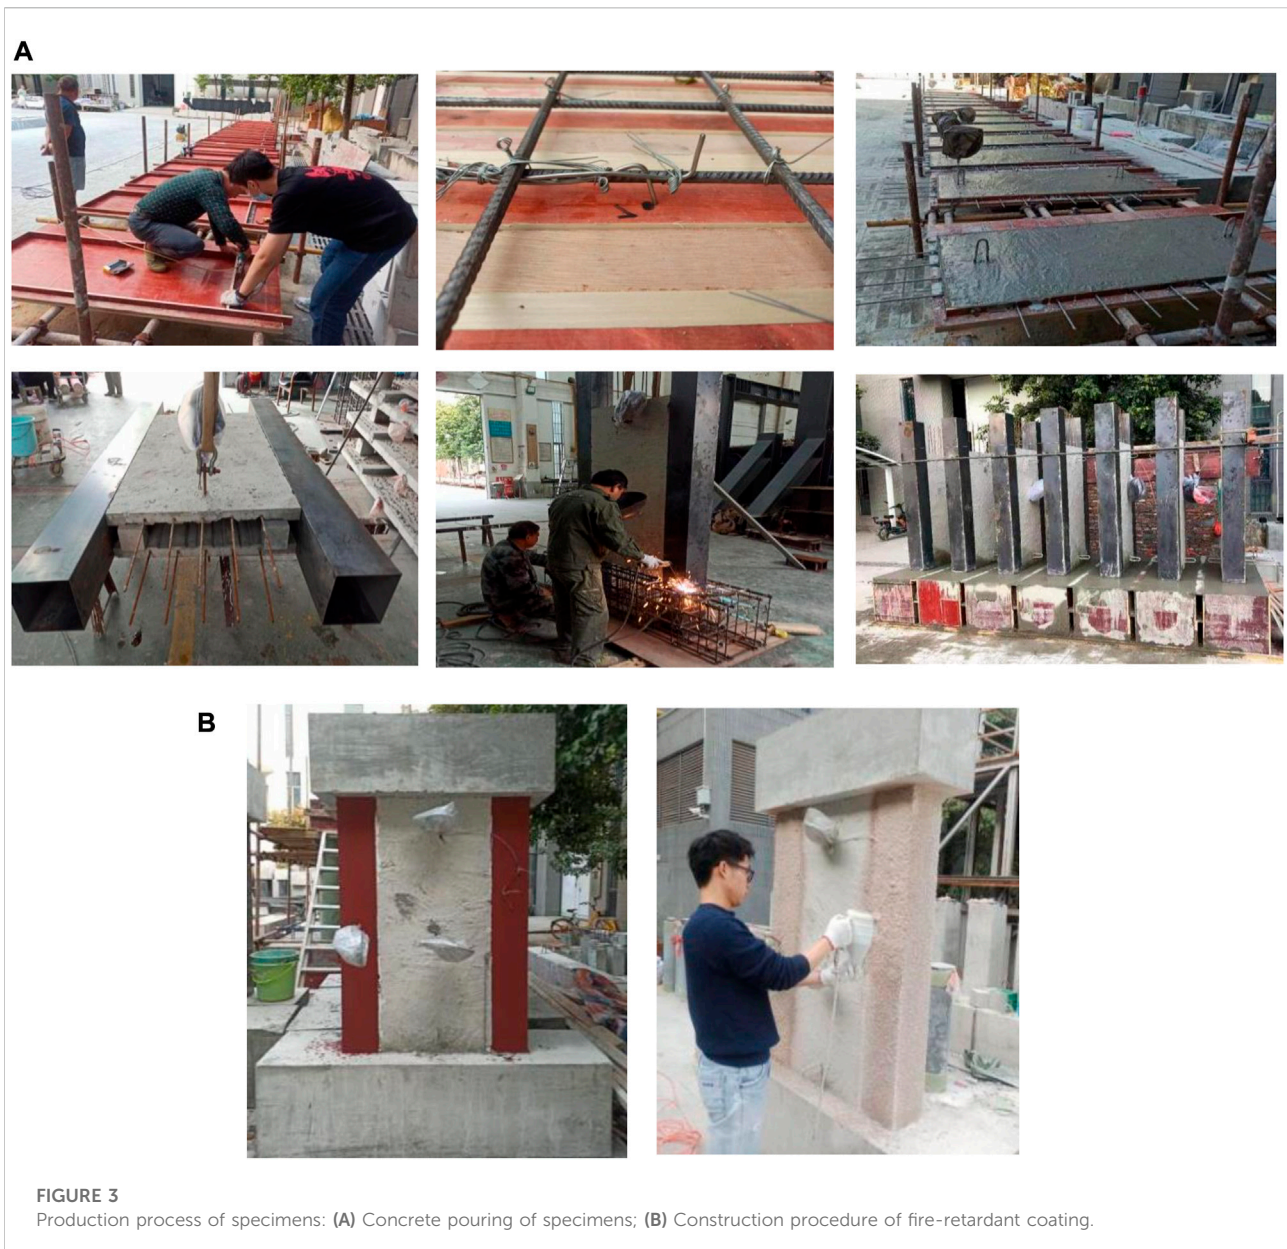
step was to pour the foundation beam. The fourth step was the pouring of concrete in the cavity of the precast walls and the square steel tubes, as well as the pouring of concrete for the loading beam. One hour before pouring, the waste concrete blocks were well wetted by spraying tap water. During the formal pouring process, self-compacting fresh concrete with a thickness of about 20 mm was first poured into the cavity of the precast walls and square steel tubes, and then the waste concrete blocks and self-compacting fresh concrete were alternately placed into the cavity of the precast walls and square steel tubes with short time assisted vibration using a vibrator. Finally, the loading beam was poured with cast-in-place self-compacting concrete. The fabrication process of the specimens is shown in Figure 3A.

anti-rust primer was applied, and the primer was brushed after the anti-rust primer was thoroughly dried, and then the fire-retardant coating was sprayed. Fire-retardant coating and water were mixed in proportion of 1:1 for 5–10 min and sprayed on the surface of steel tube with a portable spray gun. First, the first layer of fire-retardant coating with a thickness of about 10 mm was sprayed on the surface of steel tubes, and then the second layer of fire-retardant coating with a thickness of about 10 mm was sprayed after an interval of 24 h. Finally, the total thickness of fire-retardant coating on the surface of steel tubes was 20 mm, as shown in Figure 3B.

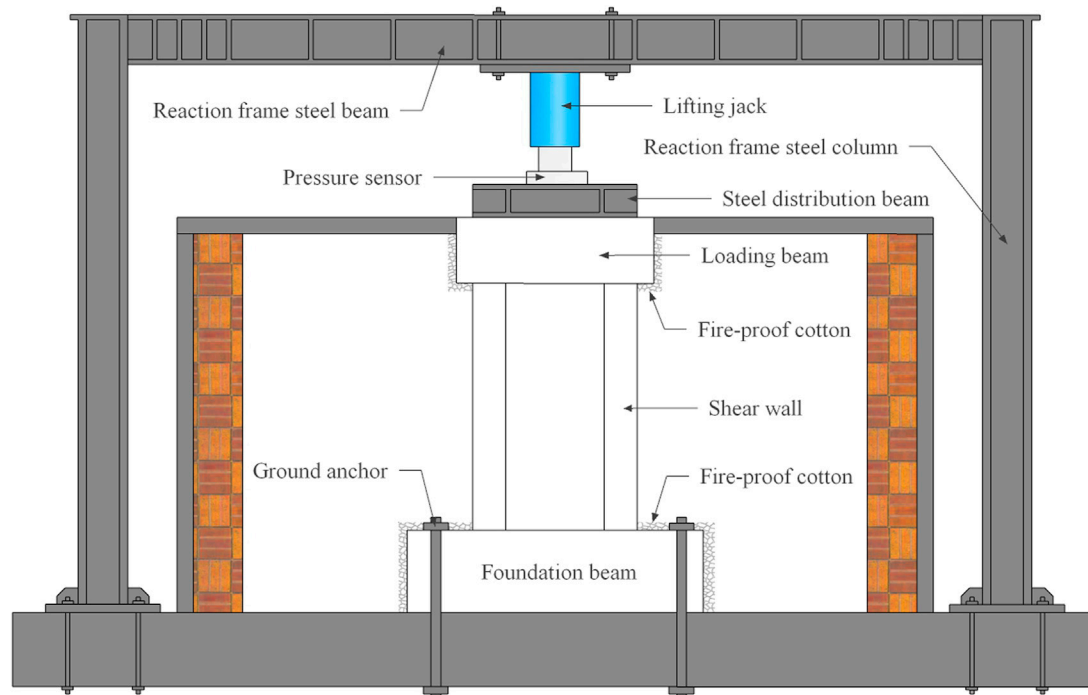
FIGURE 4
Test setup.

The dimensions of the furnace chamber were $4\text{ m} \times 3\text{ m} \times 2.2\text{ m}$. The maximum load capacity of the reaction frame above the furnace was $1,800\text{ kN}$, and a 200-t pressure sensor was set between the jack and the steel distribution beam for real-time monitoring of the vertical load during the test. The test setup is shown in Figure 4.

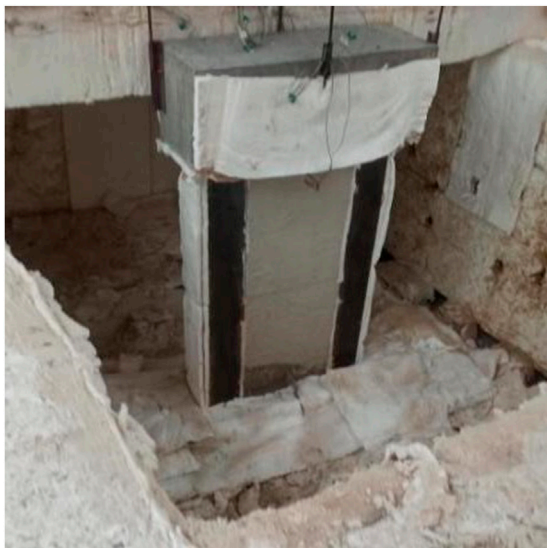
FIGURE 5
Fire protection treatment of specimens.

During the fire resistance test, two layers of fireproof cotton were wrapped around the concrete surfaces of the loading beam and foundation beam to ensure that the loading beam and foundation beam would not be damaged throughout the test. The left and right sides of the specimen were wrapped with two layers of fireproof cotton to ensure that both sides of the shear wall were exposed to fire. The fire protection treatment of specimens is shown in Figure 5.

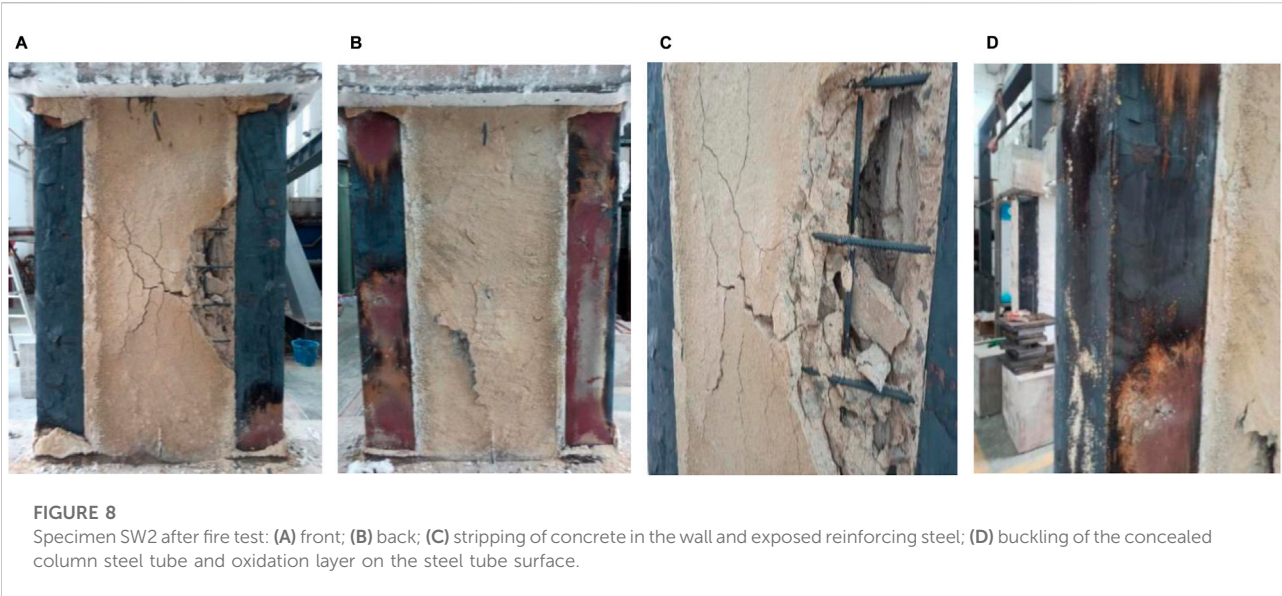
At the end of the flame test, when the temperature cooled to room temperature and the furnace lid was opened, it was observed that the fire-retardant coating of the specimen had peeled off (but it can be seen from Figure 11B that the temperature field of the square steel tube cross-section did not rise rapidly throughout the open flame test. Therefore, the peeling of the fire-retardant coating occurred after the test, probably due to the vibration when the furnace lid was opened.). The concrete surface of the specimen was light yellow after the fire. The concrete on one side of the specimen near the steel tube was heavily spalled, horizontal and vertical reinforcement was exposed, and the precast walls on this side was bulging. On the other side of the specimen, several small cracks with irregular distribution appeared on the concrete surface, and

the concrete surface of the wall tended to spall, but no reinforcement was exposed. Since the outer surface of the steel tube was coated with fire-retardant coating, the steel tube did not bulge and the surface was relatively flat. The failure mode of specimen SW2 is shown in Figure 8.

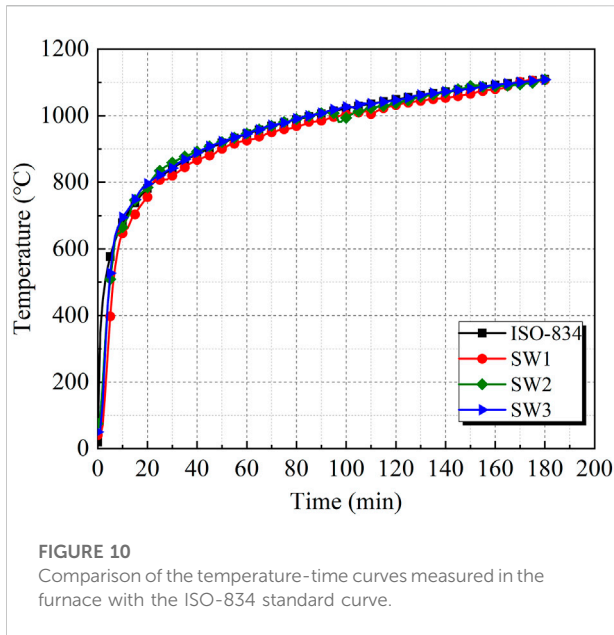
Figure 10 shows the measured average air temperature-burning time curves in the furnace chamber for three specimens compared to the ISO-834 standard temperature rise curve. It can be seen from the figure that the measured heating curves of the three specimens are basically consistent with the standard fire temperature-time curve.
