# Impact of deicing salts on pervious concrete pavement

Two pervious concrete projects (named as SR28 and SR431), with the same mixture design but different winter maintenance activities, were included in this research. Both projects are located in the Lake Tahoe area, Nevada, United States. Testing results indicated that the mechanical properties were significantly higher in SR28 cored samples than the ones in SR431. It was found that the SR28 pieces have fewer air voids, while the SR431 samples have higher water absorption and hydraulic conductivity, and the SR28 samples show fare better performance against repeated freezing and thawing cycles than the SR431 ones. scanning electron microscope pictures of crack surfaces in cores taken from SR28 indicate that the cement binder phase has been largely retained. However, in the coring sample of SR431, needle-shaped residues can be seen within the cement binder phase and an abundance of precipitated micro-sized crystalized particles can be observed. On a micrometer scale, the  $\mu$ CT examination reveals that the porosity of SR28 samples is significantly less than that of SR431. The analyzing results give a clue to demonstrate the du

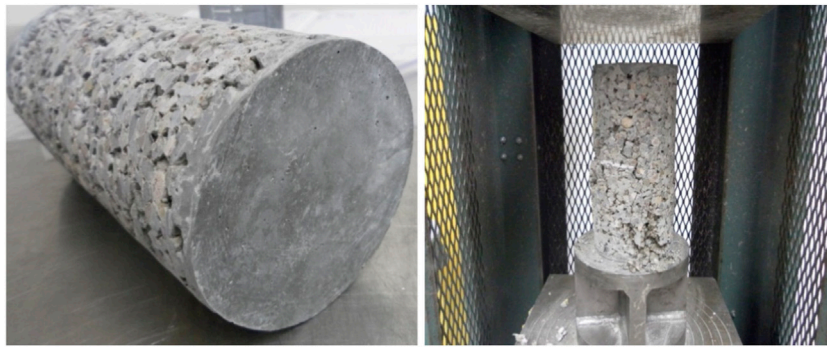
**FIGURE 1**  
Compressive strength testing pictures of samples.

Six height measurements were taken of each sample after the cement tops had cured. After that, the cores were broken apart by being vertically crushed at a rate of 200 kg per second ([Figure 1](#)). For each specimen, the enormous force required to produce failure was measured and documented.

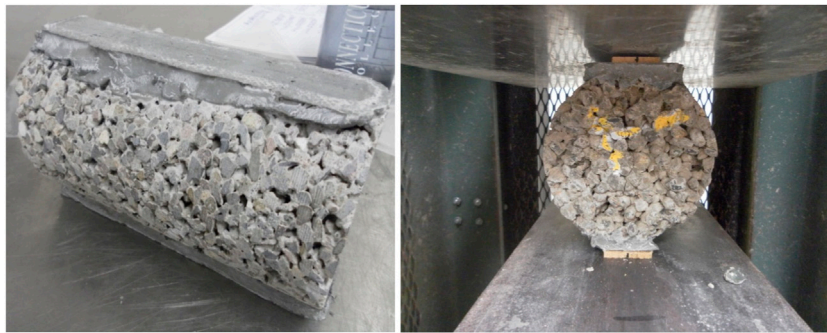
**FIGURE 2**  
Splitting tensile strength test process.

After being cured, the six heights of each cement sample were measured. Following the failure at 60 kg/s, the cores were crushed along their diameter. For each sample, the highest force applied to achieve loss was recorded. Figure 2 depicts the sample pictures for the strength testing results.

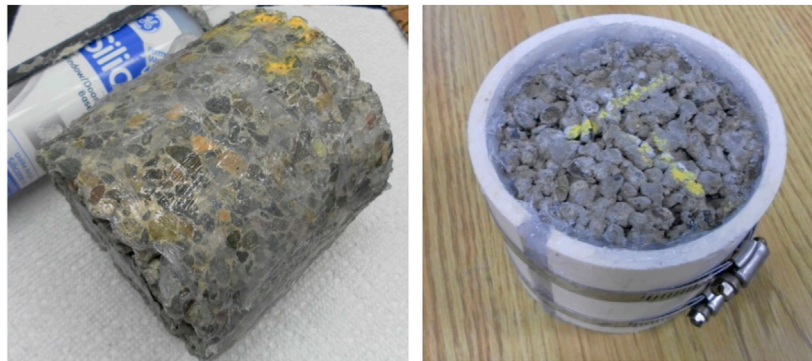
**FIGURE 3**  
Pictures of water permeability testing preparation.

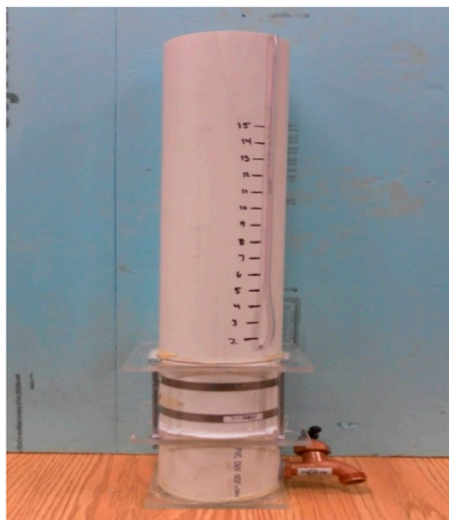
**FIGURE 4**  
The test equipment for water permeability.

To make a standpipe, a PVC pipe with a nominal diameter of 4 inches was utilized. Schaefer et al. (2006) inspired the design of the standpipe. Each standpipe required the cutting of three pipe pieces: a length of 51 cm (20 inches) for the top standpipe tube and two portions measuring 10.2 cm in length. The bottom drainage reservoir was made out of one of the 10.2 cm components. The other 10.2 cm section included the specimen.

Water came out of a hole with a radius of 1.55 cm in the bottom of the PVC. The pipe's bottom was sealed with silicone sealant. Drill a hole with a radius of 5.1 in the center of another plastic plate. The second plate was hit with four holes in the four outer quadrants. After that, to align the second plate with the pipe's 10.2 cm opening, it was secured to the head of the lower piece of PVC.

Close to the bottom, a small hole was bored into the top PVC piece. This hole was used to attach a small, clear plastic pipe that measured the standpipe's water level and was affixed to the outside in a straight, vertical position. The transparent line was then drawn at one-inch intervals by measurement from the PVC's bottom to a height of 38.1 cm. The bottom of the top PVC piece was covered with a plastic plate.

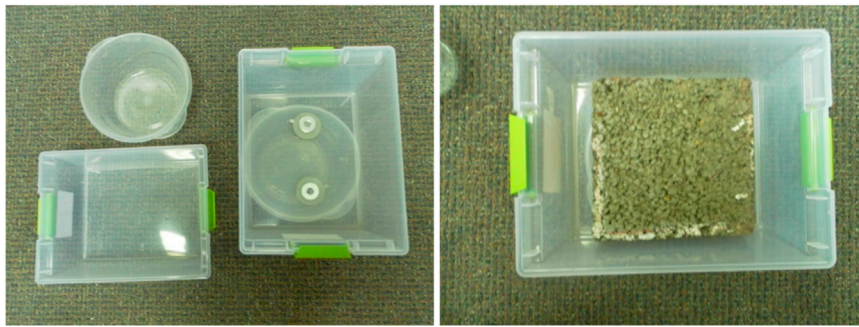
**FIGURE 5**  
Pictures of testing the salt scaling procedure.

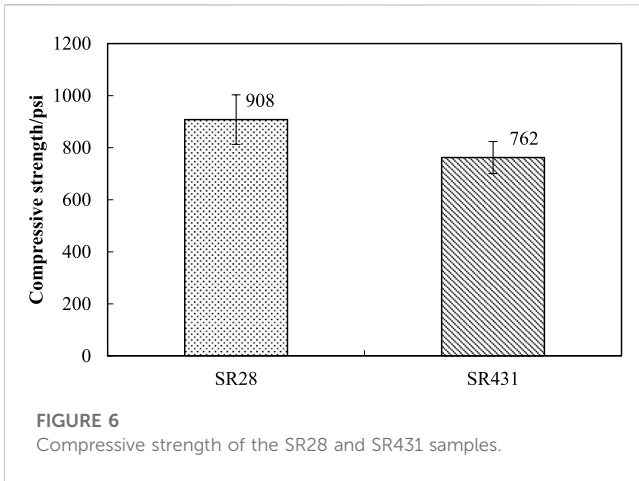
**FIGURE 6**  
Compressive strength of the SR28 and SR431 samples.

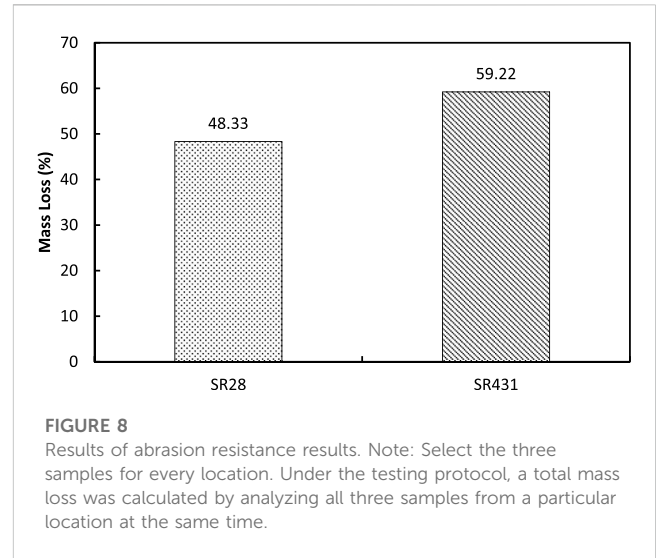
**FIGURE 8**  
Results of abrasion resistance results. Note: Select the three samples for every location. Under the testing protocol, a total mass loss was calculated by analyzing all three samples from a particular location at the same time.

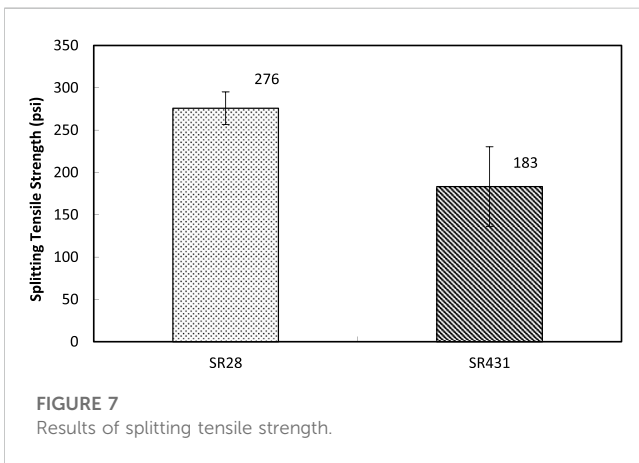
**FIGURE 7**  
Results of splitting tensile strength.

Figure 7 displays the results for splitting tensile strength. The strength of the concrete samples from SR28 compared to SR431 was higher, measuring  $1.9 \pm 0.13$  MPa and  $1.26 \pm 0.32$  MPa, similar to the results of the compressive strength testing.

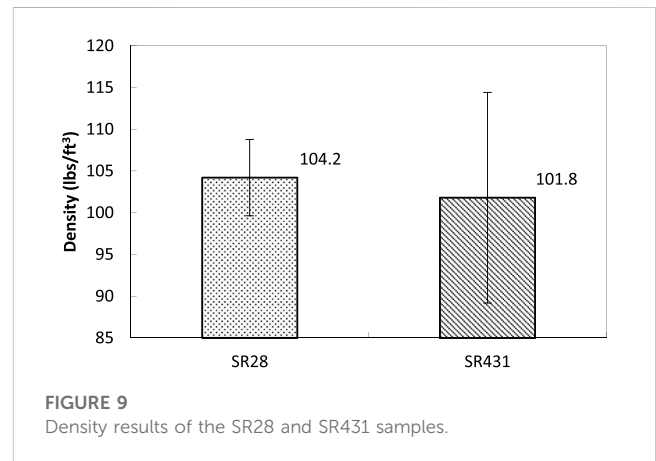
**FIGURE 9**  
Density results of the SR28 and SR431 samples.

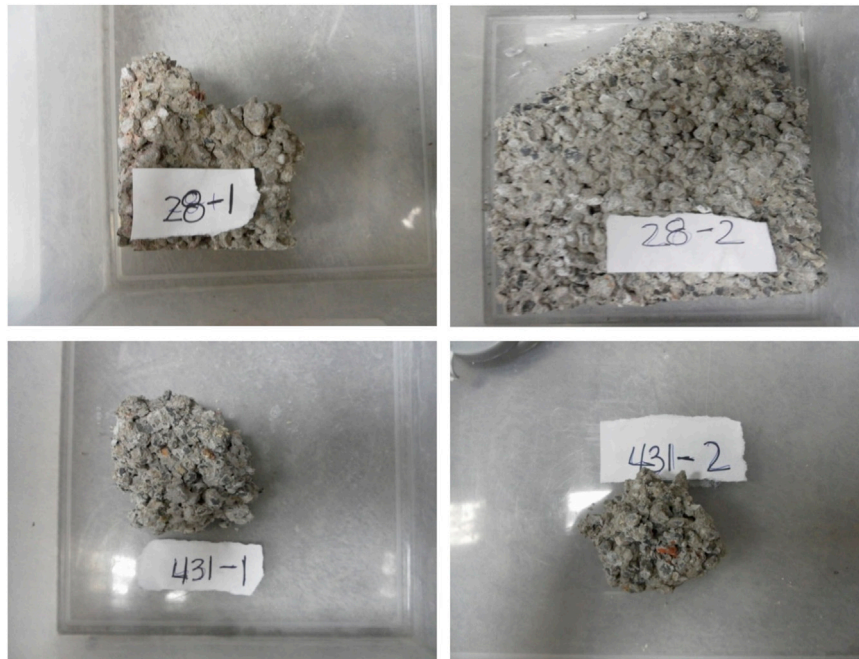
**FIGURE 13**  
Following seven freeze/thaw cycles, the size of the SR28 and SR431.

The exterior dimensions of concrete samples subjected to seven freeze/thaw cycles using a 3% NaCl solution are shown in Figure 13. The SR431 samples display more noticeable salt scaling compared to the SR28 which have exterior dimensions that are generally well-retained. Figure 14 shows the mass loss from SR28 and SR431 has a math relationship with freeze/thaw cycles in a solution of 3% salt solution. The picture shows that the SR28 site's mass loss is more stable than the SR431. The mass losses changing the SR28 were from

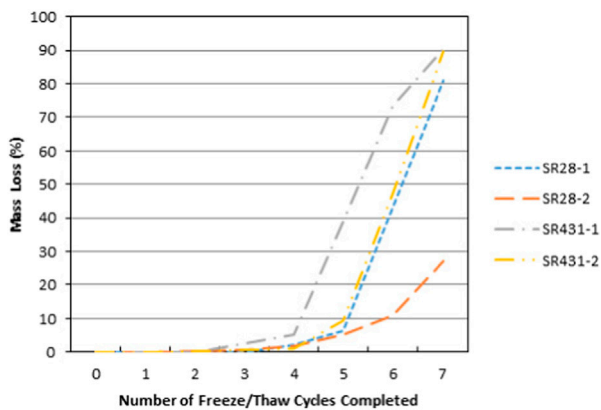
**FIGURE 14**  
Loss in mass of samples from SR28 and SR431.

81.07% to 27.24% after seven freeze/thaw cycles in 3% NaCl solution, whereas the mass losses of the SR431 sample were 90.35% and 89.77%, respectively.

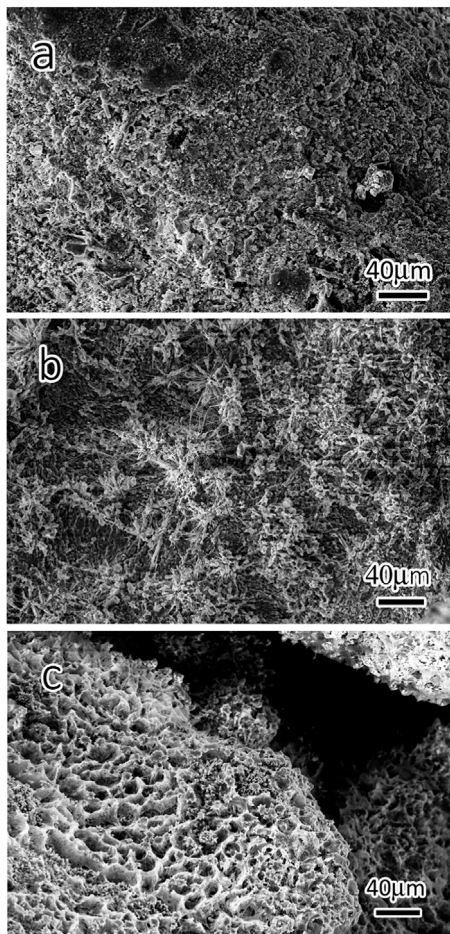
**FIGURE 15**  
Fracture surface SEM pictures in low magnification of SR431 (A) limited, (B) moderate, and (C) severe.

were observed by using SEM. Figure 15 shows the SEM characteristics of the core from the SR431 site. Parts Figures 15A–C of this figure stand for limited, moderate, and severe conditions, respectively. Although there are a few porous areas, Figure 15A) of the small sample exhibits a rather strong amorphous cementitious phase. The amount of amorphous phase has greatly decreased in Figure 15B), where needle-shaped precipitates may be seen. Additionally, as can be shown in Figure 15C), the amorphous phase evolved into pores, and many tiny crystals have been observed in the pores.

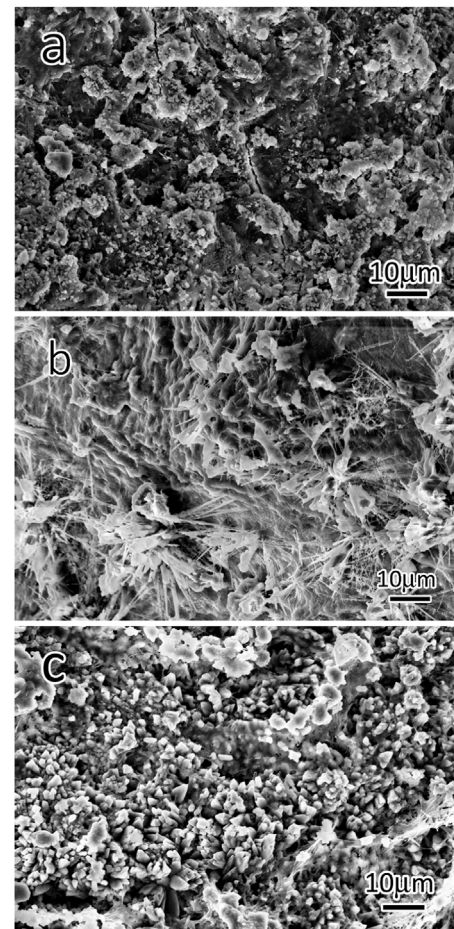
**FIGURE 16**  
Fracture surface SEM pictures in high magnification of SR431 a) limited, (B) moderate, and (C) severe.

The SEM of SR431 is shown in Figure 16 to show more structural properties. The limited, moderate, and severe environments were shown in Figures 16A–C, correspondingly. A fraction of the cementitious phase contained several crystal structures, while other similar amorphous phases were also found but lacked random orientations. Despite the majority of the material in Figure 16B being the homogeneous amorphous binder phase, a great number of needle-shaped deposits be detected. The majority of the phase has been replaced as the dominant phase in Figure 16C by the needle-shaped precipitates, which have grown into massive crystals.

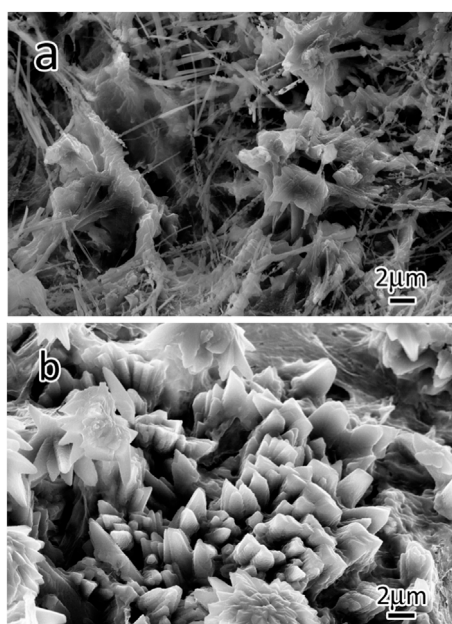
**FIGURE 17**  
Fracture surface SEM pictures in high magnification of SR431, (A) moderate, and (B) severe.

In Figure 17, the high-magnification SEM pictures of SR431 under different conditions. Figure 17A gives the needle-shaped precipitates with diameters around 100 nm and smooth or rough surfaces. In the needle-shaped agglomerates, a minor quantity of the binder phases, which primarily contribute to the samples' strength, may still be visible. However, as illustrated in Figure 17B, the binder phase is rarely visible, and many crystals were found in place of sediments in the shape of needles. The diameter is 1  $\mu\text{m}$  and the length is 10  $\mu\text{m}$  of the crystals that were measured. This explains why these samples have the worst strength.

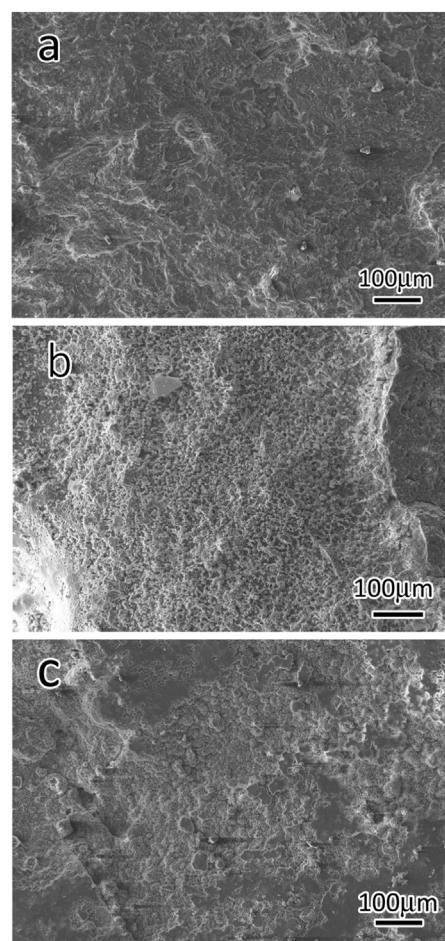
**FIGURE 18**  
Fracture surface SEM pictures in low magnification of the SR28 site, (A) limited, (B) moderate, and (C) severe.

The microstructure of the SR28 sample also was studied the same as the SR431. Figure 18 shows the SEM pictures of the fracture surfaces of samples of SR28. The fracture surface of the limited selection one, illustrated in Figure 18A, has a normal amorphous phase. It can be seen that the microscopic morphology of the sample is very dense, and the pores are invisible. No residues are seen on the fracture surface, which is relatively flat. In moderate samples, the surface is less flat than in limited samples. Despite the main binder phase still predominating, some uniformly distributed precipitates have been found. The severe samples exhibit extremely rough surfaces with many crystal residues, similar to the samples from site SR431 (Figure 18C).

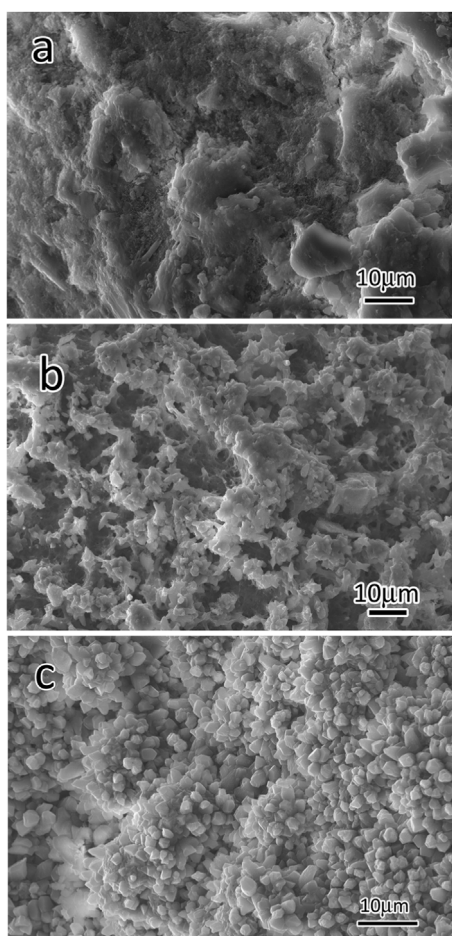
**FIGURE 19**  
Fracture surface SEM pictures in high magnification of the SR28, (A) limited, (B) moderate, and (C) severe.

Figure 19 depicts the SEM fracture morphology of a cored sample of SR28. The amorphous binder phase is in great condition and there are not many precipitates in Figure 19A. Figure 19B shows that the homogenous amorphous phase has decreased in quantity and has been replaced by some crystal-sized nanoparticles. Distinct from the SR431, the precipitated equidistant crystals are the dominant phase in SR28, and the majority of the amorphous phase is present. Approximately 1  $\mu\text{m}$  is the average size of the isotropic crystals. The samples from SR431-

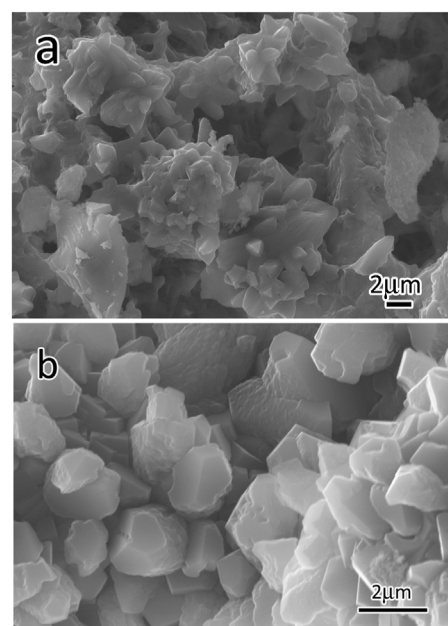
**FIGURE 20**  
Fracture surface SEM pictures in high magnification of the SR28, (A) moderate, and (B) severe.

The morphology of SR28-mod samples under different conditions showed in Figure 20 using magnified high-magnification SEM. The amorphous binder phase contains a few isotropic crystals. Furthermore, in Figure 20B, a little amount of amorphous phase and a lot of isotropic crystals were discovered to be the dominating phases. The crystals were around 1  $\mu$ m in size on average.

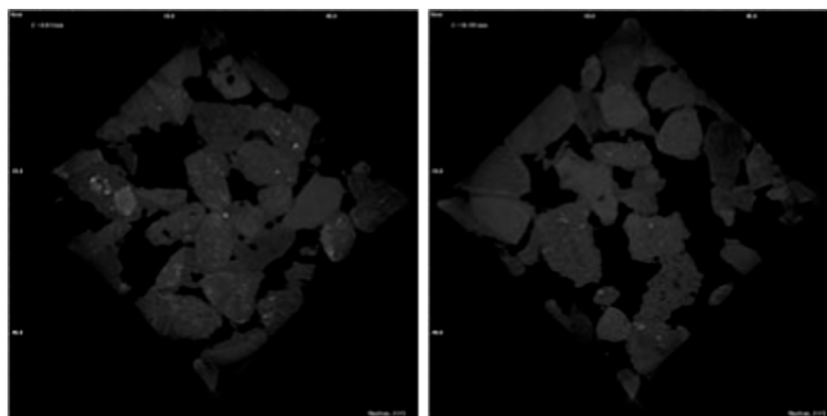
**FIGURE 21**  
The  $\mu$ CT pictures of the SR28 sample.

The samples from SR28 and SR431 exhibit the usual 2D microstructures in Figures 21, 22. As demonstrated by these pictures, pore content was higher in SR431 than in SR28.

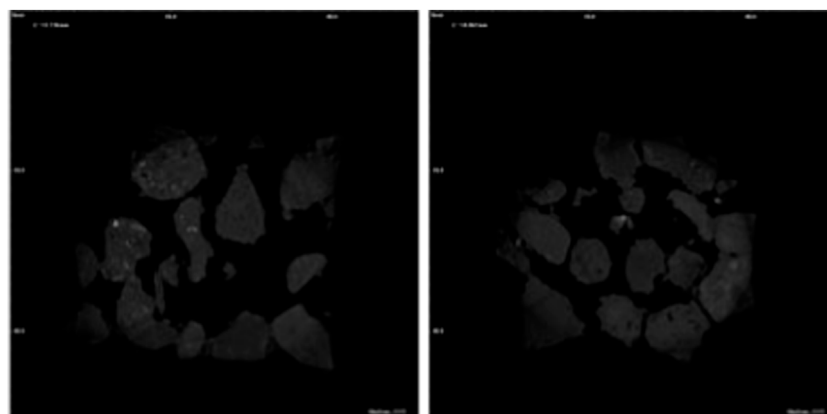
**FIGURE 22**  
The  $\mu$ CT pictures of the SR431 sample.
