Wang J, Pang S, Ji S, Li X, Wang L and
Zhang J (2024), Weathering resistance of
novel sustainable prefabricated thermal
insulation wall.

Weathering resistance of novel sustainable prefabricated thermal insulation wall

prefabricated concrete, sandwich insulation wall panel, weathering resistance, temperature effects, concrete

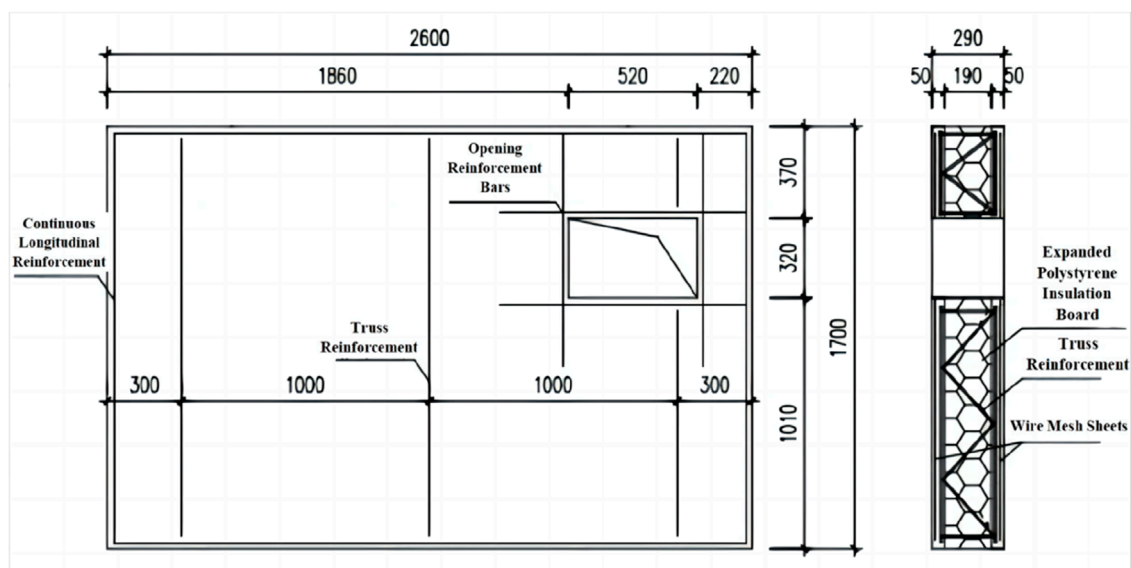
FIGURE 1
Design illustration of the insulation wall panel.

The specification of the wall panel is shown in Figure 1. The sandwich insulation wall panel specimen is mainly composed of the following parts: inner leaf wall (C30 self-compacting concrete), insulation layer (EPS insulation board), outer leaf wall (C30 self-compacting concrete), connectors (truss reinforcement), anti-cracking layer (steel mesh), finish layer (flexible waterproof putty, coating, and finish tiles). The upper half of the external finish consists of coated finish, while the lower half is composed of finish tiles.

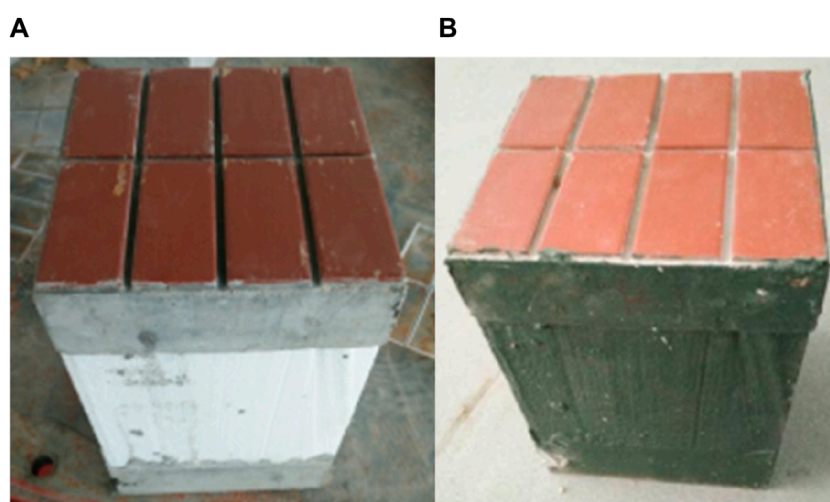
FIGURE 2
Insulation wall cubic specimens: (A) before waterproof treatment and (B) after waterproof treatment.

To obtain the bonding strength between finish tiles and wall panels at different stages of the experimental process and analyze their variation patterns, synchronous test blocks were tested during the weathering resistance test. At each stage of the experiment, samples of the finish tiles were taken out for testing without damaging the wall panel specimen. Although the bonding strength obtained by this method may not entirely represent the overall changes in the wall panel, it can significantly reflect the damage to the material and interface strength caused by the experimental conditions. Nine sets of sandwich insulation cubic specimens with pasted finish tiles were produced, with dimensions of $200\text{ mm} \times 200\text{ mm} \times 290\text{ mm}$. Except for the absence of truss reinforcement, the procedures for each layer were consistent with the insulation wall panel. The testing block specimen is shown in Figure 2. It is noted that except for the surface covered by finishing tiles, both sides of the other surfaces were coated with waterproof material. This step ensures that moisture only enters from the external finish surface during the test period, making it more representative of the conditions affecting the wall panel.

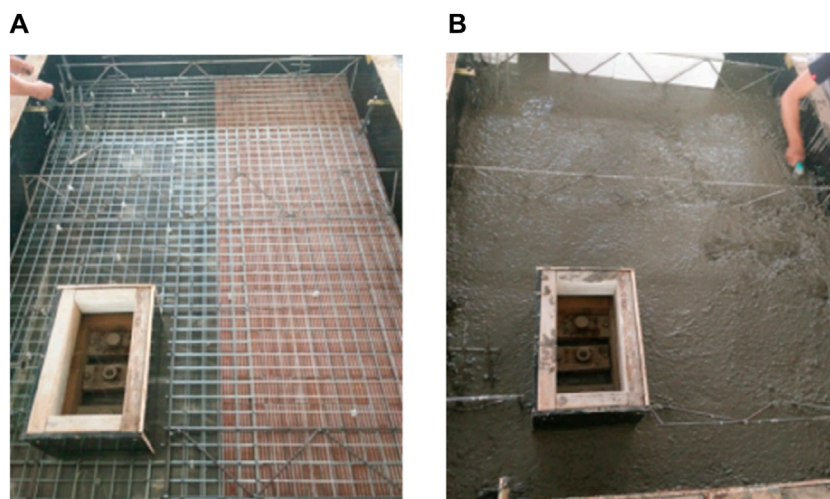
FIGURE 3
The outer wall production. (A) Placement of wire mesh and truss reinforcement; (B) Pouring of concrete and smoothing.

As shown in Figure 3, the pre-bound wire mesh and truss reinforcement was placed into the wall panel mold. It is recommended to add small spacers for proper positioning. The concrete was poured starting from the side with finishing tiles, manually controlling the thickness and smoothing the surface.

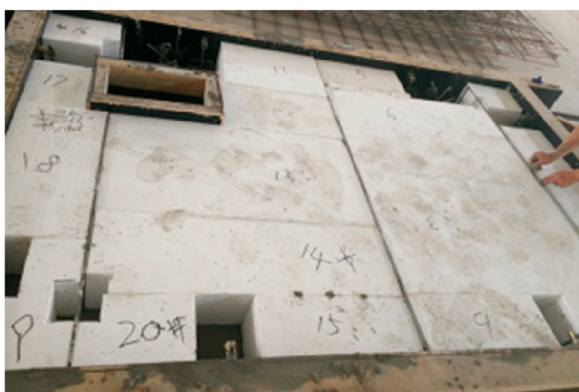
FIGURE 4
Installation of the insulation board.

The openings for embedded parts were reserved. The pre-cut and arranged EPS insulation boards were inserted, and manually compacted and pressed tightly, as shown in Figure 4.

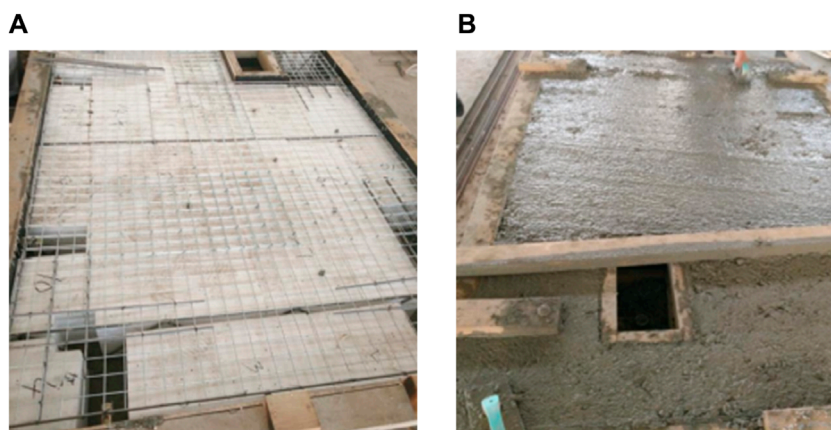
FIGURE 5 Installation of the insulation board. **(A)** Placement of wire mesh and embedded parts; **(B)** Pouring of concrete and smoothing.

The inner wall wire mesh and the embedded parts for wall panel installation were inserted. The wire mesh was properly bound with the truss reinforcement, then the concrete was poured and the surface was smoothed, as shown in Figure 5.

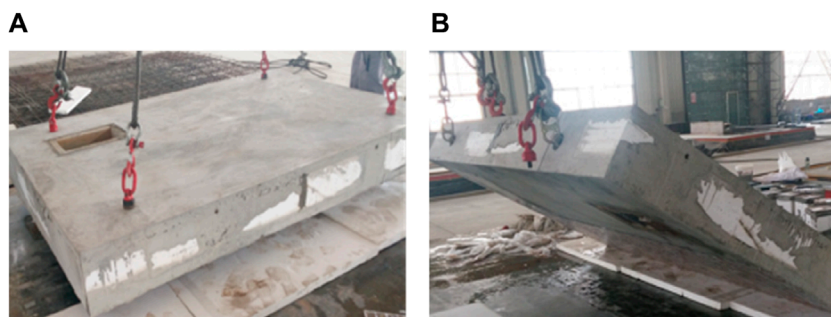
FIGURE 6 Hoisting and installment of the wall panel. **(A)** Horizontal lifting of the wall panel; **(B)** Vertical hoisting of the wall panel.

As shown in Figure 6, the wall panel mold was removed, and the wall panel was lifted horizontally using a crane. The insulation boards were placed at both ends of the wall panel after demolding. Then the wall panel was lifted vertically and positioned on the wall panel supports.

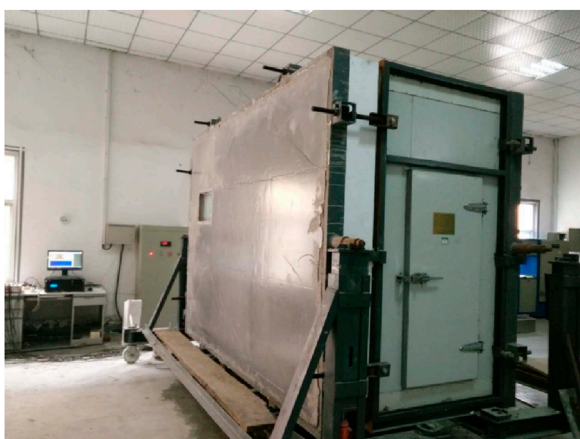
FIGURE 7 The wall panel and testing equipment after installation.

The sandwich insulation wall panel was secured to the base wall using expansion bolts around the perimeter of the test base. The gaps between the inner leaf of the test wall panel and the surrounding base wall were filled with adhesive to prevent unnecessary moisture from affecting the test results. The installed wall panel and instruments are depicted in Figure 7, with the test wall panel positioned inside the box for the next steps of the test.

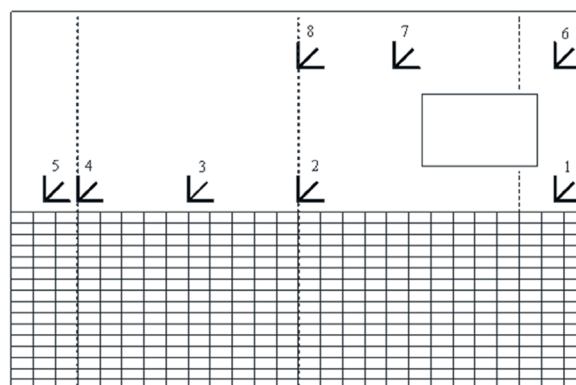
FIGURE 8 Illustration of strain gauge positions.

To monitor the strain variations at different locations of the sandwich thermal insulation wall panel throughout the entire experiment (Hou et al., 2019a), strain gauges were affixed to the concrete surface of the external leaf wall, as illustrated in Figure 8. Positions 1, 6, and 7 were primarily designated for detecting strains near the window openings. Positions 2 and 4 were located on the concrete outside the truss steel bars, position 3 was in the concrete between two truss steel bars, and positions 2 and 8 were

at different locations on the same truss steel bar. These positions were mainly utilized to analyze the stress impact of truss steel bars on the external leaf concrete. This approach aimed to analyze the

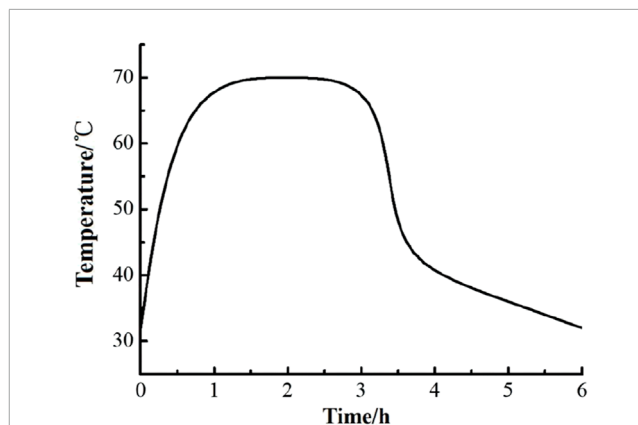
FIGURE 9
Thermal-rain cycle temperature loading curve.

Thermal-rain cycling was conducted for a total of 80 cycles, with each cycle lasting 6 h. The sample temperature was raised to $(70 \pm 5)^\circ\text{C}$ within 1 h and maintained for 2 h in an environment with a temperature of $(70 \pm 5)^\circ\text{C}$ and relative humidity of 10%–30%. Then water spraying was performed for 1 h at a water temperature of $(15 \pm 5)^\circ\text{C}$, with each wall panel sample sprayed with a volume of $(1.0 \pm 0.1) \text{ L}/(\text{m}^2 \cdot \text{min})$, followed by a 2-h resting period. Thermal-cold cycling was conducted for a total of 5 cycles, with each cycle lasting 24 h. The specimen temperature was raised to $(50 \pm 5)^\circ\text{C}$ within 1 h and maintained for 7 h in an environment with a temperature of $(50 \pm 5)^\circ\text{C}$ and a maximum relative humidity of 30%. Then the sample temperature was lowered to $(-20 \pm 5)^\circ\text{C}$ within 2 h and maintained for 14 h in an environment with a temperature of $(-20 \pm 5)^\circ\text{C}$. Freeze-thaw cycling was performed for 30 cycles, with each cycle lasting 8 h. Water was sprayed for 1 h at a water temperature of $(15 \pm 5)^\circ\text{C}$, with each wall panel sample sprayed with a volume of $(1.0 \pm 0.1) \text{ L}/(\text{m}^2 \cdot \text{min})$. The sample temperature was maintained for 1 h at a temperature of $(20 \pm 5)^\circ\text{C}$. The sample temperature was lowered to -20°C within 1 h and maintained for 4 h in an environment with a temperature of $(-20 \pm 5)^\circ\text{C}$. The sample temperature was raised to 20°C within 0.5 h. Finally, the sample was left to rest for 0.5 h.

The temperature curves of the wall panel's outer surface during one cycle of hot-rain and hot-cold cycles obtained from temperature sensor data are depicted in Figures 9, 10.

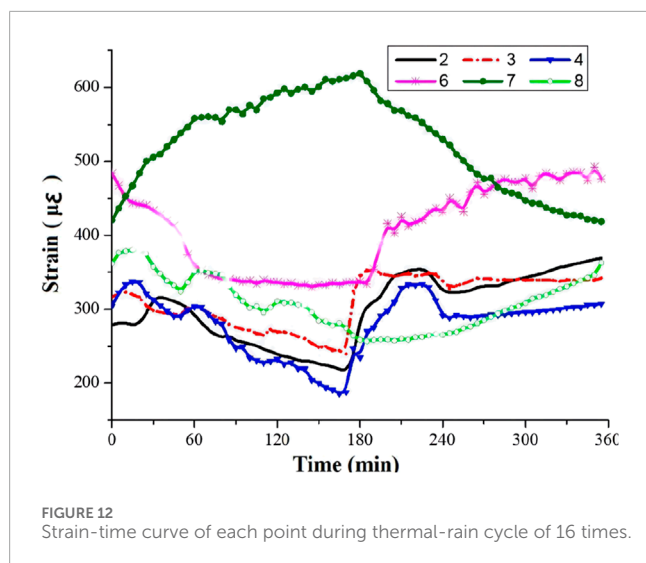
To analyze the strain characteristics at different positions during the same cycle, the strain values at each point in the 16th cycle of the thermal rain cycle were taken, and the strain-time relationship curve was obtained, as shown in Figure 12.

It was found that the strain at each point changed significantly during the 0–60 min heating stage. During the 60–180 min high-temperature constant stage, the strain at each point did not completely stop changing but continued to change with slight fluctuations in temperature. During the 180–240 min water-spraying stage, the temperature dropped sharply, and the strain at each point also changed sharply. During the 240–360 min drying stage, the strain continued to change but with a smaller amplitude. Tensile strain showed in position 7 with the increase in temperature and compressive strain with the decrease in temperature, while the other points showed the opposite trend. Compressive strain occurred during the heating stage and tensile strain during the cooling stage. It can be seen that, unlike the thermal expansion and

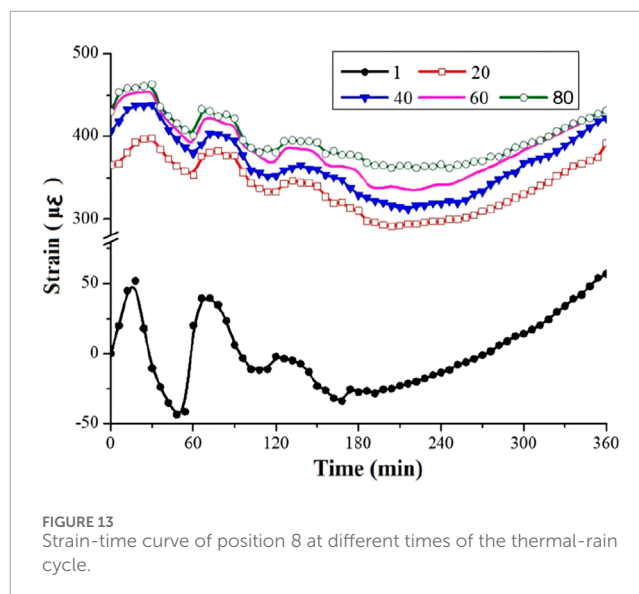
To analyze the influence of different numbers of cycles on the concrete strain, strain curves at position 8 in the 1st, 20th, 40th, 60th, and 80th thermal rain cycles were taken, as shown in Figure 13. It was found that in the 1st thermal rain cycle, at the beginning of the test, the heating instrument inside the box had just started working, and the temperature rise process had not reached a relatively uniform and stable state compared to later cycles. Therefore, the initial fluctuation was relatively large, but the overall trend was consistent. In addition, the strain growth during the first 20 cycles was significant, and after 20 cycles, the strain continued to increase, but the growth rate was very small, and the deformation amplitude decreased with more cycles. This indicates that the strain and deformation at this location mainly occurred in the early cycles, and there was residual strain and deformation at the end of each cycle, continuously accumulating to produce plastic deformation. Point 8 was located at the upper part of the wall panel. During the initial temperature rise, this location experiences thermal expansion, but it was then constrained, and the expansion cannot proceed freely, resulting in compressive stress. However, its deformation was influenced and constrained by the surrounding concrete and window openings, showing fluctuating changes. In the high-temperature stage, the final trend was still dominated by expansion being restricted, with the concrete under compression. Conversely, in the later cooling stage, the concrete undergoes tension, and its changes are much smoother than in the heating stage.

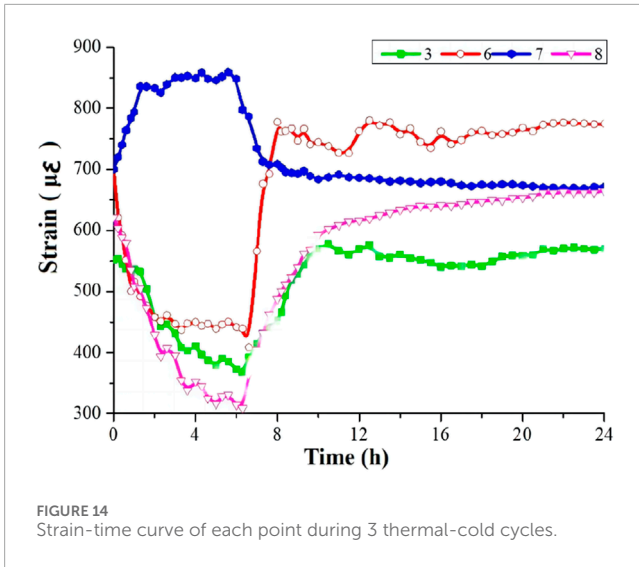
The strain analyses was conducted on points 3, 6, 7, and 8 on the outer surface of the wall panel during the third cycle of thermal-cold cycles. The strain-time relationship curve is shown in Figure 14. It was found that each point exhibited a consistent trend of strain variation with the thermal-cold cycle, changing periodically along with the temperature curve. During the 0–1-hour heating phase, significant strain changes occurred at all points. In the 1–8-hour high-temperature constant phase, the strain at each point did not completely cease; initially, it continued to change with minor temperature fluctuations and later tended to stabilize with increasing time. In the 8–10-hour cooling phase, a rapid temperature drop resulted in a sharp change in strain at all points. In the 10–24-hour low-temperature constant phase, strain continued to change but with a smaller amplitude, and later, strain almost ceased to change. Point 6 exhibited the largest amplitude and maximum strain value among all measured points, with the greatest changes during the heating and cooling phases. This point is located at the corner near the window, constrained by the edge of the wall panel and the middle of the truss reinforcement. Therefore, during the heating and high-temperature phases, the concrete expansion is significantly constrained, leading to compressive strain. In the cooling and low-temperature phases, the concrete shrinkage is restricted, resulting in a tensile state, and the residual strain after one cycle reaches 150 $\mu\epsilon$. At point 7, there is an accumulation of compressive strain during thermal-cold cycles, which may contribute to the healing of fine cracks. The deformation trends at points 3, 6, and 8 are relatively consistent, with point 3 exhibiting the smallest change and point 6 the largest.

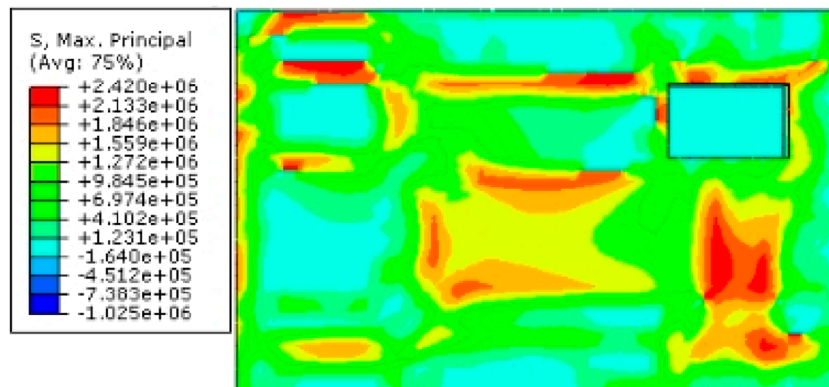
FIGURE 19
Principal stress distribution diagram of the wall panel during high temperature stage.

Figure 19 shows the distribution of the maximum principal stress in the entire concrete wall panel. Typically, the maximum principal stress is used to assess the cracking of brittle materials such as concrete. It can be observed that the maximum principal stress in the inner leaf wall was distributed in a ring shape, following the positions constrained by the surroundings. However, the external leaf wall was less affected by the constraints from the surroundings. The uneven distribution of temperature-induced stresses in the external leaf wall is evident, with red areas indicating tensile stresses with relatively large values, and blue areas indicating the transition from tensile to compressive stresses. This suggests a significant mutual inhibitory effect of temperature stresses at various positions on the deformation of the nearby concrete. Overall, areas with larger regions of tensile stresses were found in the middle and lower parts of the window, thus indicating a higher risk of concrete cracking in these regions.

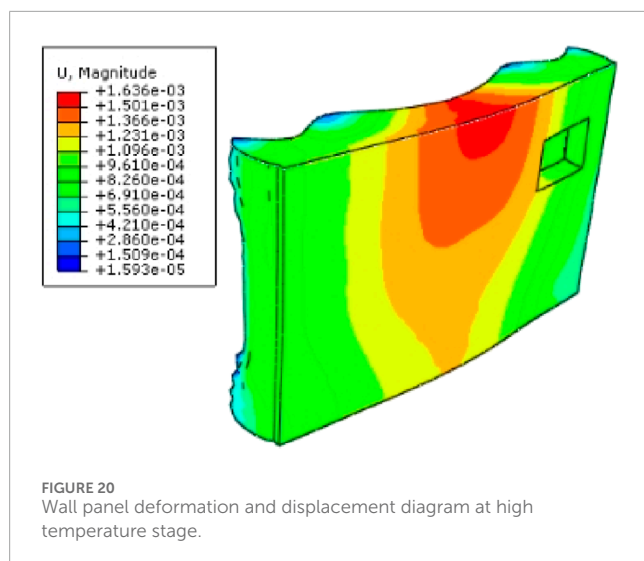
Finite element simulation results for the deformation and displacement of the wall panel during the high-temperature stage are shown in Figure 20. Along the thickness direction of the wall panel, it can be observed that during the expansion deformation caused by temperature rise, the deformation of the wall panel was significantly constrained at the positions with truss steel reinforcement in the length direction of the wall panel. However, in the height direction of the wall panel, where there was no tensile reinforcement, no similar phenomenon occurs. Therefore, it can be seen that the tensile reinforcement effect of the truss steel restricts the free deformation of the wall panel, ensuring that the three parts of the wall panel behave as a whole. In addition, the constraints from bolts around the perimeter mainly restricted the deformation of the inner leaf wall, while the deformation of the outer leaf wall was relatively free. Notably, the overall behavior of the wall panel showed maximum displacement in the middle-upper part, gradually decreasing from the center to the sides, with an overall displacement ranging from 0.67 to 1.6 mm.

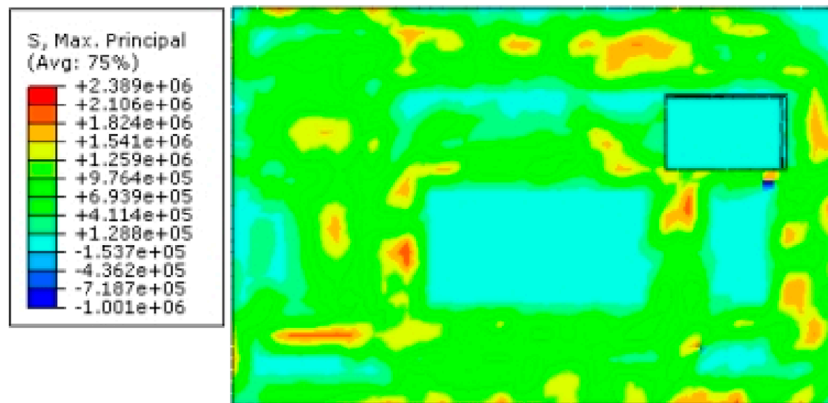
FIGURE 22
Principal stress distribution diagram of the wall panel at low temperature stage.

the temperature decrease stage, the upper part of the wall is mostly in tension, with the concrete being compressed at the upper-left corner of the window. This is consistent with the earlier experimental strain change conclusions. Also, the middle part and the area below the window of the wall have principal stresses smaller than those in the

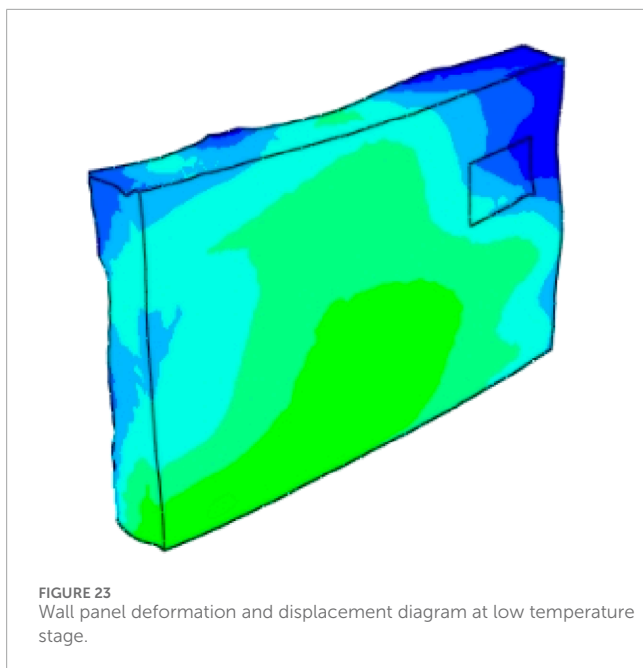
surrounding regions. Overall, the likelihood of cracking in the winter low-temperature climate is much smaller than in the hot summer climate. Notably, In the low-temperature stage, the wall did not exhibit significant deformation compared to the high-temperature stage, and the displacement mostly ranged from 0.55 to 0.63 mm.
