Wan R, Zhao H, Zhang Q, Zheng P, Zhong Z,  
Xue C and Huang L (2024), Semi-real-time  
infrared thermography for detecting layering  
defects in plasters solidification within indoor  
environments.  
*Front. Mater.* 11:1405745.  
doi: 10.3389/fmats.2024.1405745

# Semi-real-time infrared thermography for detecting layering defects in plasters solidification within indoor environments

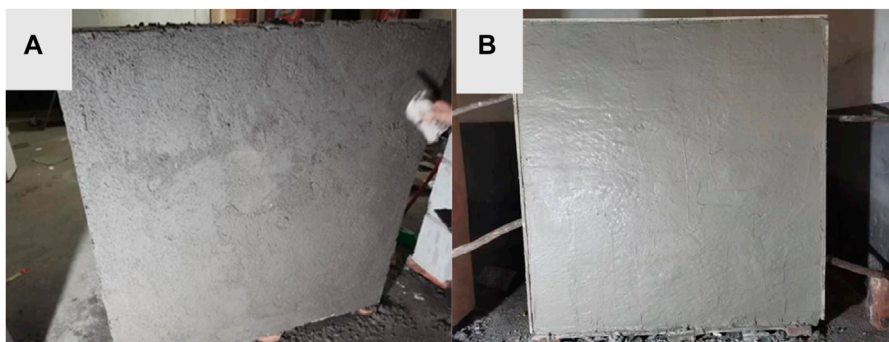
FIGURE 3 (A) The cement mortar plastered surface; (B) the gypsum mortar plastered surface.

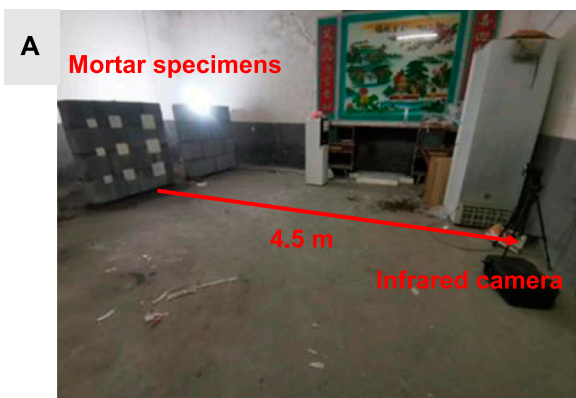
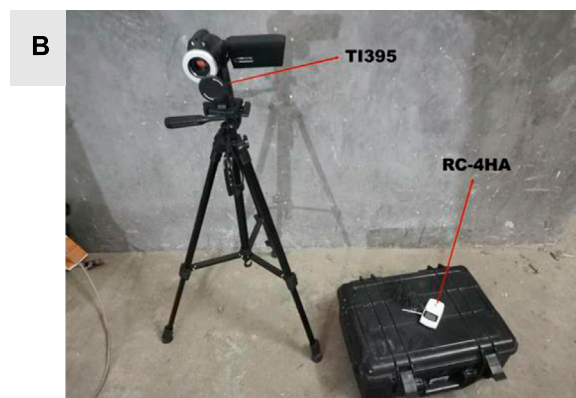
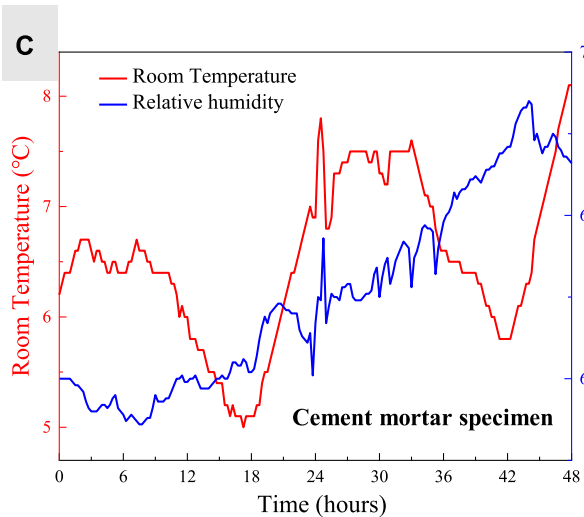
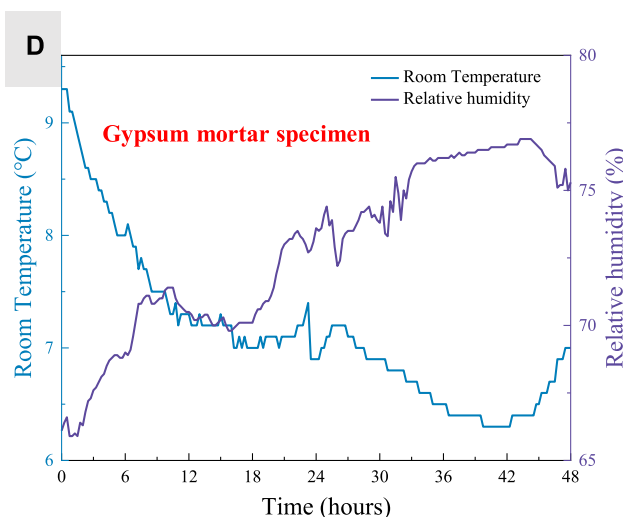
FIGURE 4 (A) Infrared thermal imaging camera and its layout diagram; (B) Picture of infrared camera and Temperature and Humidity Meter; (C) Corresponding environmental monitoring data for cement mortar specimens; (D) Corresponding environmental monitoring data for gypsum mortar specimens.

To simulate a typical indoor environment of a building, this experiment was conducted inside a civilian building located in Yinying Village, Zhenping County, Nanyang City, Henan Province, China. The specific arrangement of the experiment is

shown in Figure 4A. Data collection was performed using the TI395 infrared thermal imager (Figure 4B), whose performance specifications are presented in Table 1. Considering the impact of the indoor environment on imaging, the infrared thermal imager was placed at a distance of 4.5 m directly in front of the specimen (Figure 4A). This placement ensures the

used was configured to automatically capture thermal images every 45 s, resulting in a cumulative total of 3,840 thermal images for each round of the experiment. Simultaneously, the temperature and humidity data logger RC-4HA was set to record environmental temperature and humidity data every 15 min, starting after the plastering was completed and continuing for 48 h. The equipment setup used in the experiment and the trends in environmental temperature and humidity can be observed in Figures 4C, D.

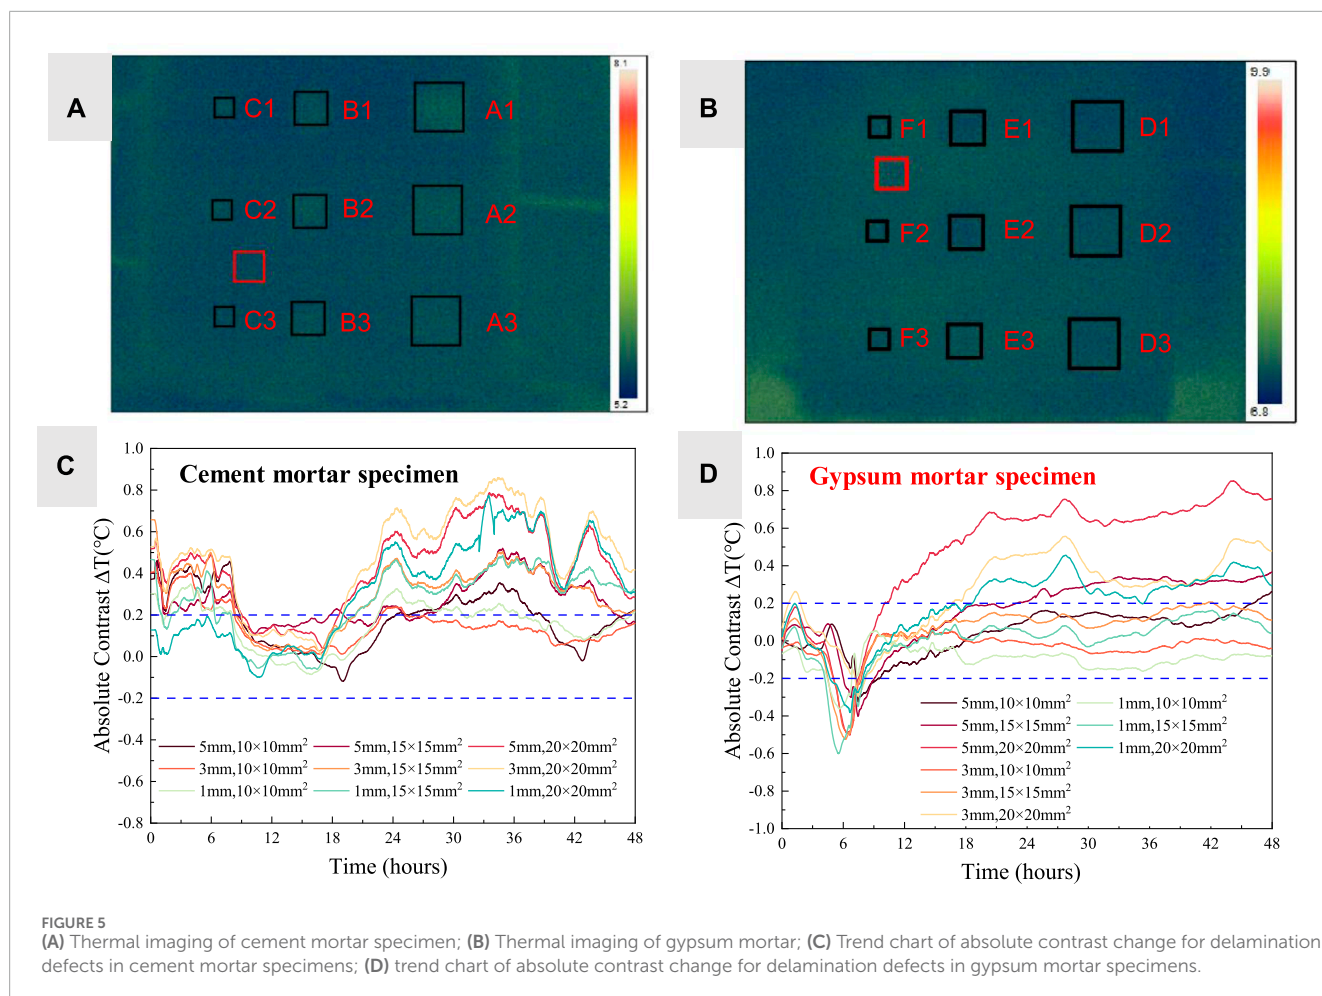
FIGURE 5

(A) Thermal imaging of cement mortar specimen; (B) Thermal imaging of gypsum mortar; (C) Trend chart of absolute contrast change for delamination defects in cement mortar specimens; (D) trend chart of absolute contrast change for delamination defects in gypsum mortar specimens.

Figure 5 delineates the patterns of absolute contrast variations within layered defect regions across various specimens. Specifically, Figure 5A illustrates the behavior in cement mortar specimens, while Figure 5B focuses on gypsum mortar specimens (Defects are represented by capital letters in Figure 5B). In the case of cement mortar, Figure 5C demonstrates that layered defects were successfully identified using IRT, a success attributed to the absolute contrast in these defect areas exceeding the 0.2°C threshold within a predetermined timeframe. It is important to note that the absolute contrast within the cement mortar's stratified defect regions displayed a complex pattern characterized by an initial decrease, followed by an increase, and then a series of decreases and increases, culminating in a final decrease. Additionally, variations were observed in the absolute contrast across different defect areas. Conversely, Figure 5D presents the detection of various stratified defect regions within gypsum mortar specimens, showcasing an absolute contrast trend that diverges from that observed in cement mortar specimens. This trend is characterized by an initial decrease

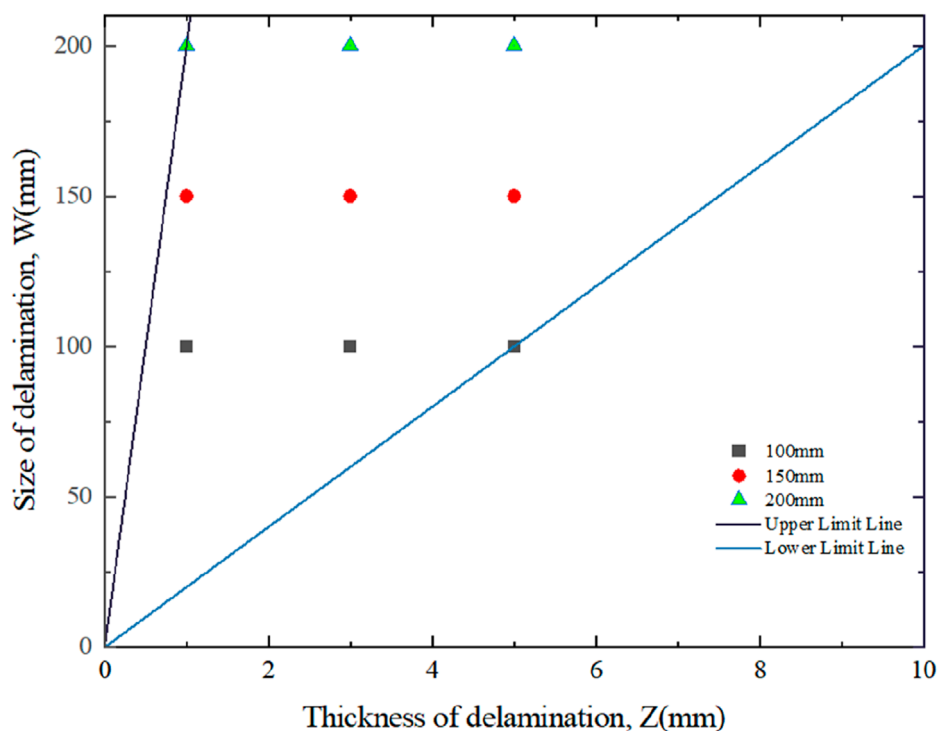
FIGURE 7  
Detectability range for delamination defects.

Figure 7 presents the detectability analysis of delamination defects. Based on the approximate linear relationship between the thickness and size of the plastering (cement and gypsum) delamination defects and their absolute contrast discussed in the

previous section, a certain detection range has been confirmed. In this experimental setup, all nine defects were effectively detected within this range. Given the findings that larger delamination defect thickness and size result in higher absolute contrast, thus favoring defect detection, it can be reasonably inferred that within 48 h post-plastering, as long as the delamination defects exceed a thickness of 1 mm, size of 100 mm, and have a width-to-thickness ratio between 20 and 200, these defects can be effectively detected.

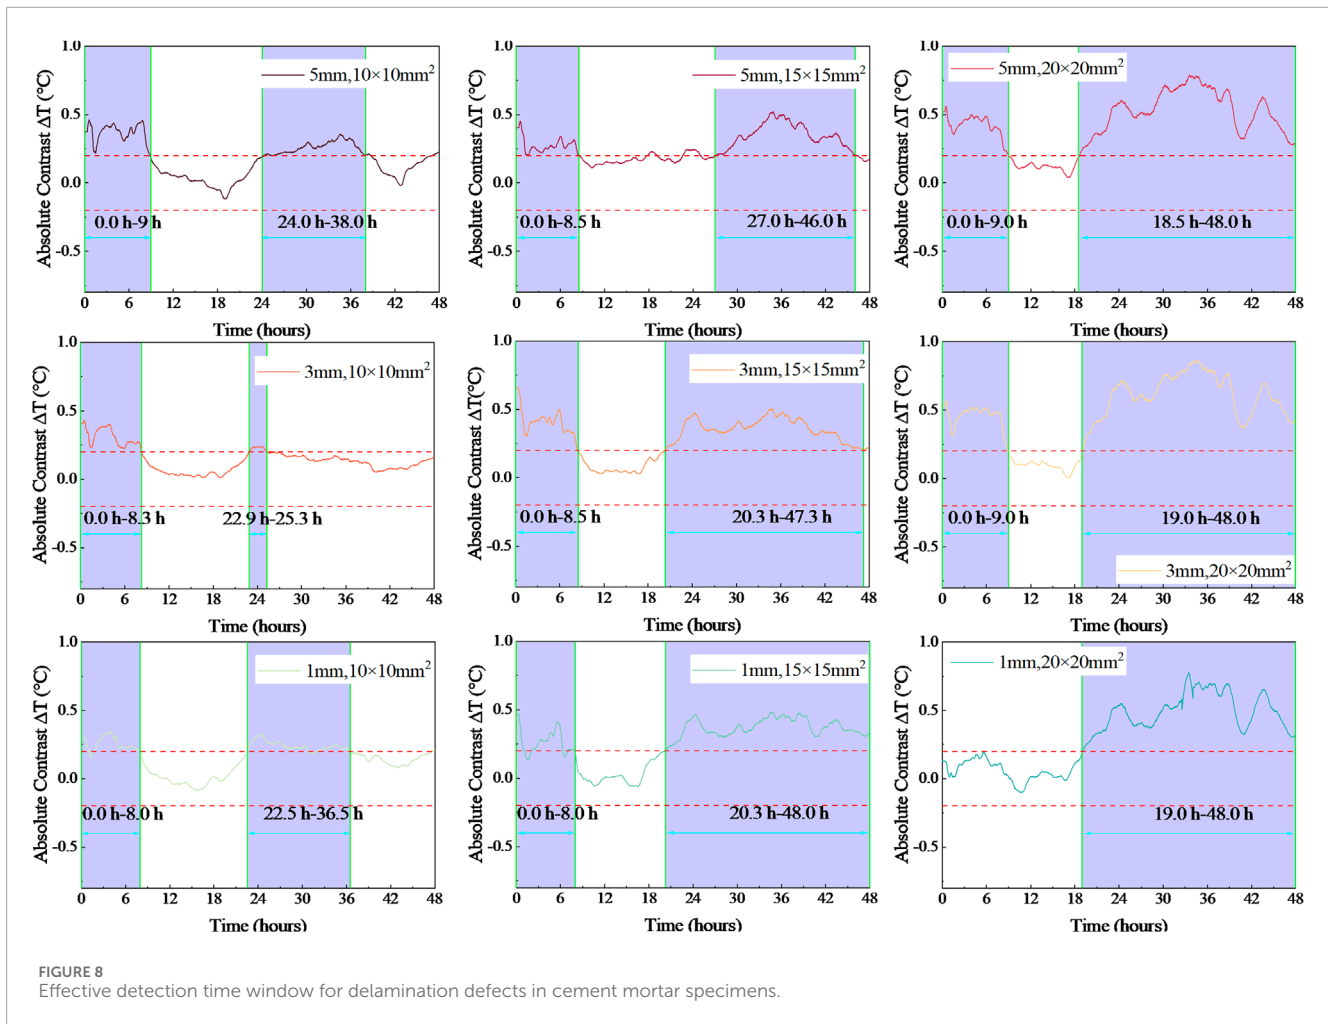
Figure 8 reveals two detection time windows for layered defects in cement mortar plasters. The first window, lasting from 8 to 9 h, allows for the observation of defects immediately after the start of

data collection. This could be attributed to the rise in environmental temperature causing the plaster surface to heat up and enabling early detection of layered defects. The second detection window extends from 14 to 29 h, with 3 mm and 15 × 15 mm<sup>2</sup> defects first observed at 20.3 h. Defects measuring 1 mm and 10 × 10 mm<sup>2</sup> are no longer observable after 36.5 h, yet defects such as 5 mm and 20 × 20 mm<sup>2</sup>, 3 mm and 20 × 20 mm<sup>2</sup>, 1 mm and 20 × 20 mm<sup>2</sup>, and 1 mm and 15 × 15 mm<sup>2</sup> remain detectable at 48 h. Notably, the 3 mm and 10 × 10 mm<sup>2</sup> defect deviates from this pattern, lasting only 2.4 h, but the absolute contrast approaches the threshold between 22.9 and 36 h.

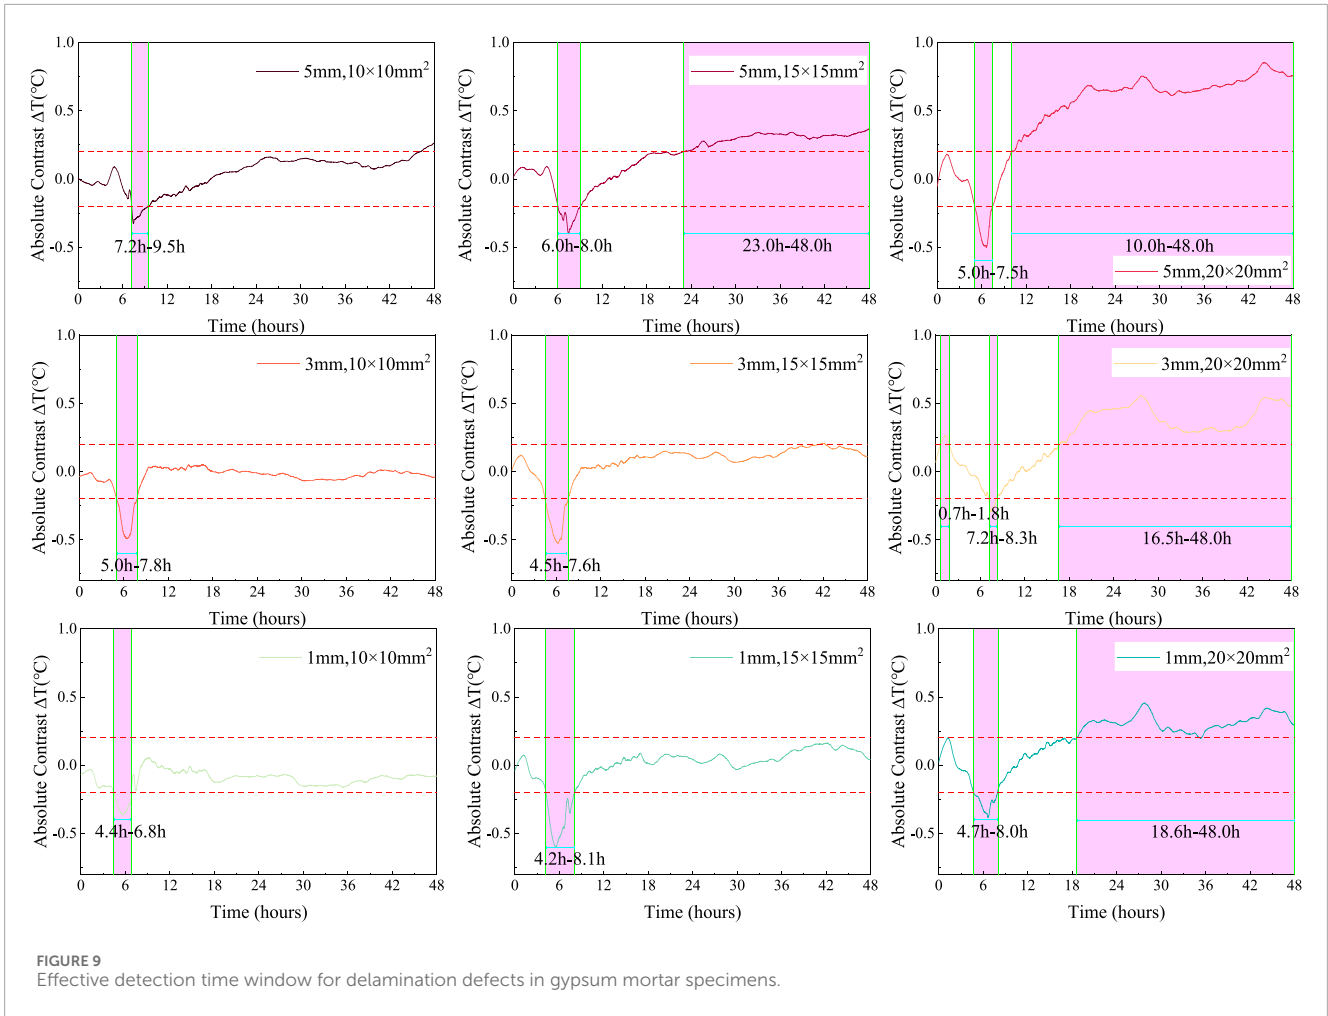
For gypsum mortar plasters, as shown in Figure 9, two detection time windows are also observed. The first window is shorter, lasting between 2 and 3.9 h, with 1 mm and 15 × 15 mm<sup>2</sup> defects initially observed at 4.2 h and 5 mm and 10 × 10 mm<sup>2</sup> defects becoming undetectable after 9.5 h. The second window, lasting from 25 to 38 h, allows for the observation of defects such as 5 mm and 15 × 15 mm<sup>2</sup>, 5 mm and 20 × 20 mm<sup>2</sup>, 3 mm and 20 × 20 mm<sup>2</sup>, and 5 mm and 15 × 15 mm<sup>2</sup>, all of which remain detectable at 48 h.

specimens. In Figure 9, This work observed the changes in absolute contrast of the delamination defect areas measuring 5mm, 200 × 200mm<sup>2</sup>, along with the variations in ambient temperature, through the data collection process for specimens of two different materials.

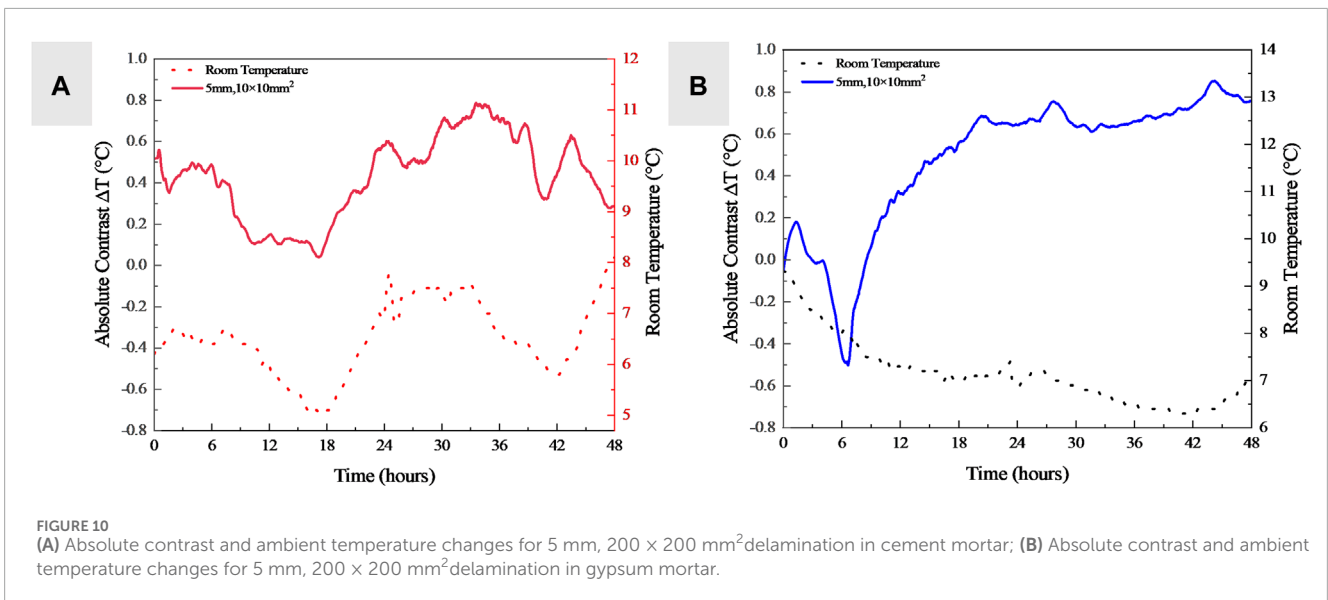
For cement mortar specimens, Figure 10A clearly reveals the consistency between the trend of absolute contrast changes in the delamination defect areas and the trend of ambient temperature changes. Notably, the peak values of absolute contrast for delamination defects within two detection time windows almost perfectly align with the peak areas of ambient temperature, underscoring the critical role of ambient temperature in the detection of delamination defects in cement mortar specimens during the curing stage.

However, the situation is slightly different for gypsum mortar specimens, as shown in Figure 10B. Initially, there is a lack of consistency between the changes in absolute contrast of the delamination defect areas and the changes in ambient temperature, and the peak values of absolute contrast for delamination defects in the initial detection window do not align with the peak values of ambient temperature. This indicates that ambient temperature is not the dominant factor affecting the detection of delamination defects in gypsum mortar specimens in the early stages. During the 0–6 h of temperature decline, the hydration heat of the gypsum mortar partially offset by the environmental cooling is detrimental to the detection of delamination defects. However, in the later stages, as the release of hydration heat decreases, ambient temperature becomes a facilitating factor, allowing the detection of some delamination defects, thereby indicating that ambient temperature plays a leading role in the detection of delamination defects in gypsum mortar specimens during the curing stage in the later phases.
