Assessment of the Integrity of Reinforced Concrete Beams Strengthened With Carbon Fibre Reinforced Polymer Using the Acoustic Emission Technique

Mat Saliah SN and Md Nor N (2022)
Assessment of the Integrity of
Reinforced Concrete Beams
Strengthened With Carbon Fibre
Reinforced Polymer Using the Acoustic
Emission Technique.
Front. Mech. Eng 8:885645.
doi: 10.3389/fmech.2022.885645

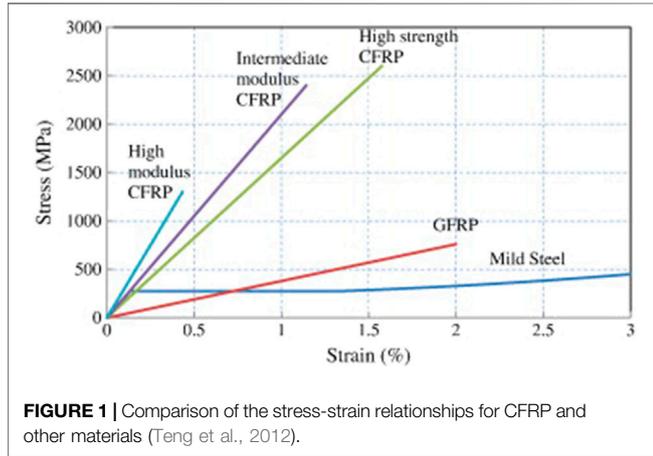
FIGURE 1 | Comparison of the stress-strain relationships for CFRP and other materials (Teng et al., 2012).

In the context of the civil engineering industry, CFRP has generally been used for repairing and retrofitting pre-cracked RC structures. General information on CFRP as a reinforcement for concrete structures has been provided by ACI 440R-96 (ACI 440R-96, 2002). Guidelines for design and construction using this material have been documented in ACI 440.2R-02 (ACI 440.2R-02, 2002). The general background of CFRP, in terms of its material composition and mechanical properties, is depicted in **Table 1**. **Figure 1** shows the typical stress-strain curves for CFRP, glass fibre-reinforced polymer (GFRP) and mild steel, which indicates the behaviour of CFRP compared to other materials. As the graph illustrates, compared to mild steel, CFRP possesses high stress with low strain as it exhibits no ductility behaviour.

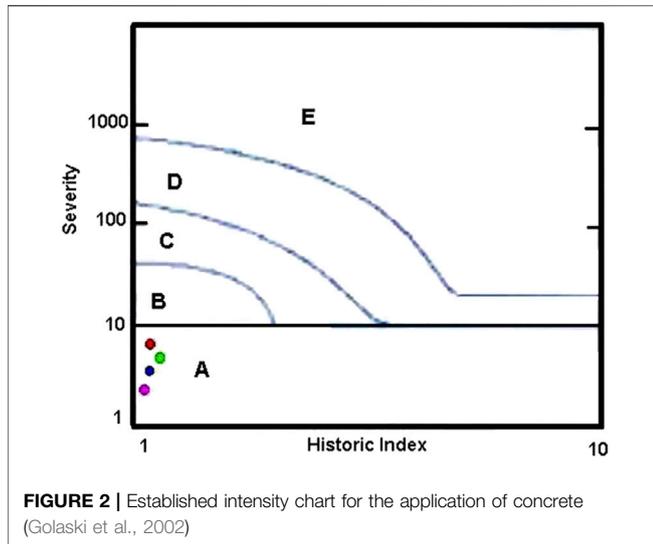
FIGURE 2 | Established intensity chart for the application of concrete (Golaski et al., 2002)

The analysis of intensity includes the log HI (abscissa) and log Sr (ordinate) graphs, as shown in **Figure 2**. Both the Sr and HI depend significantly on the acoustic emission energy, such as the

As shown in Figure 2, Zone A is defined as being where no significant emission or crack occurred, and no follow-up was recommended. Zone B is defined as a minor crack, as typically only minor surface defects occurred on the structure, which would require future reference. Zone C is defined as an intermediate crack that would require a follow-up evaluation. Zone D is defined as needing a follow-up as the crack was expanding; it required a follow-up inspection. Zone E is defined as a major crack, and a shut-down and follow-up were required.

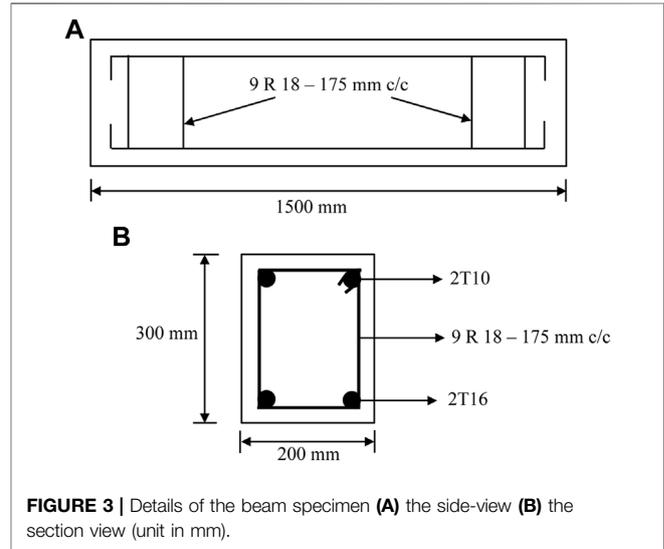
FIGURE 3 | Details of the beam specimen (A) the side-view (B) the section view (unit in mm).

a maximum size of 20 mm. The RC beam specimens were designed using BS8110: Part 1 (BS 8110-1, 1997) as a guideline for singly reinforced beams. The beams employed in this study were 200 mm wide, 300 mm deep and 1500 mm long. Two different diameters of high-yield bars (460 N/mm²) and one mild steel bar (250 N/mm²) were used to reinforce the beam. The high-yield bars were 16 mm (T16) in diameter and were utilised to enhance the tension zone. Two 10 mm-diameter hanger bars (2T10) were employed in the compression zone. Meanwhile, as stirrups, a mild-yield bar of 8 mm (R8) was used. The distance between the stirrups was 175 mm from centre to centre. The schematic diagram of the beam is presented in **Figure 3**, which shows the side view and the cross-sectional view.

The concrete mix was poured into a 200 mm × 300 mm × 1500 mm mould, into which the reinforcement was immersed with a 20 mm cover. A total of six beams were produced. After ±24 h of casting, the beams were demoulded and cured for 28 days. A detail of the beam is shown in **Figure 3**. In this study, two types of beams were prepared. The first type was a control beam, designated as S1C. This beam was used as a reference beam. The second type of beam was a control beam and was retrofitted with CFRP on the soffit. This beam was designated as S2B. The results from both types of beams were compared, and these are discussed in the following section.

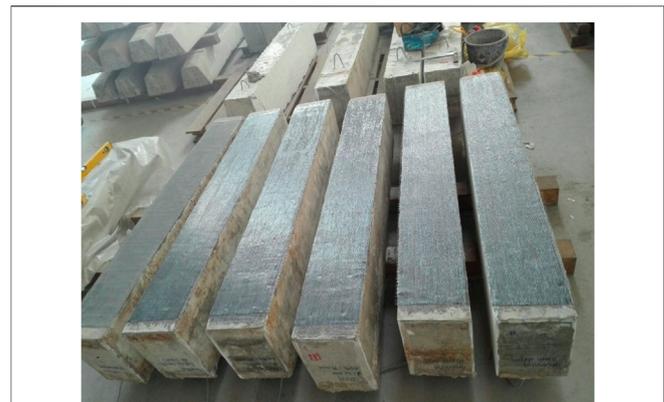
FIGURE 4 | The installed CFRP on the beam surface.

CFRP was used to reinforce the clean surface of the underside of the RC beam. The normal surface preparation was carried out before installing the CFRP, in accordance with ACI 440 (ACI 440.2R-02, 2002), on the beam surface under tension. **Table 2** shows the properties of the CFRP. A Sikadur 330 epoxy resin was used to laminate the CFRP to the beam surface. The epoxy resin Sikadur 330 for part A and part B was mixed in a weight ratio of 4:1. The epoxy resin was applied to the tension side of the beam at the point where the CFRP strip was to be installed. The CFRP strip was cut to a length of 1300 mm so that it was on the effective length of the beam. The CFRP strip was then cut lengthwise with scissors to a width of 200 mm. As Ding et al. (Ding et al., 2014) found, the CFRP length contributes to the strength of a beam. A length of 75% of the beam is recommended as the optimal length to use as a good reference for retrofitting buildings. The CFRP was then applied evenly to the concrete surface, as shown in **Figure 4**.

be achieved. The curing process took about a week to ensure that the CFRP was properly laminated to the concrete surface. **Figure 4** shows the beam after reinforcement with CFRP and before the tests.

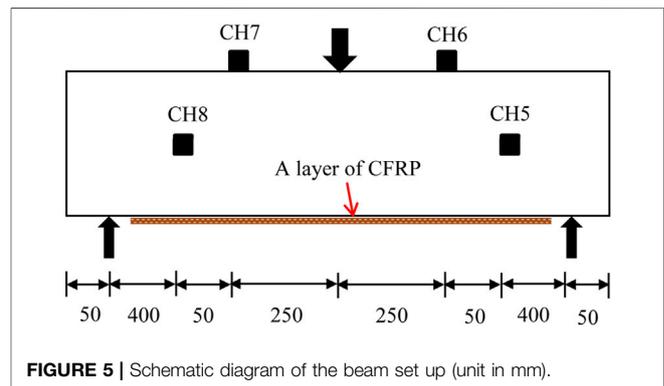
FIGURE 5 | Schematic diagram of the beam set up (unit in mm).

Four acoustic emission sensors were placed on the surface of the beam. Two sensors were placed on the top of the beam at 250 mm from the point load; these were designated as CH6 and CH7. Two other sensors were placed in the centre of the beam surface at 300 mm from the top of the point load; these were designated as CH5 and CH8. In this study, only the CH6 and CH7 sensors were analysed since they captured more data than the other two. Figure 5 shows the placement of the sensors on the beam surface after

Monotonic testing was performed using a servo-controlled hydraulic testing machine with a capacity of 1000 kN, in conjunction with acoustic emission monitoring. A three-point load was applied to the beam until it failed completely. A constant load rate of 0.02 kN/s was used. Figure 5 shows the schematic diagram of the beam setup. Meanwhile, Figure 6 shows the beam setup with all the instruments.

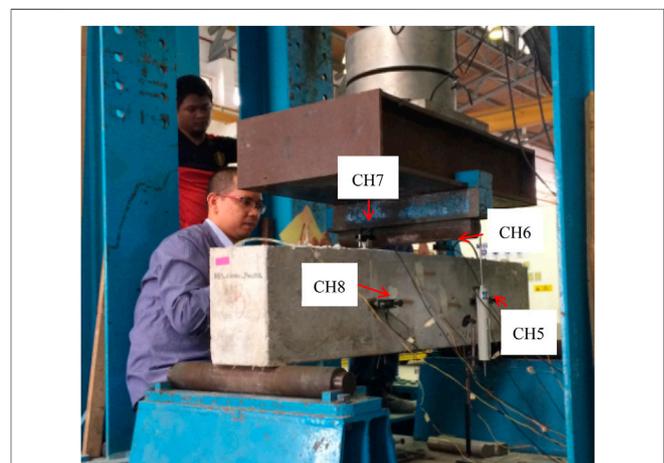
FIGURE 6 | Beam set up and set up of all instrumentations.

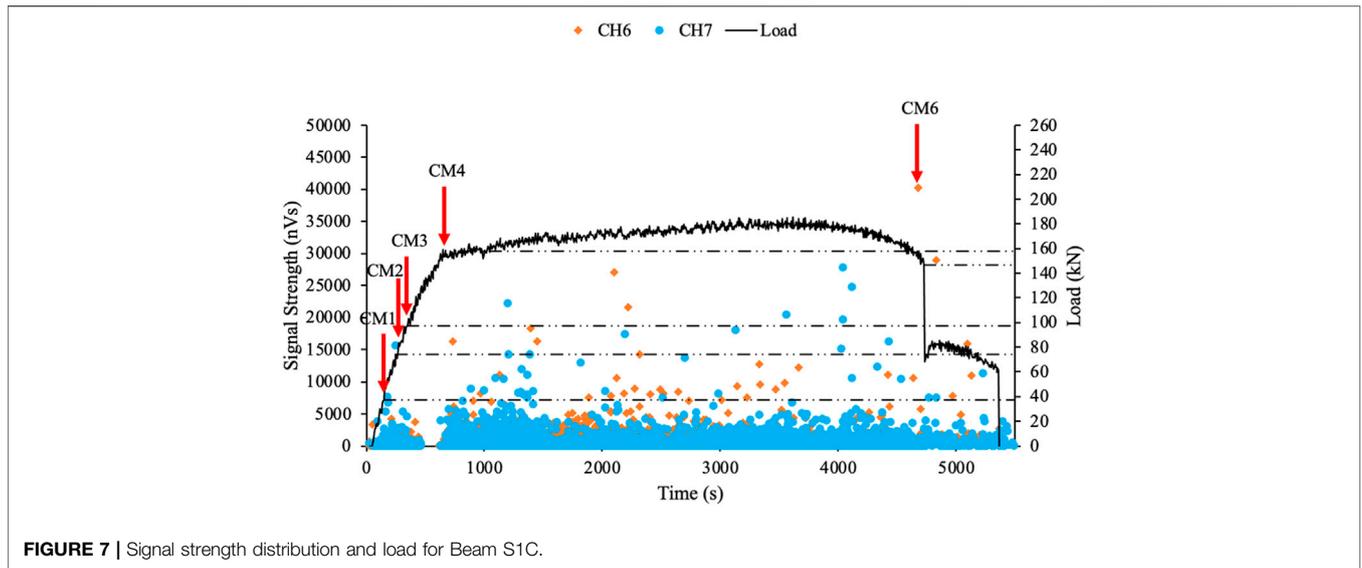
FIGURE 7 | Signal strength distribution and load for Beam S1C.

Figures 7, 8 show the acoustic emission signal strength distribution and the load used to identify the crack modes for the control beam, S1C and the beam retrofitted with CFRP. The identification of the crack modes was described in the preceding analysis section. Five crack modes were identified for the control beam, S1C: the initiation crack (CM1), first crack (CM2), flexural crack (CM3), shear crack (CM4) and failure (CM6) as the beam broke down. However, beam S2B, which had been retrofitted with a layer of CFRP on the soffit, had six crack modes. These were the first crack (CM1), first crack initiation (CM2), flexural crack (CM3), shear crack (CM4), debonding of the concrete cover or failure of the CFRP bonding (CM5) and failure of the beam (CM6). The load on the respective crack modes is presented in Table 3. The crack progression in both beams was visually observed by the naked eye and validated through the acoustic emission signal strength that appeared on the computer screen during testing.

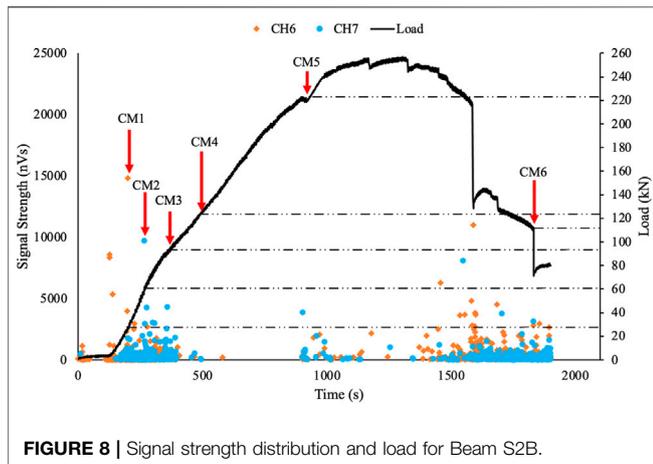
FIGURE 8 | Signal strength distribution and load for Beam S2B.

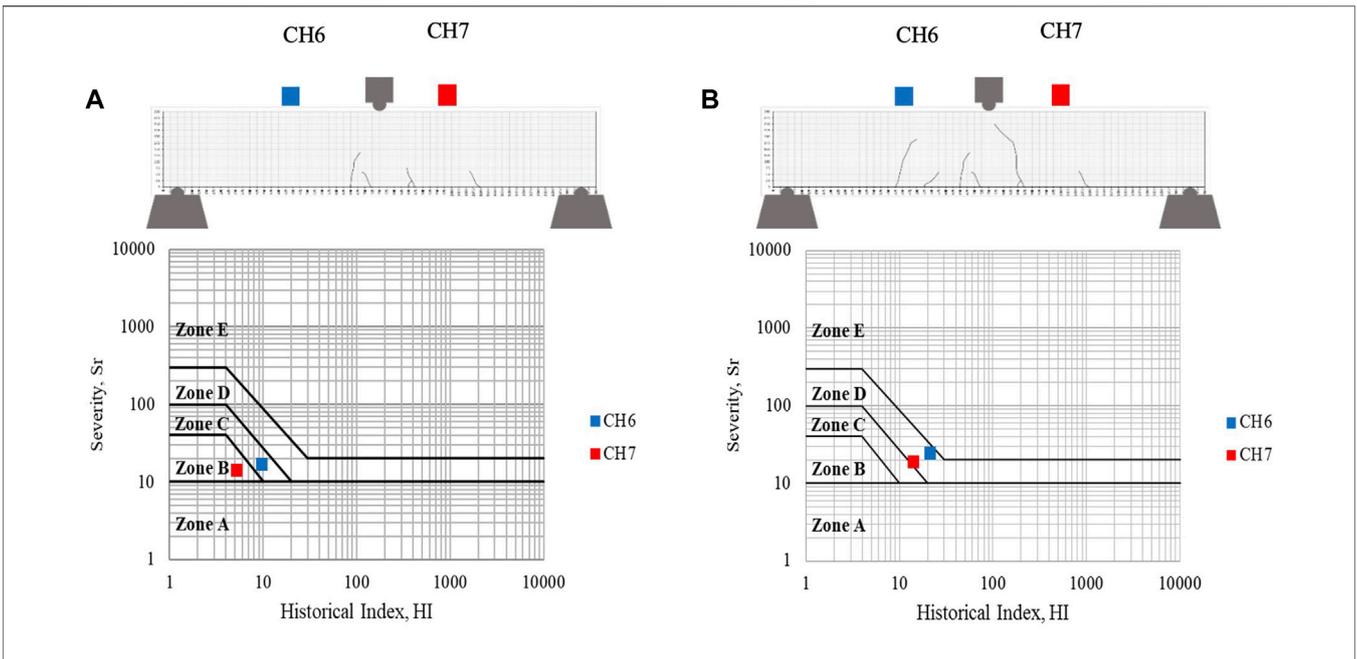
FIGURE 9 | The crack zones obtained from CH6 and CH7 for beam S1C **(A)** CM1 and **(B)** CM2.

The intensity plots of CH6 and CH7 in beam S1C, which was subjected to monotonic loading of all crack modes, are shown in Figures 9–11. The plots of the intensity zones for both sensors could be used to predict the future performance of the beam. Figure 9A shows that the intensity zone for the crack initiation (CM1) for both sensors fell into zone A when the beam was subjected to a load of 37.00 kN. Therefore, no significant crack emission occurred in the beam.

CH6 indicates that CM2 was in intensity zone B (minor damage), indicating the formation of the first crack in the beam (see Figure 9B). This occurred when the load was increased to 73.81 kN. However, CH7 was located in zone C, meaning that two cracks formed on the underside of the beam in tension, representing moderate damage. Although the sensors were in the same position, namely on the top of the beam and 300 mm from the point load, the sensors showed different intensity zones. This is closely related to the waveform of the acoustic emission detected by the sensors. The waveform of the acoustic emission arriving at the sensor plays an important role in detecting the energy released by the source. It is also related to the arrival time (TOA) of the wave and the distance of the crack to the sensor. This is because the strength of the acoustic emission signal is the most important parameter for determining the HI and Sr. In this finding, CH7 received more acoustic emission activity compared to CH6, resulting in the formation of an intensity zone. At the same time, the propagation of the crack was also found to affect the signal strength results.

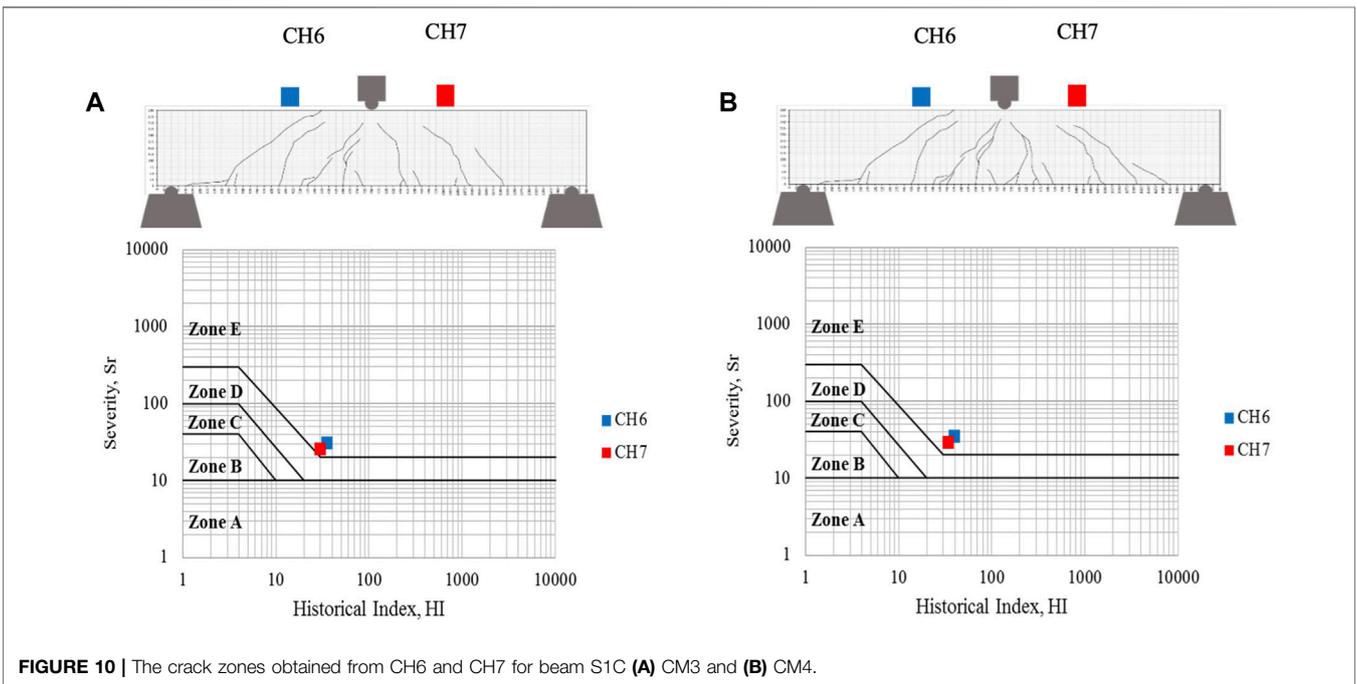
FIGURE 10 | The crack zones obtained from CH6 and CH7 for beam S1C **(A)** CM3 and **(B)** CM4.

When a tensile crack was localised (CM3), the intensity zone for CH6 indicated that the beam was in zone B, meaning that it was slightly damaged (see Figure 10A). CH7, on the other hand, indicated that the beam was in the middle of zones C and D. This means that the beam was in transition between moderate damage and consequential damage, where a significant defect would be present and require a follow-up (Gostautas et al., 2005). The

intensity zones corresponded well with the crack pattern, as can be seen in Figure 10A), where smaller cracks occurred under CH6 than under CH7. Under CH6, most cracks propagated below the neutral axis. A crack closing at CH7, on the other hand, propagated beyond the neutral axis, resulting in the development of high levels of AE activities.

As the shear crack (CM4) developed, the plot for CH6 shows that the beam was in zone D, whereby a follow-up investigation would be required (Figure 10C). However, the situation was different for CH7, where the plot lay between zone D and zone E, indicating that the beam was in transition from follow-up inspection to major damage. As Buyukozturk et al. (Buyukozturk et al., 2004) noted, shear failure occurs when the shear capacity of a beam cannot accommodate an increase in bending capacity. The plots agree effectively with the crack pattern when the CM4 developed. However, all the plots of both sensors show that the beam had experienced major damage, as shown in Figure 11, when it failed (CM6).

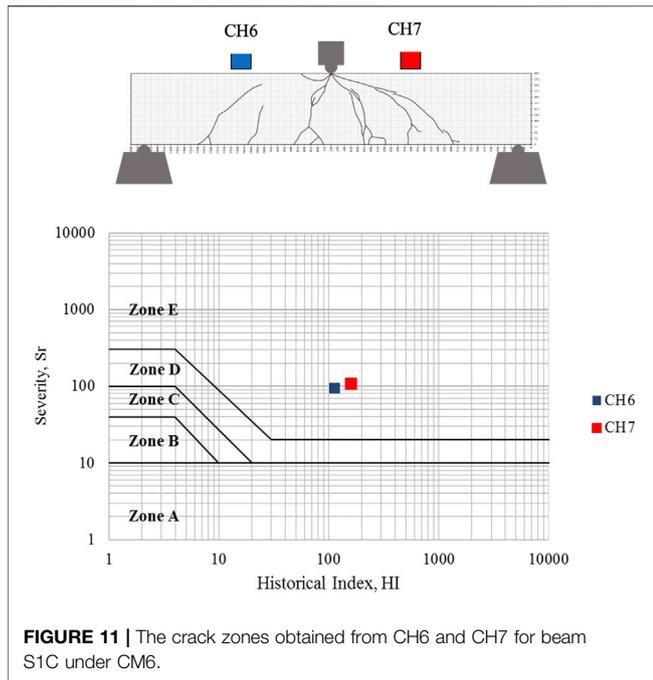
FIGURE 11 | The crack zones obtained from CH6 and CH7 for beam S1C under CM6.

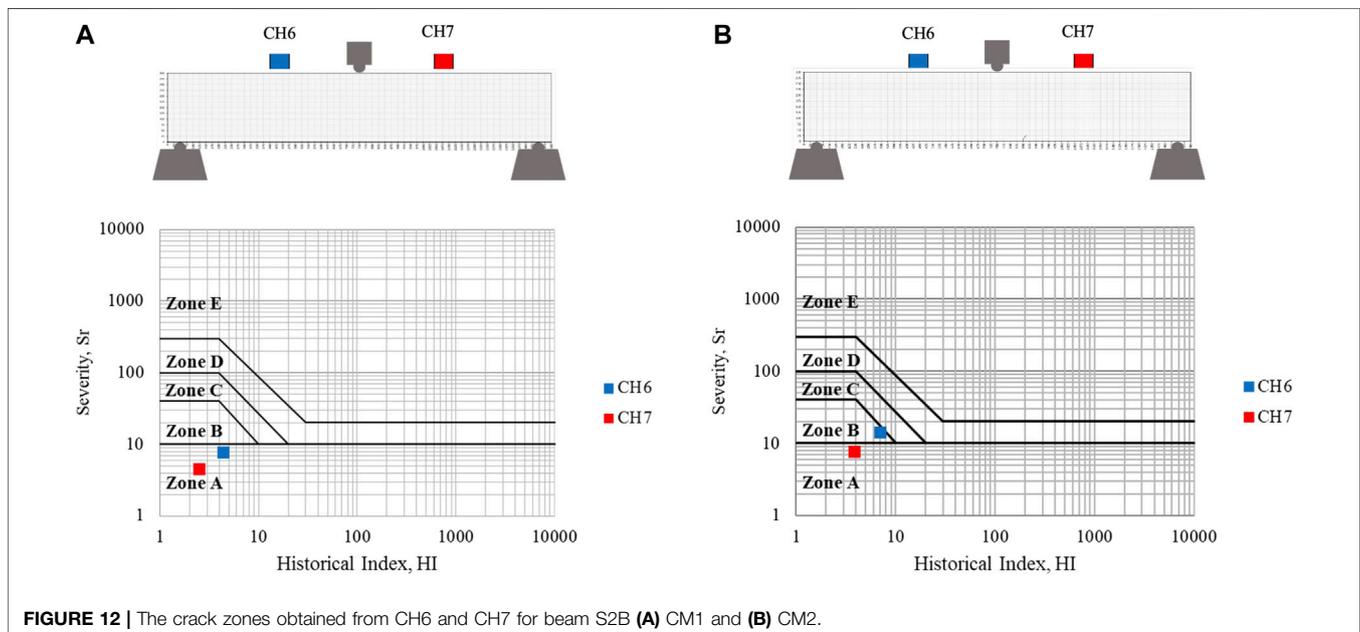
FIGURE 12 | The crack zones obtained from CH6 and CH7 for beam S2B (A) CM1 and (B) CM2.

Figure 12A shows the crack zones of beam S2B, which had been subjected to a load of 27.68 kN or at CM1. Since no crack occurred on the beam surface, the damage crack zone plot shows that the beam was in zone A at CH6. In this case, there was no plot for CH7 because the number of hits detected by the acoustic emission sensor was less than 50 (Chotickai, 2001). This means that the intensity plot represents the actual condition of the control beam reinforced with CFRP.

When the load was increased to 60.85 kN, CM2 appeared on the beam surface and propagated from the bottom of the beam. In this crack mode, the intensity plot was in zone B and zone A at CH6 and CH7, respectively. Even though no crack was visible

below CH6 (see **Figure 12B**), the intensity zone showed that the beam had a small crack. This means that the beam would need to be checked in the future (Nor et al., 2018). CH6 showed more internal cracks (micro cracks) and no external cracks, compared to CH7 at CM2. In contrast to CH7, the intensity diagram shows that the beam had no crack, although the first crack occurred under CH7. Since the intensity analysis is closely related to the signal strength or energy of AE, the crack did not seem to produce a high level of energy that could be detected by CH7, compared to CH6. In general, the sensor closest to the crack would detect more energy than the furthest sensor, which is closely related to the time at which the AE wave reaches the sensor.

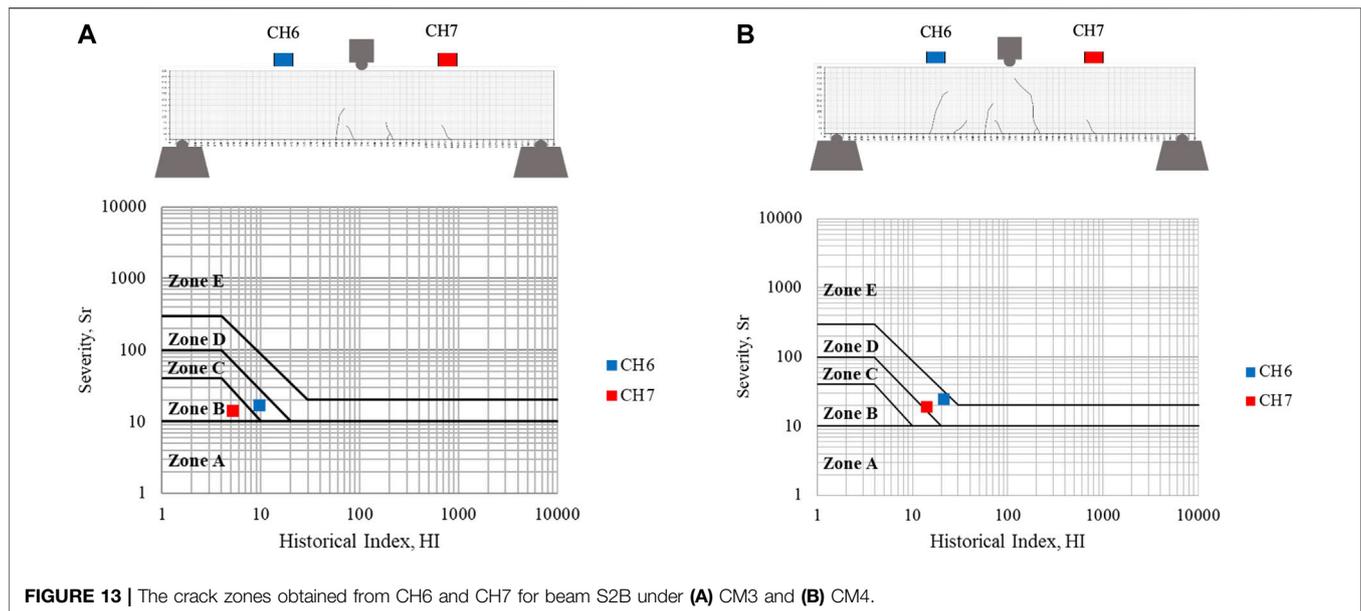
FIGURE 13 | The crack zones obtained from CH6 and CH7 for beam S2B under (A) CM3 and (B) CM4.

If the crack pattern in CM3 is referred (see **Figure 13A**), the damage crack zone for CM2 derived from CH6 can predict the occurrence of an impending crack in the beam. Therefore, the damage crack zone at CM2 could be used to predict the beam-derived intensity zone when the load was increased to 93.28 kN. As Golaski et al. (Golaski et al., 2002) stated, the intensity analysis can be used to predict an impending crack in a beam when it is subjected to load. Furthermore, the integrity and performance of the CFRP-reinforced beam can be determined at an early stage.

When the CM3 appeared on the beam surface, the intensity analysis crack plots (see **Figure 13A**) showed that the CFRP-strengthened control beam was at CH6 and CH7 in Zone C and Zone B, respectively. When the crack pattern was examined, it was found that the crack under CH6 existed and propagated far more than the other cracks under CH7. The crack under CH6 propagated almost halfway up the beam. Considering the statement by McCormac and Nelson (McCormac and Nelson, 2006) that a crack originates beyond the neutral axis, this means that the rebars had yielded. This resulted in a high stress concentration in the beam. In this context, zone C means that the beam had intermediate damage that would require further assessment.

When the load was increased to 123.20 kN, CM4 was identified. More new cracks appeared and were observed on the beam surface (see **Figure 13B**). Due to the presence of these cracks, the intensity of the acoustic emissions from CH6 and CH7 fell into Zone D. Zone D indicates a significant defect in the beam that requires a follow-up investigation.
