# Long-Term Safety of Intraperitoneal Radio Transmitter Implants in Brown Bears (*Ursus arctos*)

Intraperitoneal radio transmitters have been widely used in free-ranging wild mammals, but there are no long-term studies on their biocompatibility or technical stability within the abdominal cavity of animals. Possible negative health effects may bias results from ecological studies on instrumented animals and raise concerns over animal welfare issues. The aim of this study was to evaluate the long-term technical stability and pathological effects of Telonics intraperitoneal very high frequency (VHF) radio transmitters in brown bears (*Ursus arctos*). We instrumented 305 individual bears with intraperitoneal VHF radio transmitters during a 19-year period. We surgically removed devices that had been in bears for 1–9 years and collected transmitters from animals that died 1–13 years after implantation. We took biopsies for histopathology from tissue encapsulating implants in live bears. Retrieved transmitters underwent a technical inspection. Of the 125 transmitters removed from live bears, 66 were free-floating in the peritoneal cavity [a mean (SD) of 3.8 (1.5) years after implantation

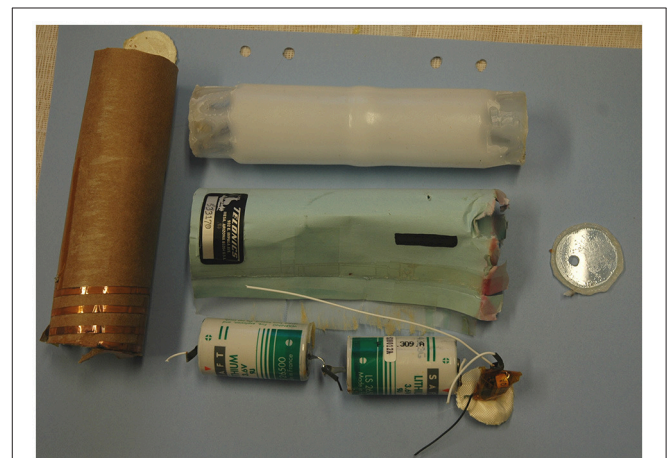
**FIGURE 1** | Components of a Telonics IMP/400/L intraperitoneal VHF implant (length 15.2 cm, diameter 3.3 cm, weight 170 g). The lithium batteries, transmitter, and antenna (central bottom) were enclosed in a thick paper tube (left), wrapped in thin paper (central middle) labeled with the company’s name and address and the serial number of the device. These parts were contained within a plastic shell cylinder (central top) with both ends closed with glued-on end caps (right). The plastic shell cylinder was coated with a 2.1 mm thick wax of unknown composition.

The basic components of a Telonics IMP/400/L implant are shown in **Figure 1**. The lithium batteries, transmitter, and antenna were enclosed in a thick paper tube, wrapped in thin paper labeled with the company’s name and address and the serial number of the device. These components were contained within a plastic shell cylinder with both ends closed with glued-on end caps. The plastic shell cylinder was coated with a 2.1 mm thick wax of unknown composition.

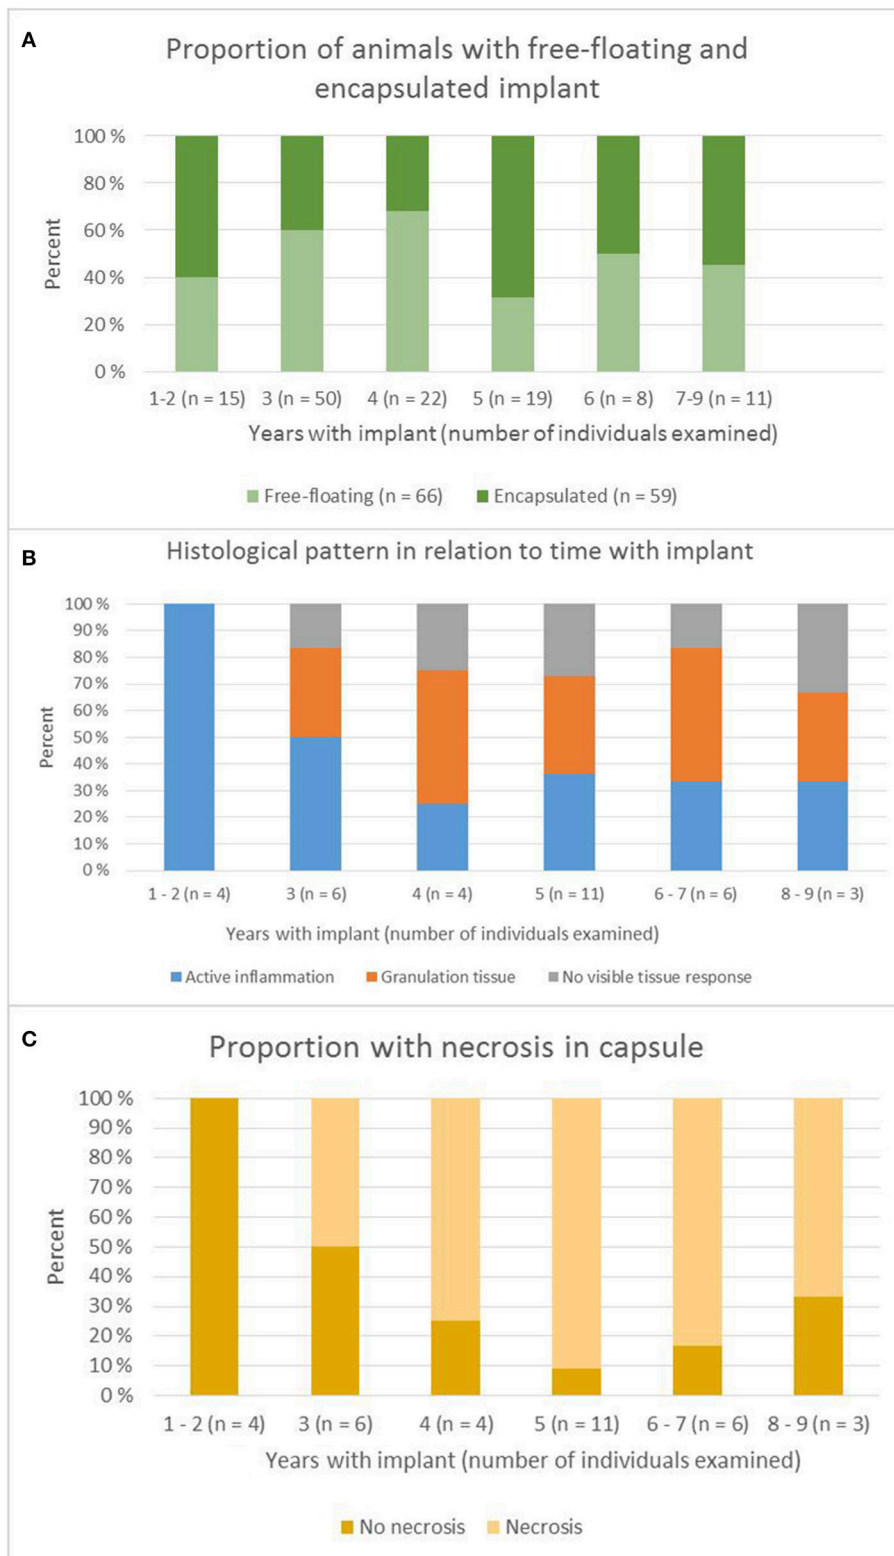
**FIGURE 2 | (A)** Proportion of bears with free-floating and encapsulated implant in relation to years with the device. **(B)** Histological pattern in relation to years with implant. **(C)** Proportion of capsules with necrosis in relation to years with implant.

of the bears, the implants were found free-floating with no encapsulation in the peritoneal cavity and could be easily removed. In 59 (47%) of the cases, the transmitters were found trapped in the greater omentum and encapsulated by 1–15 mm thick layers of connective tissue with various degrees of vascularization. In 23 of the bears (39% of those with encapsulated transmitters), we amputated the connective tissue capsule and parts of the omentum. The bears with free-floating implants had carried the implant for 3.8 (1.5) years and those with encapsulated devices for 4.0 (1.8) years. There was no significant difference in time between these two groups (Student's *t*-test,  $p = 0.42$ ). **Figure 2A** shows the proportion of encapsulated devices over time.

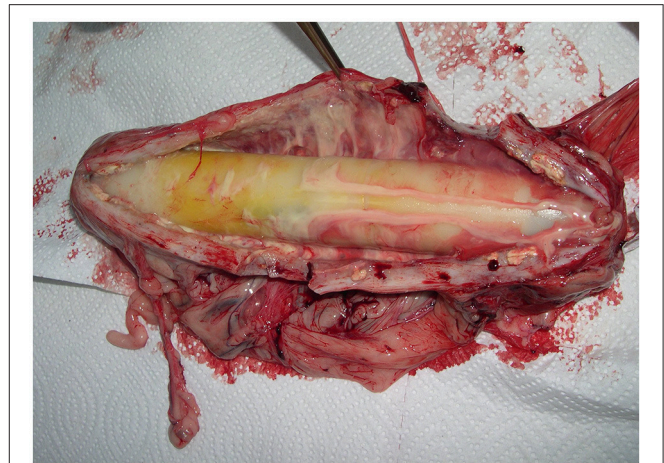
### Case 1 (Figure 4)

A female bear (W8906), born in 1981 was implanted with a Telonics IMP/400/L/HP in April 1997. The implant was removed after 8 years in April 2005. The transmitter was encapsulated within the greater omentum, which was twined around its axis in a complete volvulus, so that the proximal part of the omentum formed a rope-like structure. We amputated the greater omentum involved in the twist. The capsule wall consisted of a 10–15 mm thick, grayish, and fleshy layer of connective tissue with rich vascular supply. The internal surface was irregular and yellowish, and the external serosa was hyperemic. There was a sticky, yellowish, hemorrhagic and odorless fluid between the capsule and the implant. The swab culture was negative. Histologically, the capsule wall consisted mainly of densely woven connective tissue without any obvious organization. Foci of necrotic fat were found in some areas and small hemorrhages, moderate perivascular infiltrates of inflammatory cells, mainly lymphocytes, and a small number of macrophages with dark pigments, were widely distributed. There were abundant proliferating vessels within the connective tissue. The surface of the implant had a yellowish discoloration. The inside of the plastic cylinder was covered with small, clear droplets of fluid. Both layers of the paper wrapping were moist and the batteries and other metal parts were corroded. This bear had produced four litters, with three cubs in each, in 1998, 2000, 2002, and 2004. It was shot legally in October 2005, but the hunter provided no information about the carcass.

**FIGURE 4** | Implant (Telonics IMP/400/L/HP, 21.0 × 3.3 cm) and capsule from a 24-years old female bear (W8906) that had carried the device for 8 years.

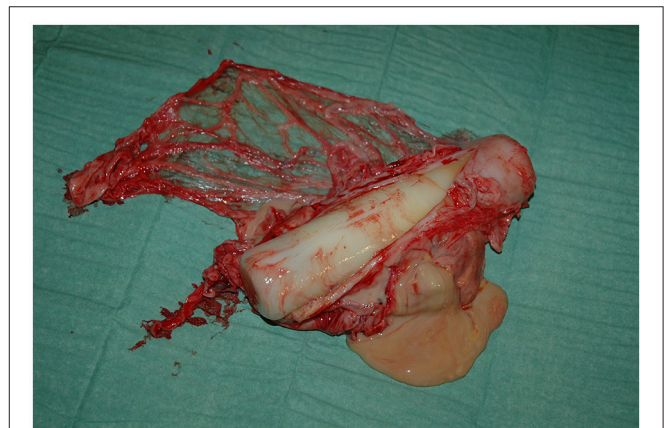
### Case 2 (Figure 5)

A female bear (W0104), born in 2000 was implanted with a Telonics IMP/400/L in April 2001. The implant was removed after 5 years in April 2006. The transmitter was found in the greater omentum, surrounded by a 5 mm thick capsule. A round, cystic, abscess-like structure 5 cm in diameter was attached to one side. We amputated the capsule and abscess. Both the capsule and the cystic structure contained a yellow, thick, opaque, and odorless fluid without any recognizable distinct odor. Three culture swabs from the capsule and fluid were negative. The internal surface of the capsule wall was smooth and displayed areas of orange discoloring. The texture of the capsule was firm, but the external layer of the tissue consisted of fat. Histologically, the internal part of the capsule was composed of laminar, loosely woven, and mostly necrotic tissue, which was diffusely infiltrated with macrophages and some neutrophilic granulocytes. The middle part consisted of dense connective tissue without any particular organization and the external layer consisted of fat infiltrated with macrophages and neutrophilic granulocytes. The blood vessels of the capsule were surrounded by mild to moderate infiltrates of lymphocytes. The coating of the implant was intact, but slightly discolored. No other damage was observed in other parts of the implant. This bear was implanted again in April 2009, and had the implant replaced both in April 2012 and April 2015 (Telonics IMP/700 in all occasions). No pathological changes were observed during these surgeries. The bear had litters in 2005 (two cubs), 2008 (three cubs), 2011 (two cubs), and 2014 (three cubs) and was alive at den entry 2015.

**FIGURE 5** | Implant (Telonics IMP/400/L, 15.2 × 3.3 cm) and capsule with abscess-like cyst from a 6-years female bear (W0104) that had carried the device for 5 years.

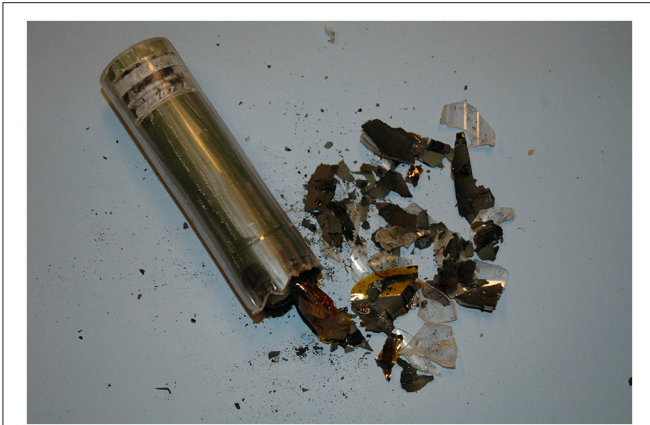
### Case 3 (Figure 6)

A female bear (W0010), born in 1999 was implanted with a Telonics IMP/400/L in April 2000. The transmitter was replaced after 6 years in April 2006. The implant was in the greater omentum, encapsulated by a 1 mm thick layer of tissue that did not require amputation to remove the transmitter. The tissue had irregular whitish surfaces and a texture resembling fat. Histologically, the tissue consisted of moderately vascularized, sparsely cellular adipose tissue with small, multifocal necrotic areas. The blood vessels within this tissue were surrounded by moderate amounts of connective tissue. On inspection, the wax coating of the implant had a “melted” appearance. One end cap was loose and the internal parts could not be removed without cracking the plastic shell cylinder. The paper wrappings appeared scorched and the batteries had short-circuited and were adherent to the inner surface of the plastic shell cylinder. This bear had produced litters with two cubs in 2005, 2007, and 2009. It was

**FIGURE 6 |** Implant (Telonics IMP/400/L, 15.2 × 3.3 cm) removed from a 7-years old female bear (W0010) that had carried the device for 6 years. The batteries had short-circuited, with subsequent over-heating of the device. The wax coating had a “melted” appearance and one end cap was detached. The batteries were adherent to the inside wall of the plastic cylinder, which had to be cracked to remove the internal parts of the device.

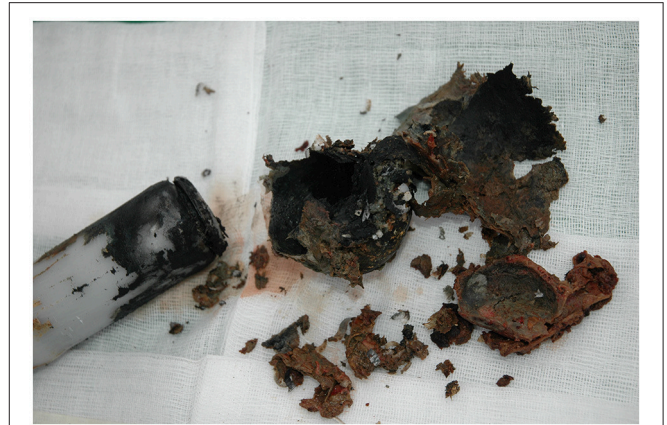
### Case 4 (Figure 7)

**FIGURE 7 |** Implant (Telonics IMP/400/L, 15.2 × 3.3 cm) removed from a 6-years old female bear (BD124) that had carried the device for 5 years. The batteries had short-circuited, with subsequent over-heating of the device and leakage from the batteries. One end cap was detached and the outside of the implant was partly covered by a soot-like material. All internal components appeared to be burned and were covered by the same soot.

A female bear (BD124), born in 2001, was implanted with a Telonics IMP/400/L in May 2002. The transmitter was removed after 5 years in May 2007. When the peritoneal cavity was opened, the author who carried out the surgery (JA), could smell a “battery-like” odor and found that the implant was encapsulated in a 15-cm wide mass of connective tissue attached to the ventral abdominal wall cranially to the umbilicus. Parts of this tissue, including the core containing the transmitter, were removed and the abdominal cavity was closed. The tissue covering the implant was firmly attached to it and had to be removed with a scalpel. One end cap was detached. Closer inspection revealed that the implant clearly had over-heated. The outside of the plastic cylinder was partly covered by a soot-like material, and the inside smelled of battery. All internal parts of the transmitter appeared to be burned and were covered by the same soot. Both batteries had obviously been exposed to high temperatures and were partly open along the sides. The inside of the tissue that covered the implant was dark and irregular and had a “fried meat” appearance, whereas the outer surface was smooth and pale reddish. Histologically, the inner surface consisted of partly necrotic, finger-like projections of connective tissue. Next to this, the capsule wall consisted of connective tissue organized in a woven pattern. In the wall, there were large accumulations of lipid-like, brownish material in the tissue, pockets of macrophages filled with yellow/brown material, and foci of calcification and mild hemorrhages. The external layer of the capsule consisted of necrotic adipose tissue with spots of yellowish discoloration. The bear had its first litter (3 cubs) the year following implantation and was legally shot in May 2009 to avoid predation of semi-domesticated reindeer in a calving area.

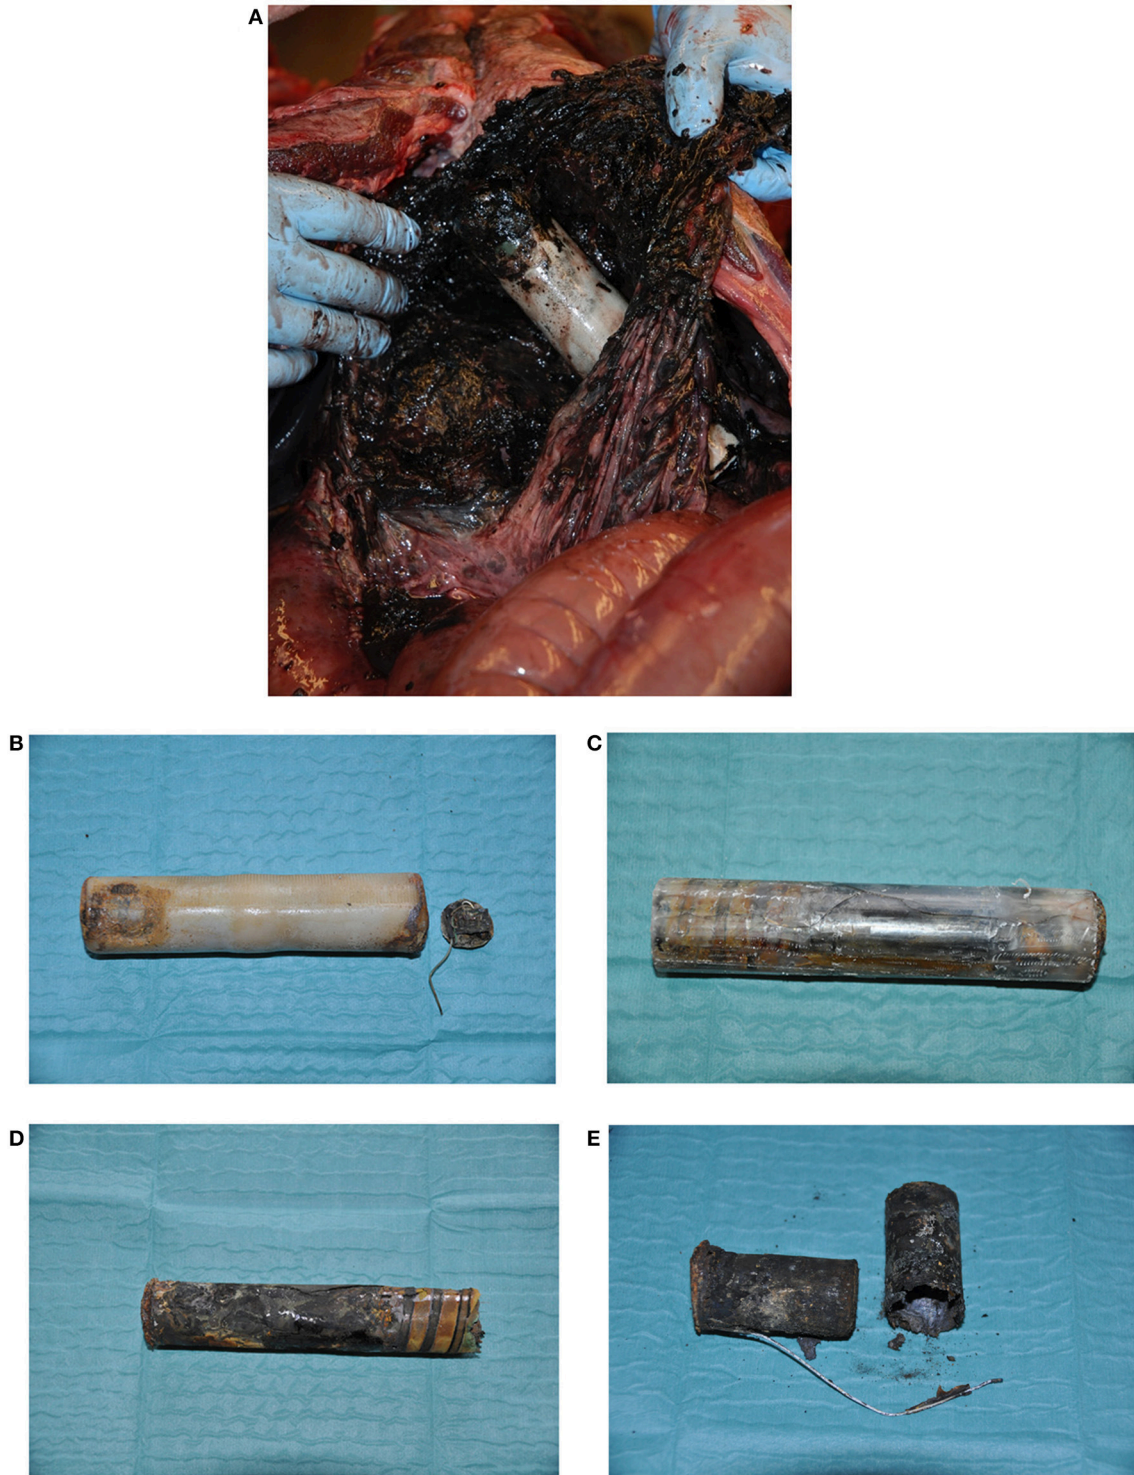
### Case 5 (Figure 8)

A female bear (W0020), born in 1999, was implanted with a Telonics IMP/400/L in April 2000. This bear went missing (no radio signal) in October 2002, but was found dead in September 2010, 10 years after surgery. At necropsy, the implant was found free-floating in the abdomen. One end cap was completely detached and a metal wire (antenna) had perforated the stomach. The cause of death was peritonitis with subsequent sepsis. The wax coating was melted at both ends of the implant. The plastic cylinder had multiple, longitudinal cracks and fell into multiple pieces when the wax was removed. All internal parts were literally burned, presumably due to short-circuiting of the batteries and subsequent over-heating.

**FIGURE 8** | Implant (Telonics IMP400/L, 15.2 × 3.3 cm) from a female bear (W0020) found dead 10 years after implantation. Cause of death was peritonitis, with subsequent sepsis, due to perforation of the stomach by a metal wire (antenna) and leakage from the batteries that had short-circuited. **(A)** Implant *in situ* at necropsy. **(B)** Implant with detached end cap and metal wire. **(C)** Implant after removal of the wax coating, showing several longitudinal cracks in the plastic cylinder. **(D)** Outer paper wrapping, after removal of the plastic cylinder, showing signs of over-heating and scorching. **(E)** Batteries showing signs of over-heating.

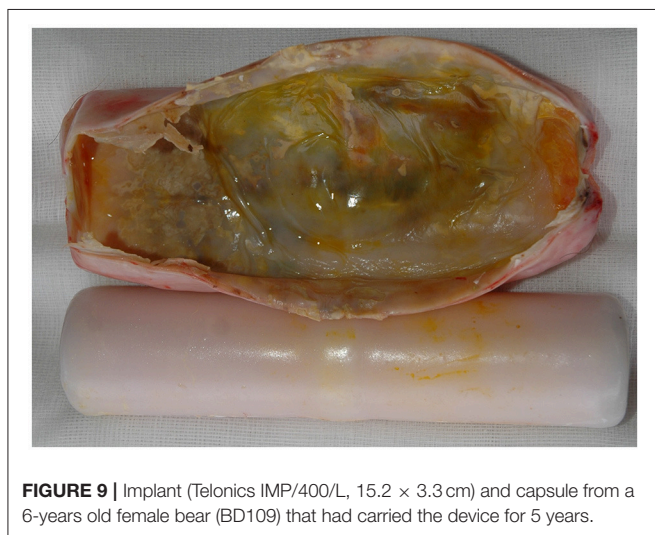
### Case 7 (Figure 9)

A female bear (BD109), born in 1999 was implanted with a Telonics IMP/400/L in May 2000. The implant was removed after 5 years in May 2005. The transmitter was in the greater omentum, surrounded by a 2–3 mm thick capsule with a rich vascular supply. We amputated part of the omentum, which was in a full volvulus, with its root having the appearance of a twisted rope. The wall of the capsule had a smooth inner surface and an outer surface that was covered with adipose tissue. The middle layer consisted of fibrous tissue containing some gray to yellow tissue. Histologically, the inner layer consisted of necrotic, laminar, and loosely woven tissue over a zone of necrotic debris without any obvious organization. The middle layer consisted of laminar, densely woven connective tissue, and the external surface was covered by adipose tissue. Spots of calcification, small hemorrhages, and mild, diffuse infiltrates of neutrophilic granulocytes were present in the tissues. Some epithelioid macrophages with foamy cytoplasm were also seen, and there were multiple aggregates of yellow pigment within the capsule wall. Except for minor signs of wax wear at the ends, all parts of the implant were unremarkable. This bear was captured again in May 2008 to change the radio collar and in May 2011 to remove the radio collar. It produced two cubs in 2007 and 2010. No further information about its fate after 2011 is available.

**FIGURE 9 |** Implant (Telonics IMP/400/L, 15.2 × 3.3 cm) and capsule from a 6-years old female bear (BD109) that had carried the device for 5 years.
