Evenhuis JV, Verstraete FJM and Arzi B
(2022) Management of failed stainless
steel implants in the oromaxillofacial
region of dogs.
Front. Vet. Sci. 9:992730.
doi: 10.3389/fvets.2022.992730

Management of failed stainless steel implants in the oromaxillofacial region of dogs

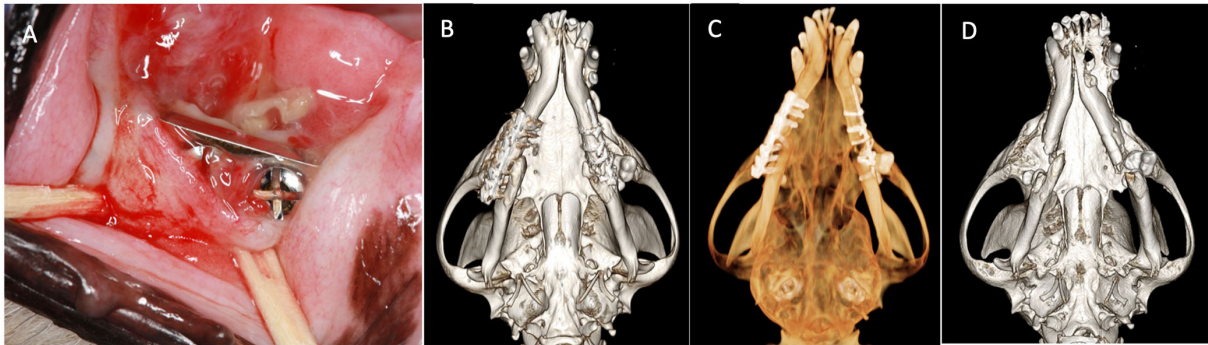
Skull CT with and without contrast revealed bilateral mandibular fractures at the level of the right and left mandibular first molar tooth. The caudal aspect of the stainless steel orthopedic plate on the right side was laterally displaced with noticeable bone loss around the four most caudal screws. The left mandible exhibited a metallic pin traversing both cortices of the caudal left mandible with associated cerclage wires (Figure 1).

FIGURE 1
Case 1 images before definitive surgery. **(A)** Intraoral view of right mandibular stainless-steel plate on presentation. **(B)** Three-dimensional bone algorithm CBCT rendering of ventral view of mandibles before removal of a failed implant. **(C)** Three-dimensional tooth algorithm CBCT rendering of ventral view of mandibles before the removal of a failed implant. **(D)** Three-dimensional bone algorithm CBCT rendering of ventral view of mandibles indicating bilateral non-union fractures.

The dog underwent removal of all orthopedic implants on both mandibles as described earlier. Extractions of the right mandibular second and third premolar teeth, left mandibular second and fourth premolar teeth, and left and right mandibular first molar teeth were performed due to severe periodontal disease. The culture and sensitivity of the removed implants and bone revealed a mixed bacterial population with some species displaying resistance to several antibiotic classes (Table 1). The dog was discharged from the hospital on amoxicillin/clavulanic acid (22.6 mg/kg two times a day), meloxicam (0.1 mg/kg once a day for 5 days), tramadol (3 mg/kg two times a day for 7–10 days), famotidine (0.6 mg/kg two times a day for 3 days), and chlorhexidine oral rinse after meals and kept in a soft muzzle until definitive repair. Based on the results of the culture and sensitivity tests, the antibiotic therapy was changed to doxycycline (Table 1).

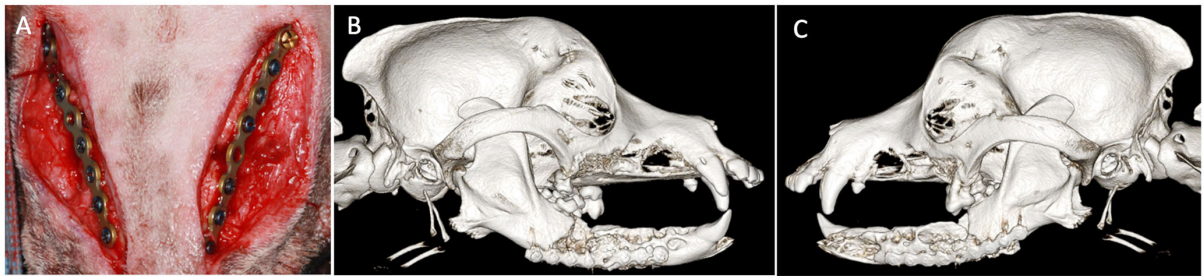
FIGURE 2
Case 1 intraoperative and postoperative images. **(A)** Intraoperative image showing placement of bilateral titanium miniplates before closure. Three-dimensional bone algorithm CBCT rendering immediately postoperatively of **(B)** right lateral view and **(C)** left lateral view of the skull after placement of titanium miniplates.

One month later, the dog returned for mandibular reconstruction with titanium locking mini-plates and rhBMP-2 as outlined earlier (Figure 2). The dog was hospitalized for an additional day following surgery and discharged on meloxicam (0.1 mg/kg once a day for 5 days), tramadol (1.6–3.2 mg/kg three times a day for 5–7 days), amoxicillin/clavulanic acid (24.0 mg/kg two times a day for 14 days), and chlorhexidine gluconate oral rinse (two times a day after meals). A follow-up call 7 days after surgery revealed that the dog was recovering clinically well. Further follow-up was performed and intraoral radiographs

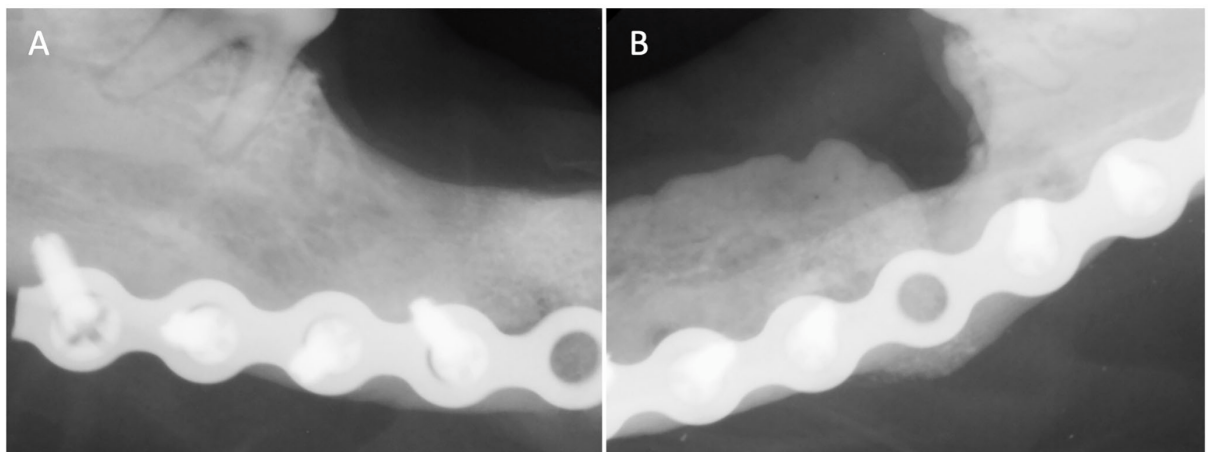
FIGURE 3
Case 1 follow-up intraoral radiographs of **(A)** right and **(B)** left mandible 3 months post-op showing appropriate bone healing of both fracture sites.

revealed appropriate healing of the fractures (Figure 3). The owner reported that the dog lived for 4 more years exhibiting a good quality of life and no observed pain or discomfort.

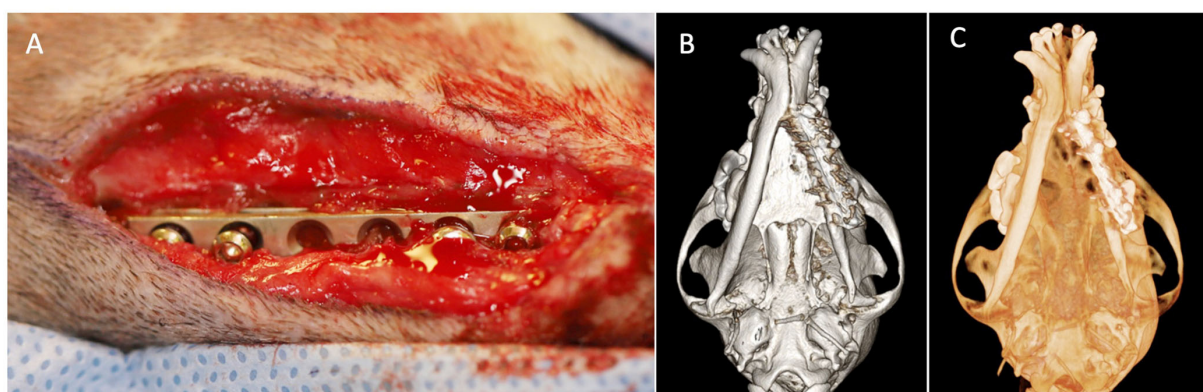
FIGURE 4

On presentation, the dog appeared cardiovascularly stable. An oral examination revealed mandibular drift to the left with multiple missing teeth. A CBCT and intraoral radiographs revealed an ~15-mm defect extending from the distal root of the left mandibular third premolar tooth to the mesial aspect of the absent left mandibular first molar tooth with evidence of remodeling. A stainless steel plate was noted in the left mandible with one screw apical to the mesial root of the left mandibular third premolar tooth and two screws penetrating the intermandibular space (Figure 4).

Case 2 images before definitive surgical treatment. (A) Intraoperative image showing an approach to left mandible revealing stainless steel plate with loose screws. (B) Three-dimensional bone algorithm CBCT rendering of ventral view of mandibles before removal of a failed implant. (C) Three-dimensional tooth algorithm CBCT rendering of ventral view of mandibles before removal of a failed implant.

The dog underwent removal of the implant as previously described. The left mandibular first, second, and third premolar teeth and left mandibular second molar teeth were extracted. Culture and sensitivity testing of the removed hardware revealed bacterial species showing no resistance to common antibiotics (Table 1). The dog was discharged from the hospital on

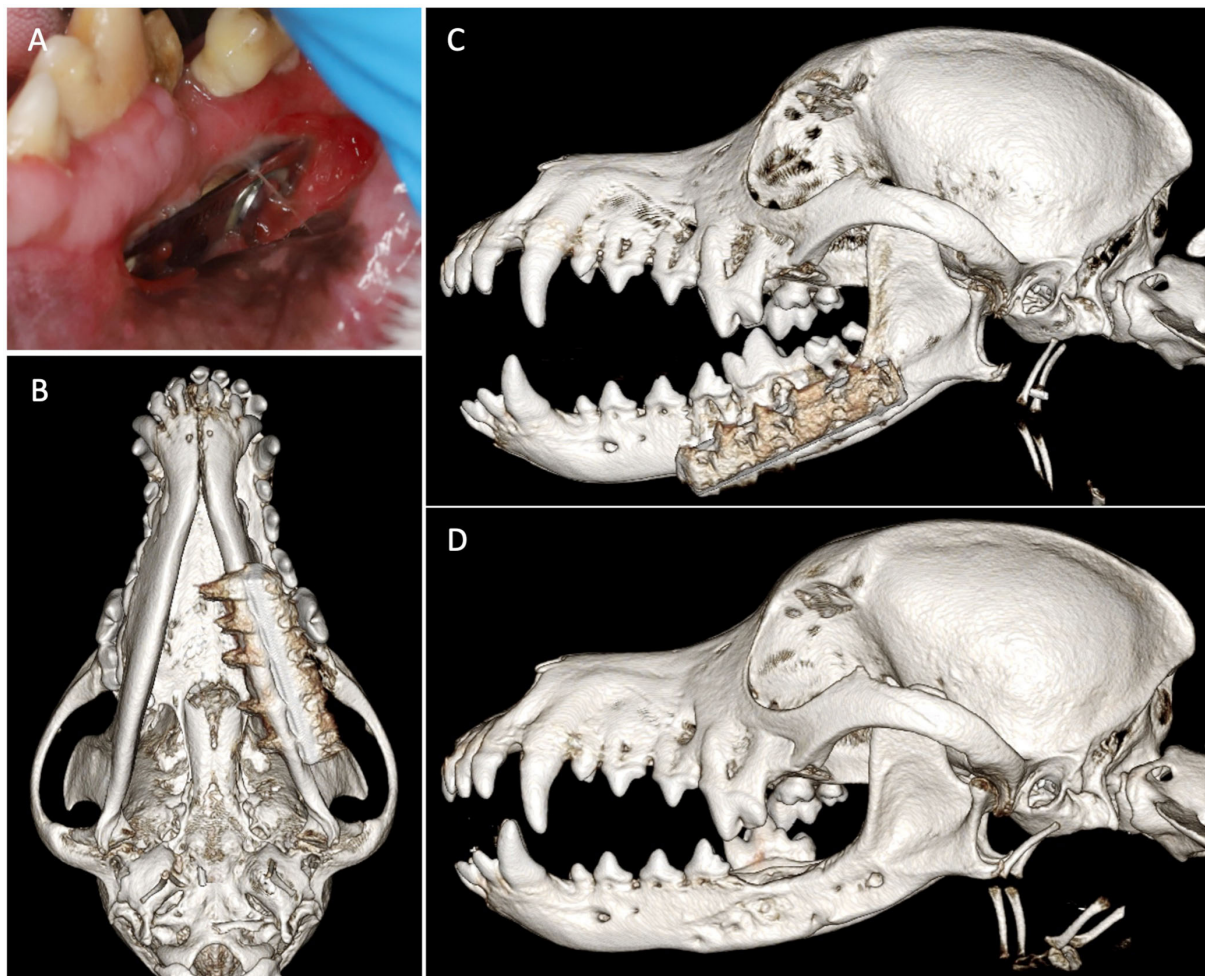
FIGURE 5

Case 5 images before and after implant removal. (A) Preoperative image showing intraoral left mandibular stainless steel plate exposure. Three-dimensional bone algorithm CBCT rendering of (B) ventral view and (C) left lateral view of skull before removal of the exposed implant. (D) Three-dimensional bone algorithm CBCT rendering of the left lateral view of the skull at 6 weeks after implant removal.

The dog was cardiovascularly stable on a general physical exam. An oral examination revealed a stainless steel plate visible intraorally along the lateral aspect of the left mandible. The mandible felt stable on palpation. CBCT scan revealed that the plate was present along the lateral aspect of the left mandible and horizontal and vertical bone loss was associated with the left mandibular first, second, and third molar teeth. The margins of the previous fracture were ill-defined with evidence of osseous bridging (Figures 5A–C). A periapical lucency was associated with the mesial root of the left mandibular first molar tooth.

The dog underwent removal of the left mandibular stainless-steel plate using the methods described above. The left mandibular first, second, and third molar teeth were extracted due to periapical lucency and severe attachment loss. A culture

At the 2-week recheck, the dog appeared to be eating and drinking normally and comfortably. The surgical sites appeared appropriately healed and the muzzle was removed. At the 6-week recheck, the dog underwent a recheck CBCT (Figure 5D). The dog exhibited mild drifting of the mandible to the right, without causing soft tissue trauma, but the mandible was palpably stable. The previous fracture site exhibited further remodeling including filling of the previous screw holes
