MULTIDISCIPLINARY LOESS GEOHAZARD INVESTIGATIONS

EDITED BY: Fanyu Zhang, Gonghui Wang, Mark Allen and Yueren Xu
PUBLISHED IN: Frontiers in Earth Science

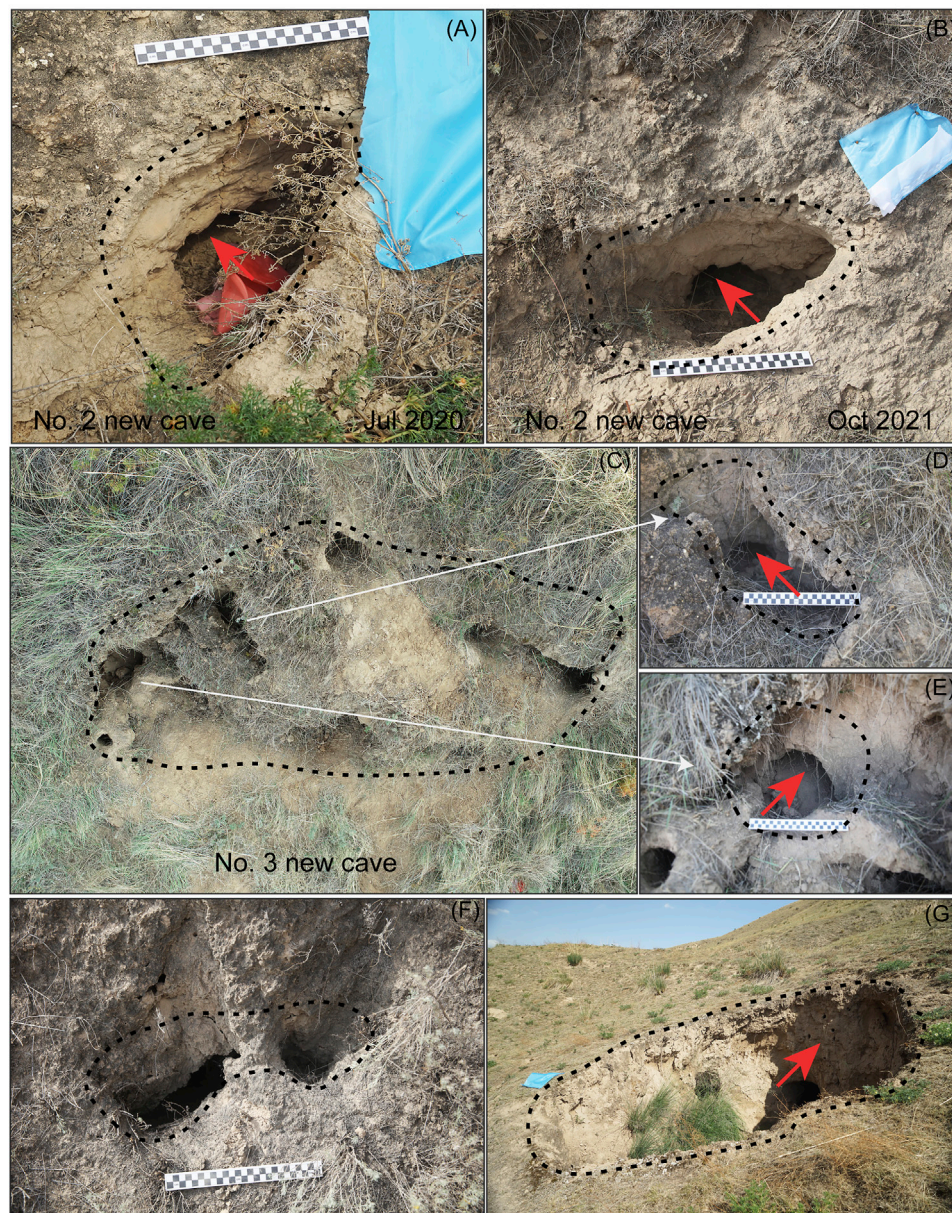
FIGURE 7 | Evidence that loess caves can “inherit” animal burrows (**A, B, D, E and F**) and develop under the influence of biotic activities (**C and G**). Both panel (**A** and **B**) are the No.2 new cave, which were photographed in Jul 2020 and Oct 2021 respectively. Panel (**C**) is the No.3 new cave, which consists of eight sub-caves [such as sub-cave in panel (**D**) and sub-cave in panel (**E**)]. The new cave in panel (**F**) and the mature cave in panel (**G**) are observed near our study area. The black dashed lines indicate the entrances of loess caves. The red arrows in panels (**A, B, D, E, F, and G**) indicate the remaining animal burrows in loess caves.

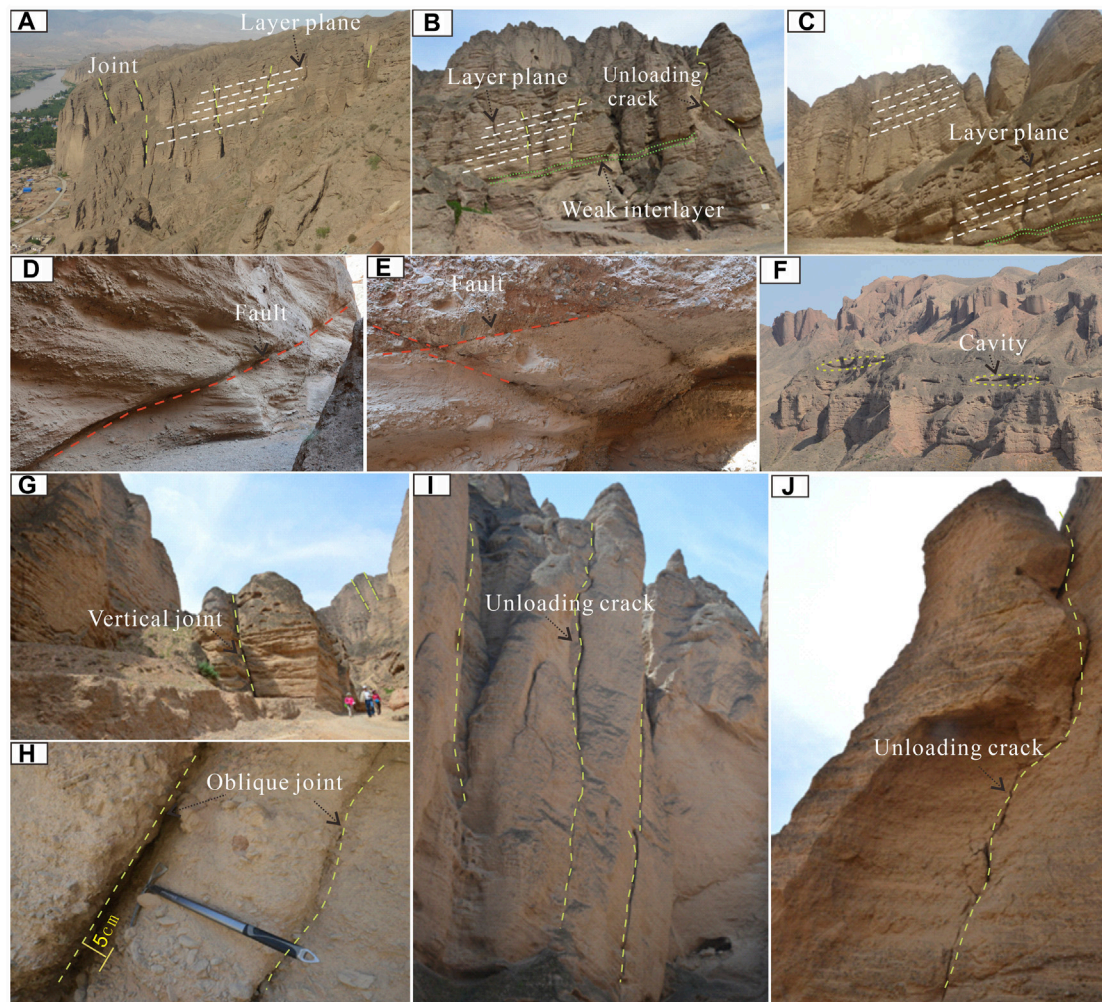
FIGURE 4 | Structural plane types and combination characteristics of typical rock slopes in the study area. (A) Layer plane and joint; (B,C) layer plane, joint, and weak interlayer; (D,E) fault; (F) cavity; (G,H) vertical and oblique joints; and (I,J) unloading fracture.
