# Evaluation of Damage to a Historic Masonry Building in Nepal through Comparison of Dynamic Characteristics before and after the 2015 Gorkha Earthquake

Aiko Furukawa<sup>1\*</sup>, Junji Kiyono<sup>1</sup>, Rishi Ram Parajuli<sup>1</sup>, Hari Ram Parajuli<sup>2</sup> and Kenzo Toki<sup>3</sup>

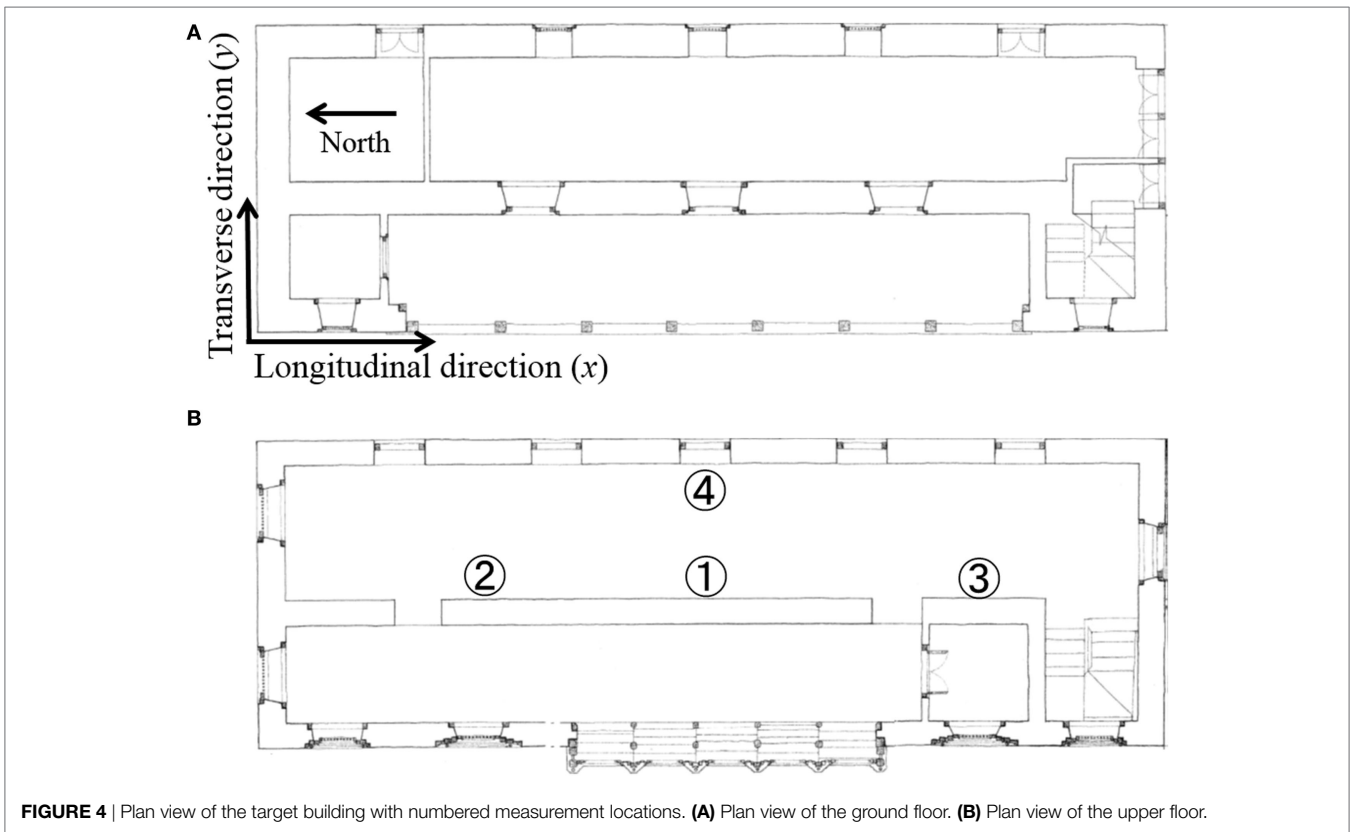
**FIGURE 4** | Plan view of the target building with numbered measurement locations. **(A)** Plan view of the ground floor. **(B)** Plan view of the upper floor.

**Figure 4A** shows the layout of the structures and measurement locations where accelerometers were placed. The measurement was conducted at locations 1, 2, and 3 before the earthquake and at locations 1, 2, and 4 after the earthquake as shown in **Figure 4B**. The measurements at the same locations were not possible due to equipment trouble. The acceleration responses were measured for 10 min in the longitudinal ( $x$ , NS) and transverse ( $y$ , EW) directions. The sampling interval of measurement data was 0.01 s. The measured waveforms were corrected for baseline and divided into segments of 4,096 data points. 10 sets of 4,096 data points without unsteady portions were extracted manually and the average of their Fourier amplitudes was computed. For smoothing, Parzen window with a frequency band width of 0.4 Hz was applied.

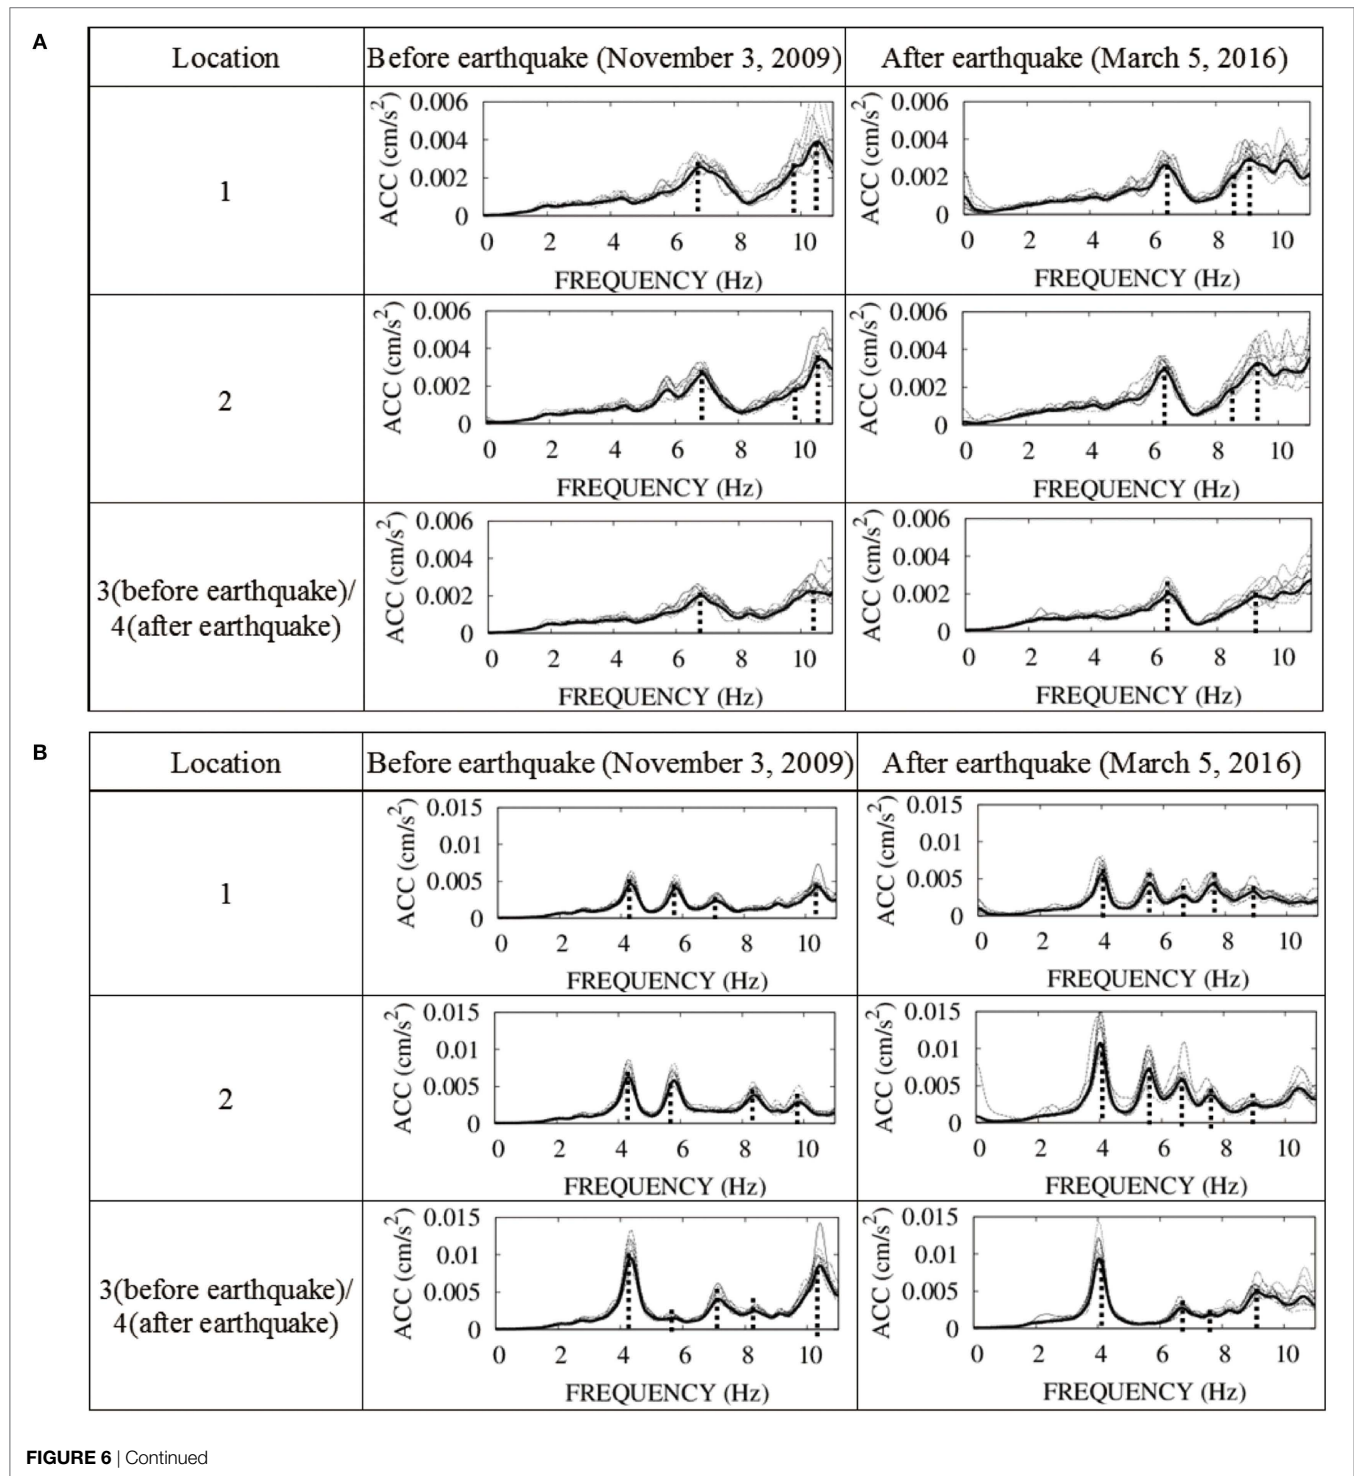
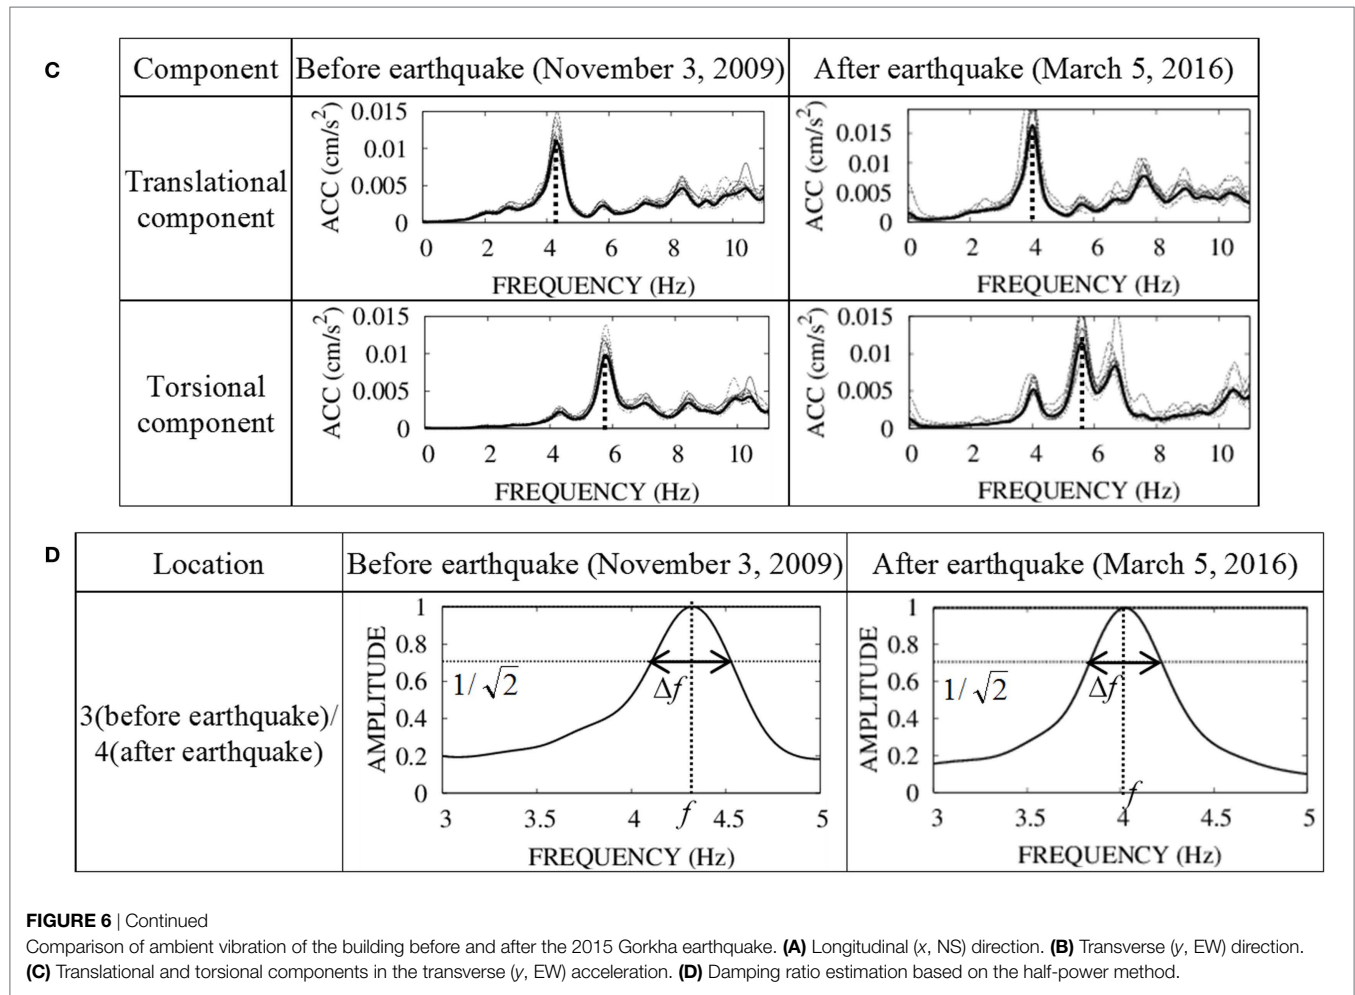
FIGURE 6 | Continued

**Figure 6A** shows a comparison between the Fourier amplitudes of the first-floor responses in the longitudinal ( $x$ , NS) direction before and after the earthquake. In **Figure 6A**, peaks can be seen at around 6.87 and 10.5 Hz before the earthquake and 6.43 and 9.2 Hz after the earthquake. It is reasonable to assume that these frequencies correspond to the natural frequencies of the dominant modes in the longitudinal direction before and after the earthquake. A slight peak can also be seen at locations 1 and 2 around 9.7 Hz before the earthquake and 8.5 Hz after the earthquake.

before and after the earthquake. In **Figure 6B**, peaks can be seen at 4.33, 5.78, 7.13, 8.4, and 10.2 Hz before the earthquake and 4.02, 5.58, 6.68, 7.64, and 9.0 Hz after the earthquake. These frequencies are considered to be the natural frequencies of the modes in the transverse direction. A greater number of the peaks can be seen in the Fourier amplitudes of the response in the transverse direction than that in the longitudinal direction. To further understand these details, the responses were separated into the translational and torsional components.

**Figure 6C** shows the sum and difference of the Fourier amplitudes at locations 1 and 2 in the transverse (y, EW) direction for pre- and post-earthquake measurements. Because the sum and the difference emphasize the translational motion and the torsional motion, respectively, it is found that the natural frequency of the translational motion is 4.33 Hz before the earthquake and 4.02 Hz after the earthquake. It can also be said that the natural frequency of the torsional mode is 5.78 Hz before the earthquake and 5.58 Hz after the earthquake.

The damping ratio of the first transverse mode is calculated by the half-power method under the assumption of white noise excitation. **Figure 6D** shows the normalized Fourier amplitude around the natural frequency of the first transverse mode. The dashed line indicates an amplitude of  $1/\sqrt{2}$ . The damping ratio  $h$  is obtained as  $h = \Delta f/2f$  where  $f$  is the natural frequency and  $\Delta f$  is the frequency band width shown in **Figure 6D**. The damping ratios before and after the earthquake are found to be 4.82 and 4.85%, respectively.

Comparison of ambient vibration of the building before and after the 2015 Gorkha earthquake. (A) Longitudinal (x, NS) direction. (B) Transverse (y, EW) direction. (C) Translational and torsional components in the transverse (y, EW) acceleration. (D) Damping ratio estimation based on the half-power method.

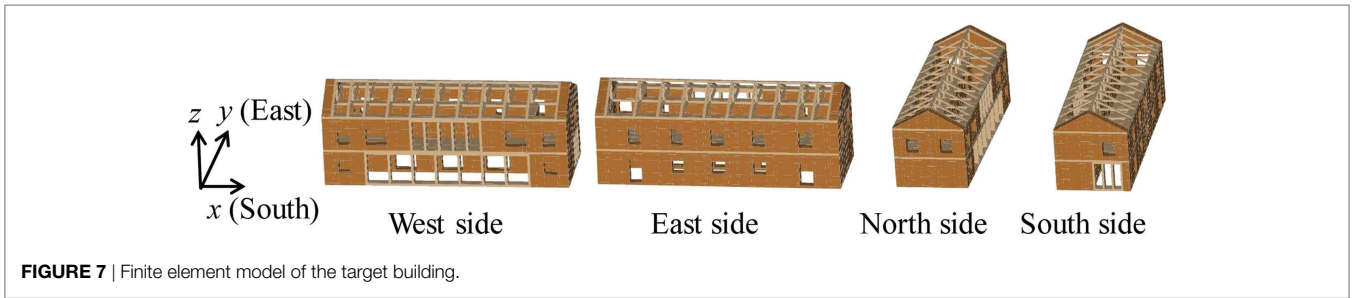
FIGURE 7 | Finite element model of the target building.

In the finite element modeling of the building shown in **Figure 7**, the following assumptions are introduced. The thickness of

the brick wall is 60 cm, and the section area of the timber is 15 cm × 15 cm. All components are modeled with 8-node solid elements. The total number of nodes and the elements are 5,674 and 3,128, respectively.

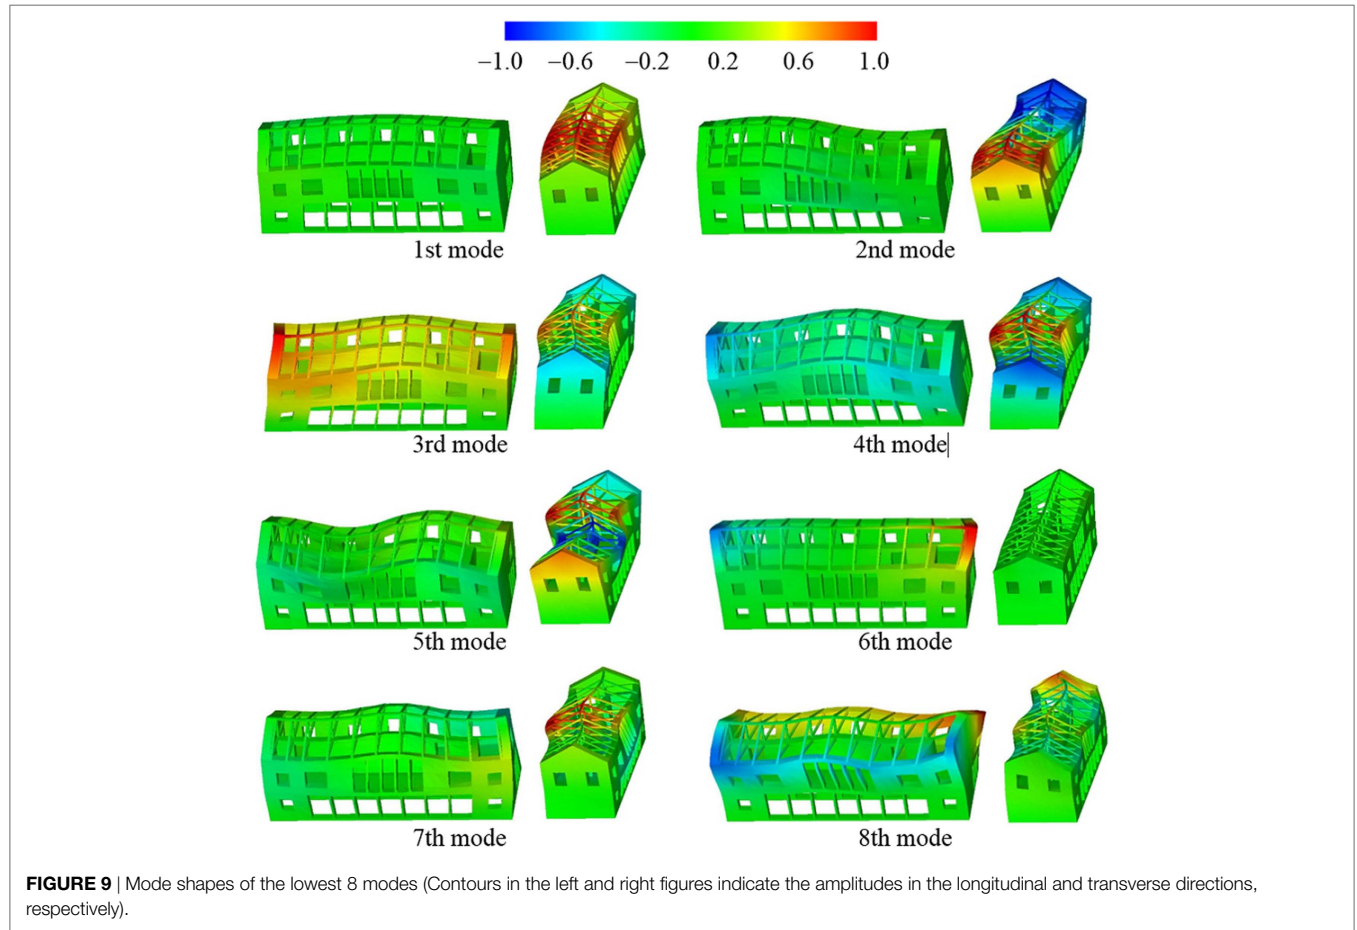
The mode shapes of the eight natural modes are shown in Figure 9. The eigenvector is scaled so that the largest absolute value of its elements be 1.0. Those mode shapes conform to the observed Fourier amplitude spectra shown in Figure 6. For example, the third, sixth, and eighth modes are dominant in the longitudinal ( $x$ ) direction and other modes are dominant in the transverse ( $y$ ) direction. In the second mode shown in Figure 9, the phases of the north and south side vibrations are opposite as observed in Figure 6C.

**FIGURE 9** | Mode shapes of the lowest 8 modes (Contours in the left and right figures indicate the amplitudes in the longitudinal and transverse directions, respectively).
