Emergency Survey and Stability Analysis of a Rainfall-Induced Soil-Rock Mixture Landslide at Chongqing City, China

Chang Zhou¹, Dong Ai², Wei Huang^{2*}, Huiyuan Xu², Liwen Ma², Lichuan Chen³ and Luqi Wang⁴

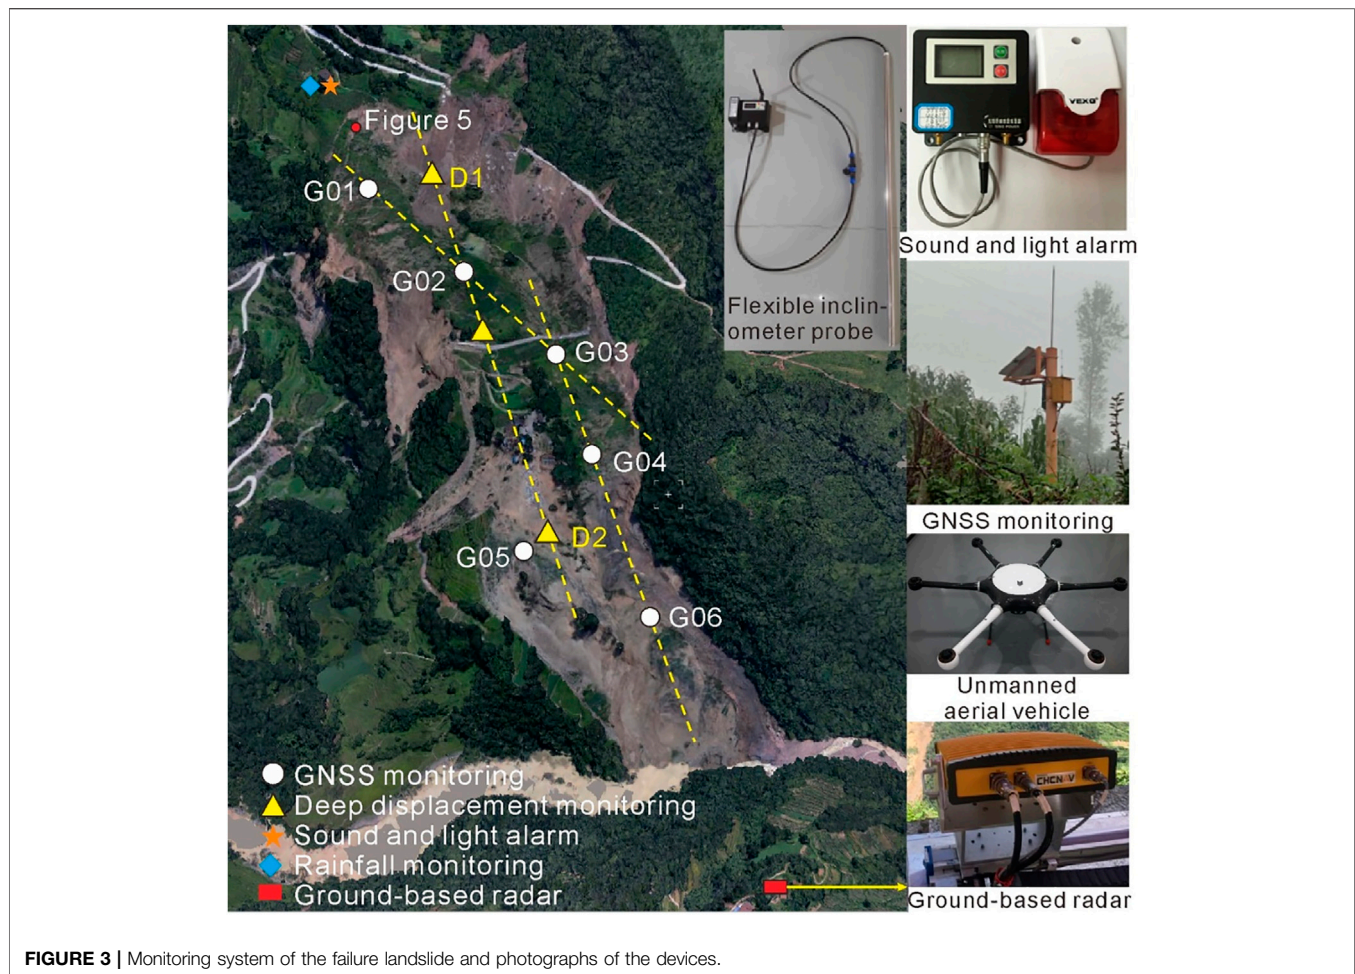
FIGURE 3 | Monitoring system of the failure landslide and photographs of the devices.

An emergency monitoring was started from July 27 to Aug 2. Ground-based radar was 2.8 km away from the landslide (Figure 3). The surface deformation of the landslide was scanned from July 27 to October 2. Unfortunately, the monitoring was non-continuous due to the power issues and a change in the device location. Therefore, two periods are selected to analyze the deformation characteristics of the landslide debris.

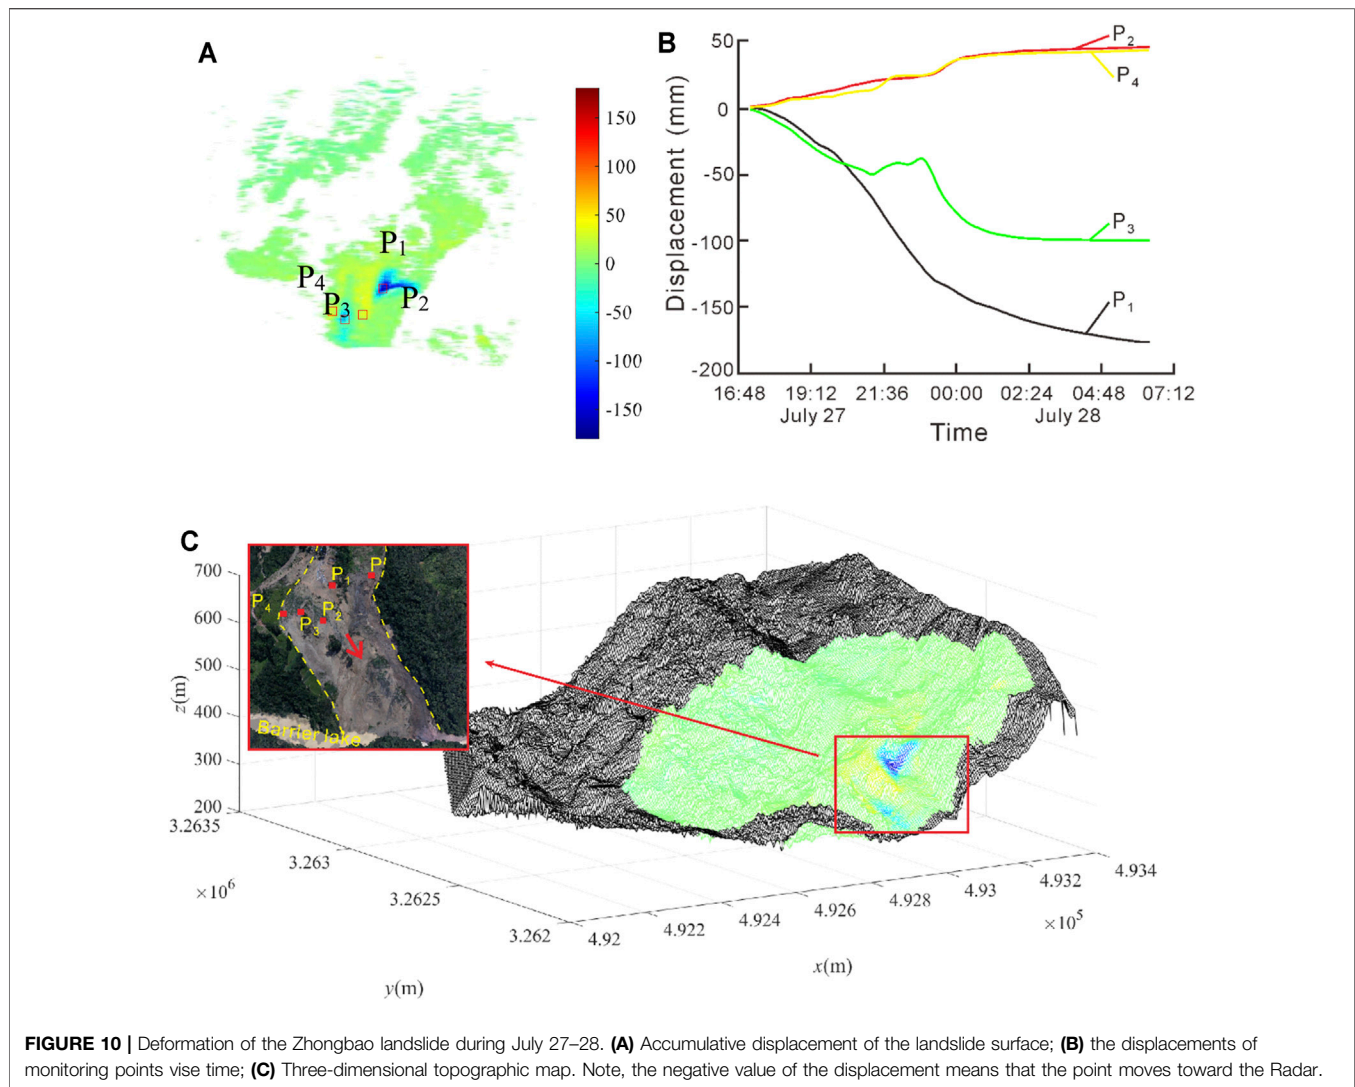
Figure 10 is the monitoring results of the landslide surface from 16:00 July 27 to 06:00 July 28. The uphill and middle of the landslide showed no obvious deformation, but the downhill section had large deformation with the largest displacement being 200 mm (Figure 10A). The displacements of four monitoring points in the downslope are shown in Figure 10B. It is observed that the displacement of P2 and P4 slowly increased and reached about 50 mm. However, the displacement at P1 and P3 had the largest values. The velocity of P1 gradually decreased after July 28. The displacement at P3 sharply increased at 22:00 July 27 and then tended to be stable. Moreover, local deformation was also found at the cliff on the northeast side of the downslope (approximately -50 mm).

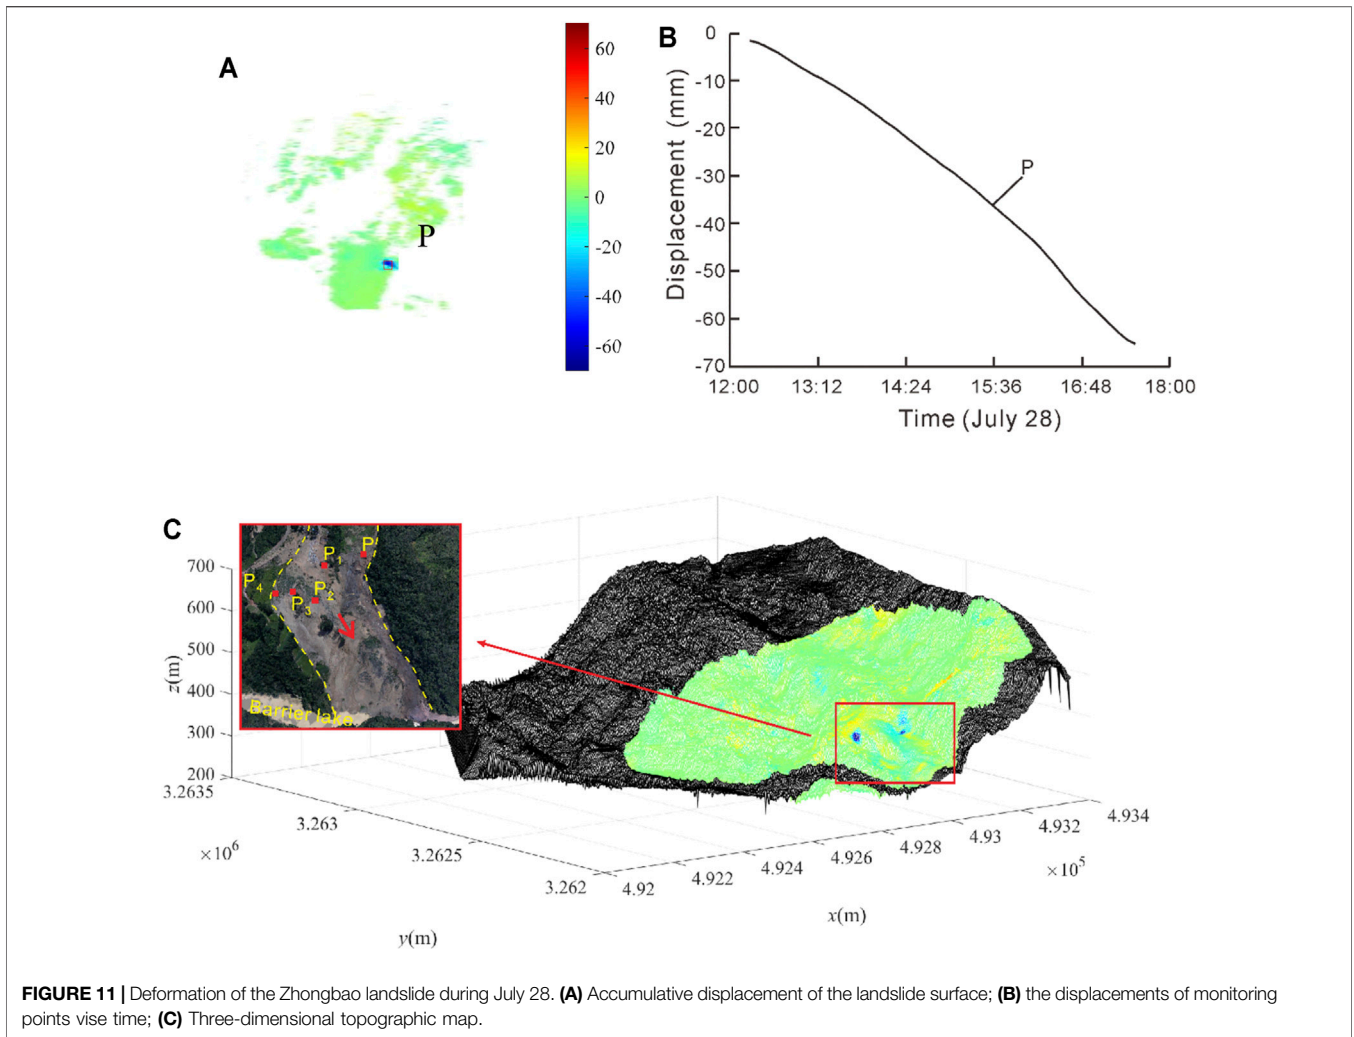
Figure 11 shows the displacement of the landslide surface from 11:00 to 17:00 July 28. It was found that the largest
