# Leveraging Remote-Sensing Data to Assess Garage Door Damage and Associated Roof Damage

Rachel N. Kovar<sup>1</sup>, Tanya M. Brown-Giammanco<sup>2\*</sup> and Franklin T. Lombardo<sup>1</sup>

<sup>1</sup> University of Illinois at Urbana-Champaign, Urbana, IL, United States, <sup>2</sup> Insurance Institute for Business and Home Safety, Richburg, SC, United States

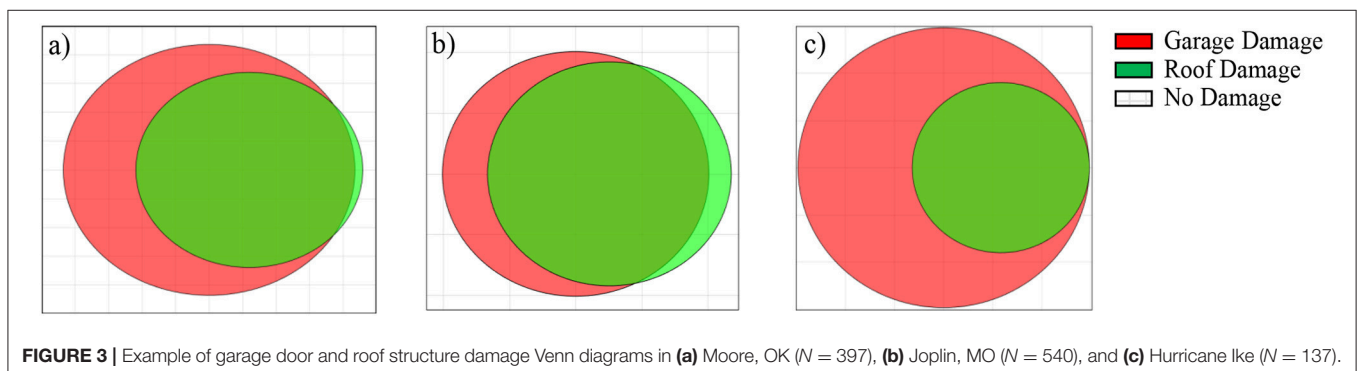
**FIGURE 3** | Example of garage door and roof structure damage Venn diagrams in (a) Moore, OK ( $N = 397$ ), (b) Joplin, MO ( $N = 540$ ), and (c) Hurricane Ike ( $N = 137$ ).

**Table 1** shows the total number of homes analyzed in Joplin, Moore, and Hurricane Ike, the number of homes with garage doors and associated damage, as well as those with roof structure damage with or without garage door damage. The data show that homes were more likely to have damage to the roof structure if there was garage door damage. Although there were cases where homes suffered roof structural damage without garage door damage, they were minimal. When all three events were combined, less than 10% of the homes had roof structure damage without a garage door failure, compared to approximately 60% of homes that had roof structure damage and garage door damage. **Figure 3** provides an illustrative look at the damage overview for each of the three events in the form of Venn diagrams. An interesting observation from both **Table 1** and **Figure 3** is that an overwhelming percentage (~94%) of homes that suffered some sort of roof structure damage also suffered garage door damage [423/(423 + 29)]. The following sub-sections will investigate various factors that may have contributed to the damage levels observed.

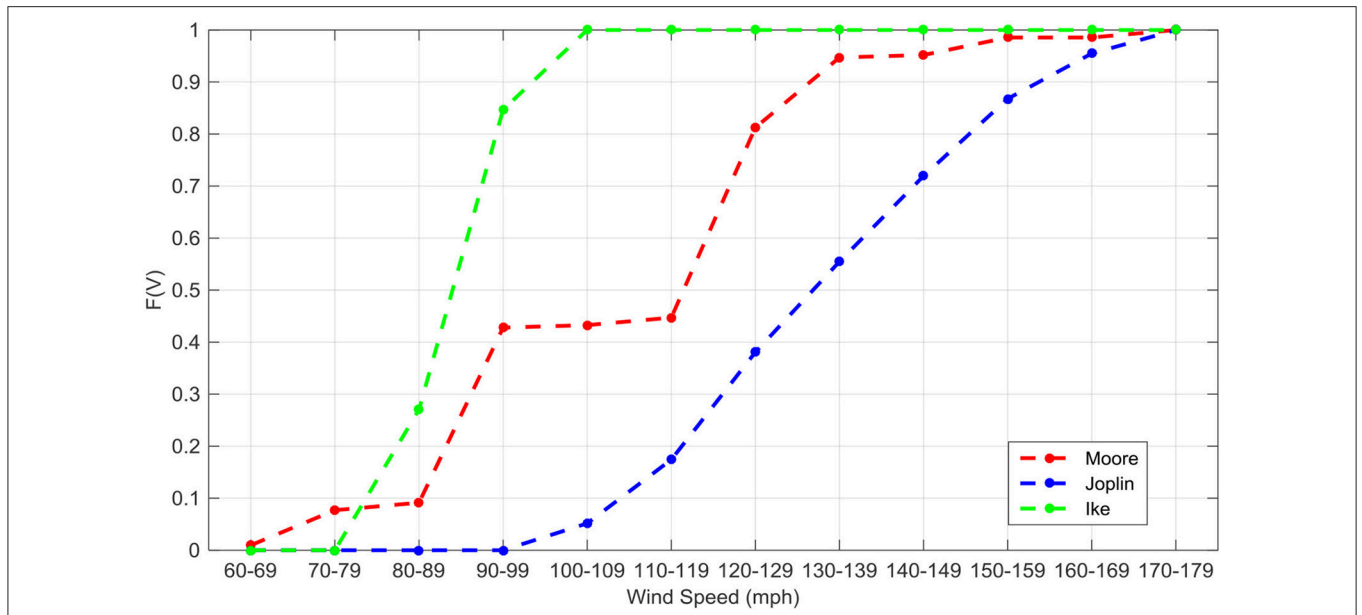
FIGURE 4 | Normalized cumulative percentage, F(V), of damaged homes by wind speed range.
