Practical methods to identify seepage paths in dam abutments in semi-arid areas: The Mujib dam in Jordan

The Mujib Dam in Jordan experienced high seepage in 2004 in the right abutment. Initial examination of the cause blamed the rocks there and excluded the clay core hydro-fracturing. The problem later was resolved by grouting the right abutment heavily. This work believes that the grouting quantity was excessive and can be minimized if seepage paths were identified. For this purpose, the excavation cut photos were revisited during construction, the piezometric levels of wells drilled after the seepage event were examined, and the physio-chemical characteristics of seepage water were correlated to those in the reservoir. All those methods combined succeeded in finding the seepage paths and their percentage contribution to the total seepage volume. They found that three-fourths of the seepage water occurred through a small area circling the right abutment gallery stair shaft walls and suggested that the remaining one-fourth can be stopped over time by sediment deposition on the reservoir floor. Therefore, the previously applied grouting volume was high. In conclusion, the methods u

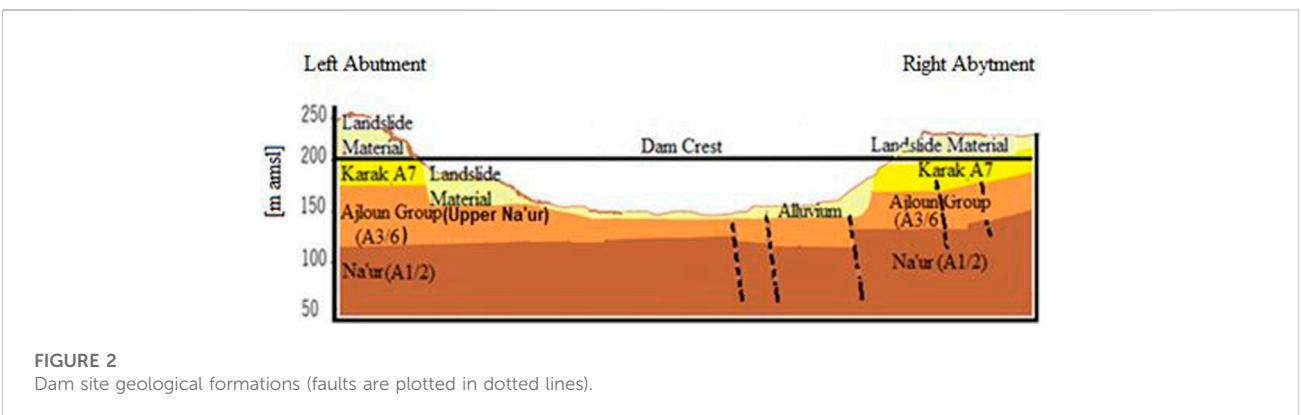
Abed (2017) and the Jordan Ministry of Water and Irrigation and Federal Republic of Germany (2008) described the geological formations across the dam axis as shown in Figure 2.

FIGURE 2
Dam site geological formations (faults are plotted in dotted lines).

On the valley floor, the top 4–8 m is composed of a material that slides from the valley flanks. It is underlaid by Fuheis/Hummar/Shueib formations of the Ajloun group (A3/6), which are basically a sequence of marl, limestone, and shale of low strength. They are well joined, and their pores are filled with residues of gypsum deposited from the top through stress relief joints. On the valley flanks, the Karak formation (A7) of the Ajloun group appears sitting underneath the sliding material and on the A3/6 formation. The A7 formation is 35 m deep and divided for simplicity into three layers: the top layer is massive limestone, marly limestone, and marl, with moderate strength; the middle layer is micritic limestone of 22 m thickness with intercalations of marly limestone, and it is moderate to strong in strength; and the bottom is a sequence of

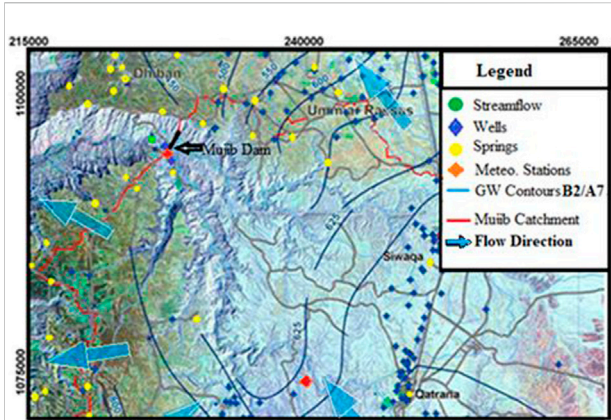
FIGURE 3
Groundwater contours and flow direction in the Mujib Dam aquifer system.

To understand the flow in and around the dam body, the hydrogeology of the dam surroundings must be described. According to the Jordan Ministry of Water and Irrigation and the Federal Republic of Germany report (2008), the Karak (A7) and Na'ur (A1/2) formations are aquifers, whereas the Ajloun group (A3/6) is an aquitard sandwiched between them. In fact, the Karak aquifer is a sub-aquifer of a larger aquifer system, named (A2/B7), which is basically the most productive one in Jordan. At the dam site, the groundwater flow lines diverge away from the dam site (blue arrows in Figure 3), which means that the aquifer outcrops there and the reservoir water could be a source.

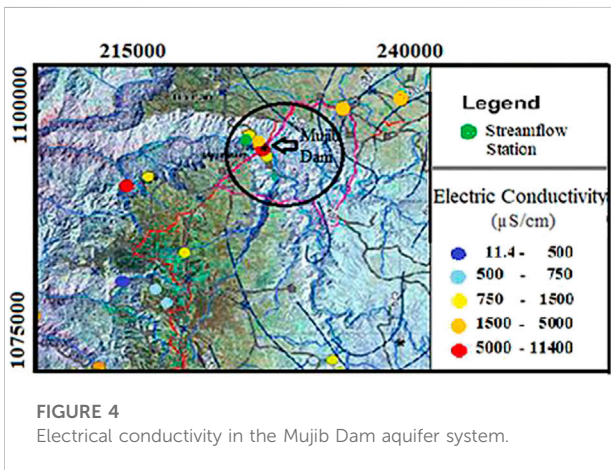
FIGURE 4
Electrical conductivity in the Mujib Dam aquifer system.

According to the Jordan Ministry of Water and Irrigation and the Federal Republic of Germany report (2008), the electrical conductivity (EC) of aquifers at the dam site varies between 750 and 11,400 µS/cm (Figure 4). The low EC describes the water that seeped from the reservoir and had constituents concentration (mean and standard deviation) in mg/L as reported: bicarbonates (136.3, 10.9), sulfate (138.1 m 10.3), chloride (59.6, 7.0), and sodium (40.4, 0.7), whereas the high value describes water rich in bicarbonates (141.27, 7.25), sulfate (2477, 230), chloride (2514, 717), and sodium (1466, 330) which describes Na'ur aquifer water.
