Damage Types and Deterioration Characteristics of Check Dams Built on Mountain Streams in Southeast Korea

Keywords: condition assessment, non-permeable check dams, stream management, check dam deterioration, visual inspection

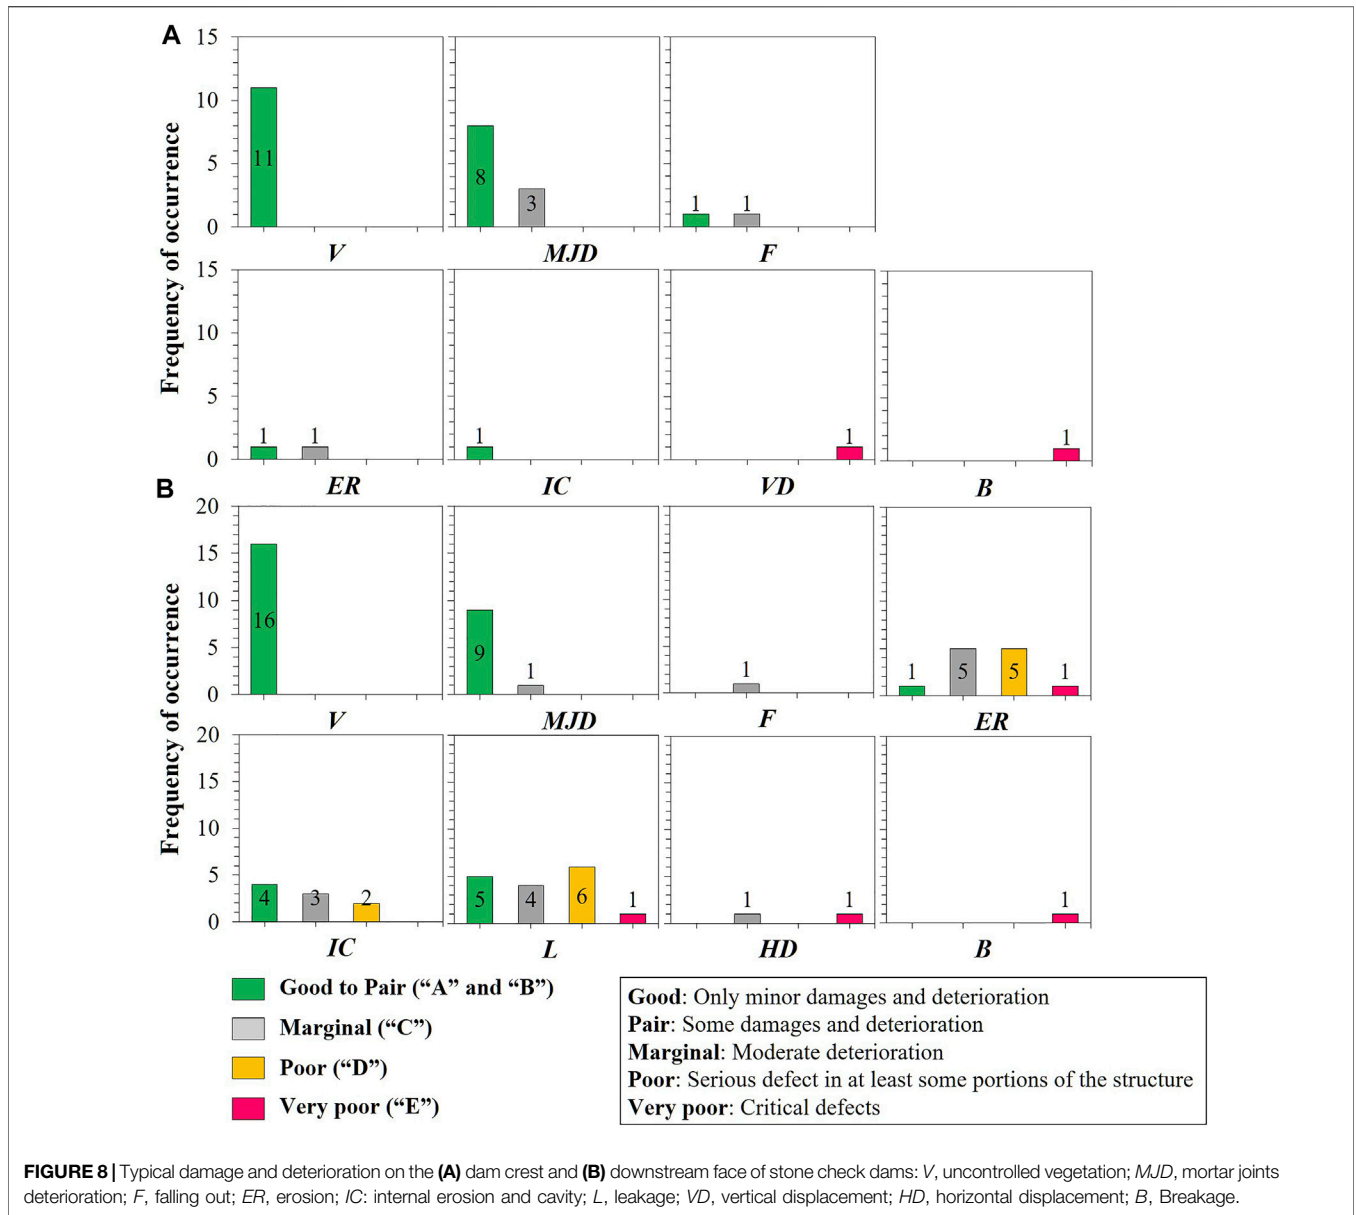
The patterns of *V* were classified into instances where grasses infiltrated and took root by themselves, where grasses and shrubs were found mixed together, and where trees infiltrated and grew by themselves (**Figure 9A**). Twenty-seven instances (dam crest: 11 instances; downstream face: 16 instances) of *V* occurred in 13 stone check dams. Of these observed instances, one was that of a tree and the remainder were that of combined grasses and shrubs growing together.

Twenty-one instances of *MJD* (dam crest: 11 instances; downstream face: 10 instances) were found in 11 inspection targets, and they were classified as typical stone check dam deterioration (**Figure 9B**). The *MJD* damage area accounted for 3.6–67.7% of the inspection area, but the majority of it was

Three instances of F were observed on two stone check dams. Two instances were attributed to impacts from debris flows at the spillway of the dam crest (Figure 9C), which produced cavities with depths of approximately 0.45 m in the damaged area. One instance displayed continuous concrete leakage in a cracked area, attributable to earth pressure, where vertical subsidence proceeded in the damaged area and developed into a Grade E horizontal displacement defect.

two instances occurring at the dam crest and 12 instances occurring at the downstream face (Figures 9D,E). In the ER instances identified in the downstream face, the foundation was scoured to a depth of 0.15–0.65 m in 11 instances of Grades C, D, and E defects. IC indicates an empty cavity that occurs when the flow in leaking areas continually carries away the internal material and discharges it downstream. IC is a significant defect that reduces the durability and stability of a check dam body, by increasing the dam’s internal porosity (Kasahara et al., 2010) (Figure 9F). IC inspection was performed on ten stone check dams (dam crest: 1 instance; downstream face: 9 instances). In the three instances of C and the two instances of D damages, multiple (2–4) defects with depths of 0.19–0.45 m were observed in a single inspection target.

L denotes the continuous flow of water through gaps inside the check dam (Figure 9G). Stone check dams are composed of

FIGURE 9 | Various deterioration types observed on stone check dams: **(A)** grasses and shrubs infiltrating the dam crest, **(B)** exposure of internal concrete due to joint spalling, **(C)** falling out caused by impact of bedload transport, **(D)** and **(E)** erosion of abutment slope and foundation; **(F)** vertical subsidence due to internal concrete outflow; **(G)** clear leakage and horizontal displacement of downstream face; **(H)** damage to the dam body due to the hydraulic force of flooding.

heterogeneous materials, and they are structurally less watertight than their concrete counterparts. Sixteen instances of *L* were found in the 12 stone check dams, and of these, 12 instances of leakages were observed together with foundation erosion, and a section of the damaged area had been washed downstream. In the seven instances of *L* that were Grade C or above, the filling concrete had flowed out and the internal porosity had increased, compromising the structural stability of the dam. Three instances of *VD* and *HD* were found in two inspection targets, and they were accompanied by *L* and *IC*, regardless of direction. One instance of *B* damage was confirmed, where the dam could not withstand the hydraulic force of flooding, and more than 70% of the structure had been washed away (**Figure 9H**).
