# Deep-Seated Deformation Mechanisms of Excavated Slope and Control Methods: A Case Study

Wu Y, Zhang Q, Ding X, Wang H,  
Huang S and Yin X (2022) Deep-  
Seated Deformation Mechanisms of  
Excavated Slope and Control  
Methods: A Case Study.  
Front. Earth Sci. 10:858542.  
doi: 10.3389/feart.2022.858542

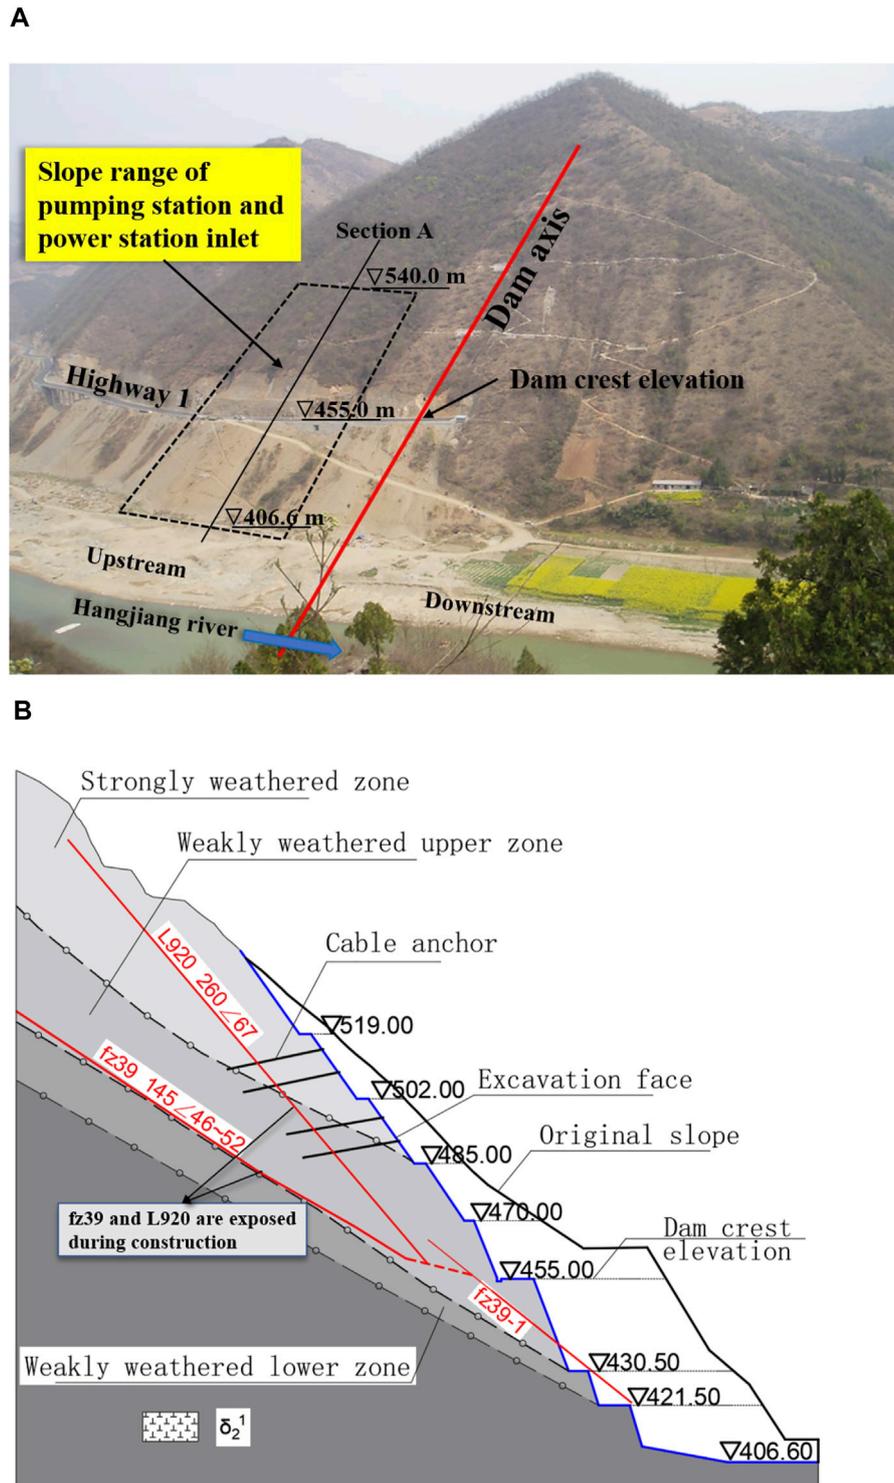
FIGURE 2 | Basic situation of the study slope: (A) covering range; (B) original design.

The object of study was the slope of the pump station and power station inlet of the Huangjinxia Water Control Project (**Figure 2A**). The slope is located along the left bank, from 16.8 to 162.9 m upstream of the dam axis. According to the Design Code for Engineering Slopes in Water Resources and Hydropower Projects (The Water Conservancy Standards Compilation Group of the People's Republic of China, 2007a), the slope grade is Grade 1. In the preliminary design stage, no controlling structural surfaces, such as fz39 and L920, were found on the slope. The basic principle of slope design is to ensure the stability of strongly weathered rock mass. The design scheme of the slope follows (**Figure 2B**):

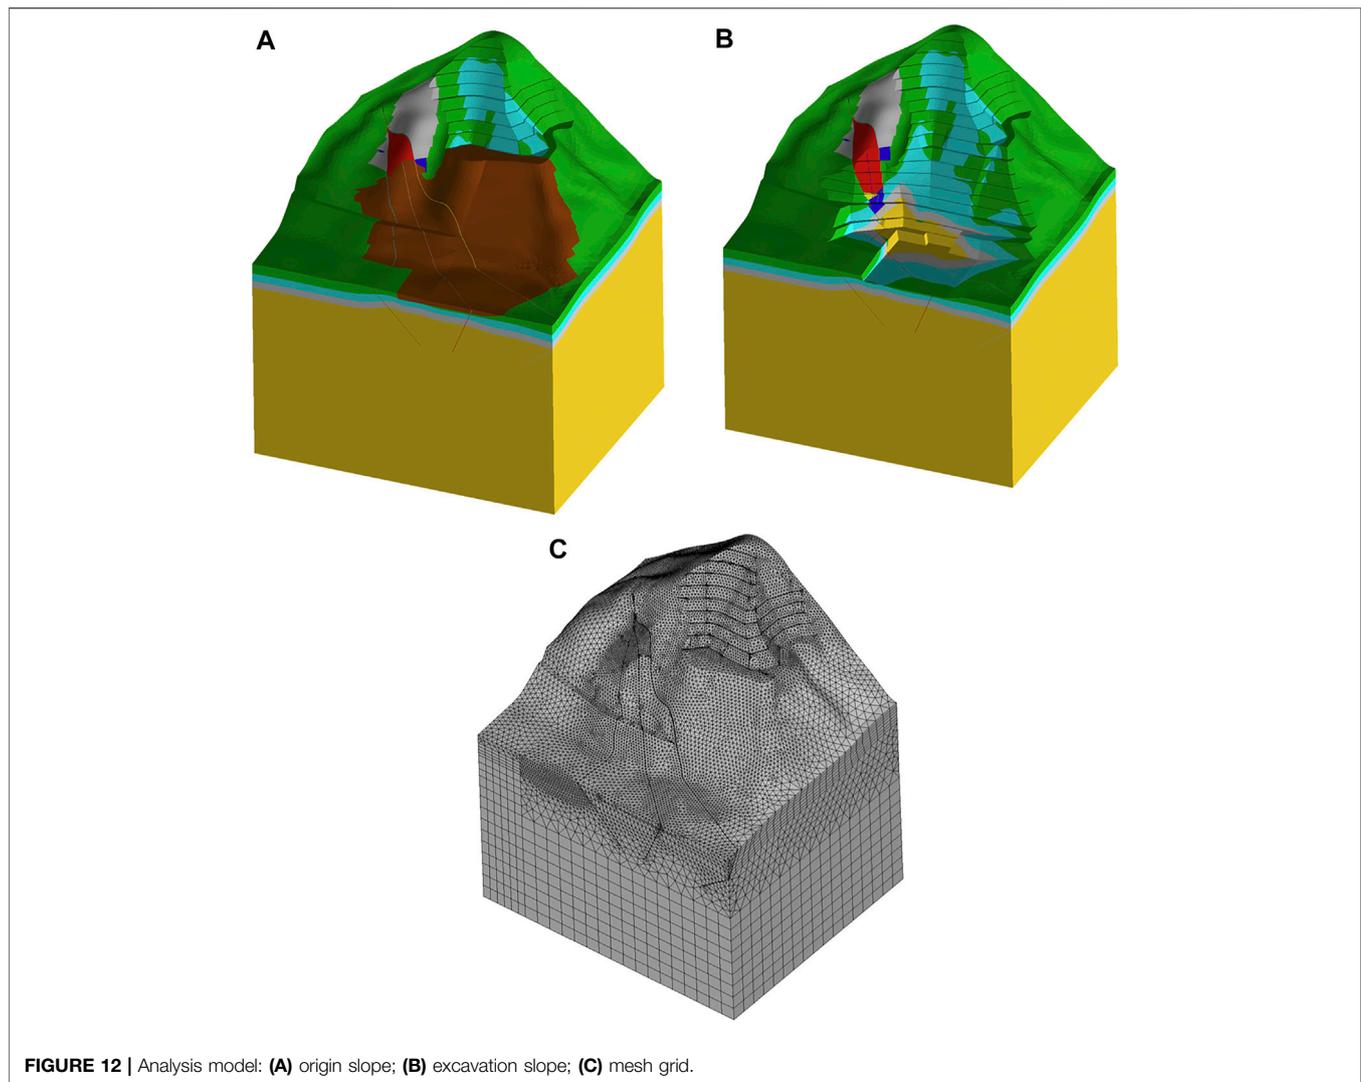
**FIGURE 12 |** Analysis model: (A) origin slope; (B) excavation slope; (C) mesh grid.

The numerical analysis model of the slope is shown in **Figures 12A–C**; its dimensions were  $600 \times 500 \times 700$  m ( $X \times Y \times Z$ ). The  $X$ -direction of the model was parallel to the water flow direction, and its positive direction pointed downstream. The  $Y$ -direction was consistent with the dam axis, and its positive direction pointed from the river valley to inside the mountain. The  $Z$ -direction was vertical, and its positive direction pointed upward. The mesh model was composed of 106,000 nodes and 585,600 elements.

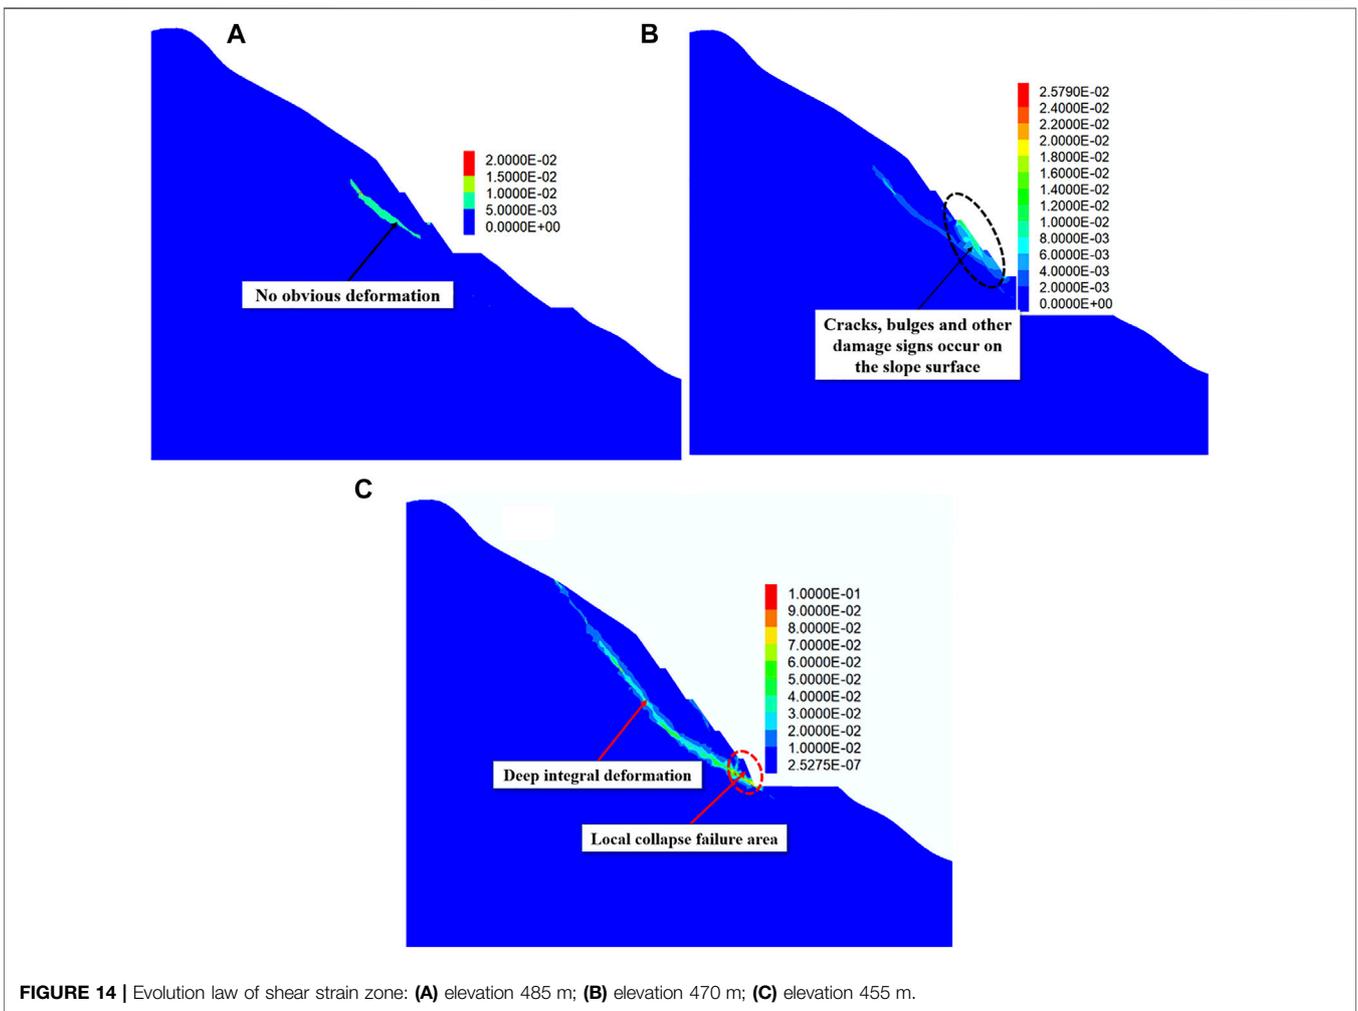
The distributions of the incremental shear strain on the excavation slope are shown in Figures 14A–C. When the slope was excavated above an elevation of 485 m, the shear strain concentration zones were distributed mainly in the structural surfaces fz39 and L920 in the middle of the slope, and there were no obvious deformation signs at this stage. When the slope was excavated at an elevation of 485–470 m, the shear strain concentration zones appeared on the excavation face, and deep shear strain concentration zones developed along the structural surfaces. At this stage, cracks appeared on the excavation face, and the deep parts of the slope began to deform. When the slope was excavated at an elevation range of 470–455 m, a shear strain concentration zone appeared at the front edge of the excavation slope, and the deep shear strain concentration zone had been penetrated, corresponding to local slippage at the front edge of the slope and a sudden change of the deep deformation.
