Causes of Tunnel Diseases in a Karst Stratum and Remediation Measures: A Case Study

Shen Jiajia¹, Zhang Hu², Wan Li¹, Zhang Changan^{1*}, Shao Xing¹, Lin Zanquan² and Song Jie^{1*}

¹Shandong Provincial Communications Planning and Design Institute Group Co., Ltd., Jinan, China, ²School of Civil Engineering, Central South University, Changsha, China

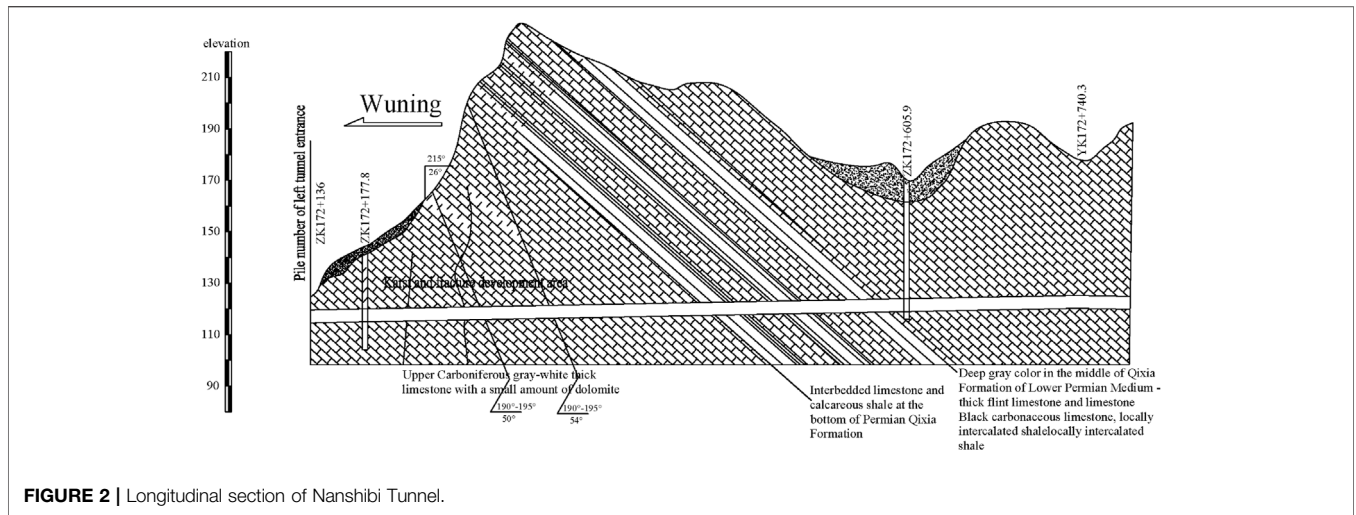
FIGURE 2 | Longitudinal section of Nanshibi Tunnel.

teeth, karst grooves, and caves are exposed on the surface, which is a typical karst water-rich area. In addition, the tunnel is located in the Pingxiang–Xinjian fault zone, where secondary faults are developed, and the rock mass is crushed by intense extrusion or cutting, with poor stability, as shown in **Figure 2**.

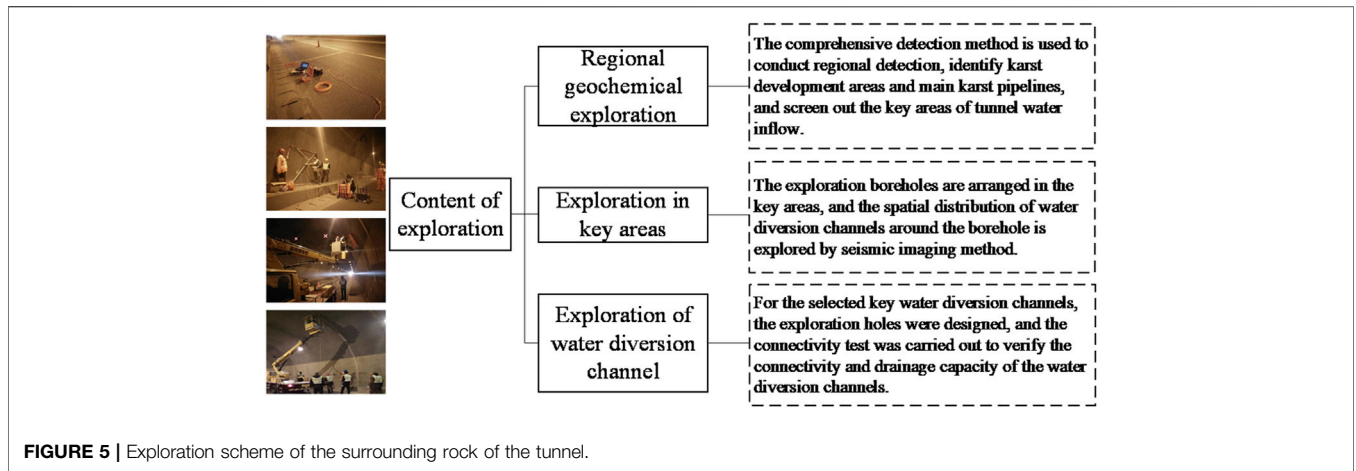
FIGURE 5 | Exploration scheme of the surrounding rock of the tunnel.

To ensure exploration accuracy, various geophysical methods are fully used in exploration. Examples of such methods are the high-density resistivity method, transient electromagnetic method, geological radar method, and seismic imaging method. These methods are used to complement and verify each other to realize the comprehensive exploration of tunnel disease, karst structure, and water passage. The exploration of the surrounding rocks proceeds gradually from region to detail, and its basic scheme is shown in Figure 5.

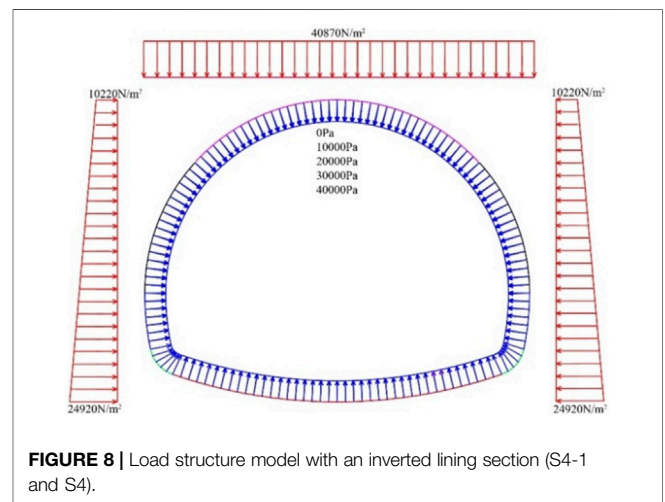
FIGURE 8 | Load structure model with an inverted lining section (S4-1 and S4).

water leakage disease and insufficient lining thickness. Accordingly, the load structure method was adopted to establish the calculation model of the typical lining in disease areas under hydrostatic pressure. The calculation models of the load structure are shown in Figures 8, 9. The calculation parameters are listed in Tables 1, 2.

- (1) The internal force distributions of the inverted arch lining (S4-1 and S4) and noninverted arch lining (S3) are different because of the differences in the structural form and constraint conditions. In general, because of the closed

structure of the ring, the internal force distribution of the lining with the inverted arch is more even, and the force performance is more superior. The most unfavorable lining position with the inverted arch is mainly distributed in the vault, arch shoulder, and arch foot, whereas the most

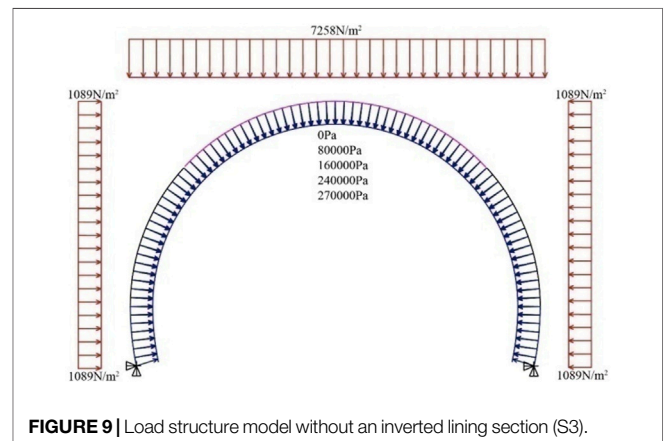
FIGURE 9 | Load structure model without an inverted lining section (S3).

unfavorable position of the lining without the inverted arch is the vault and arch shoulder.

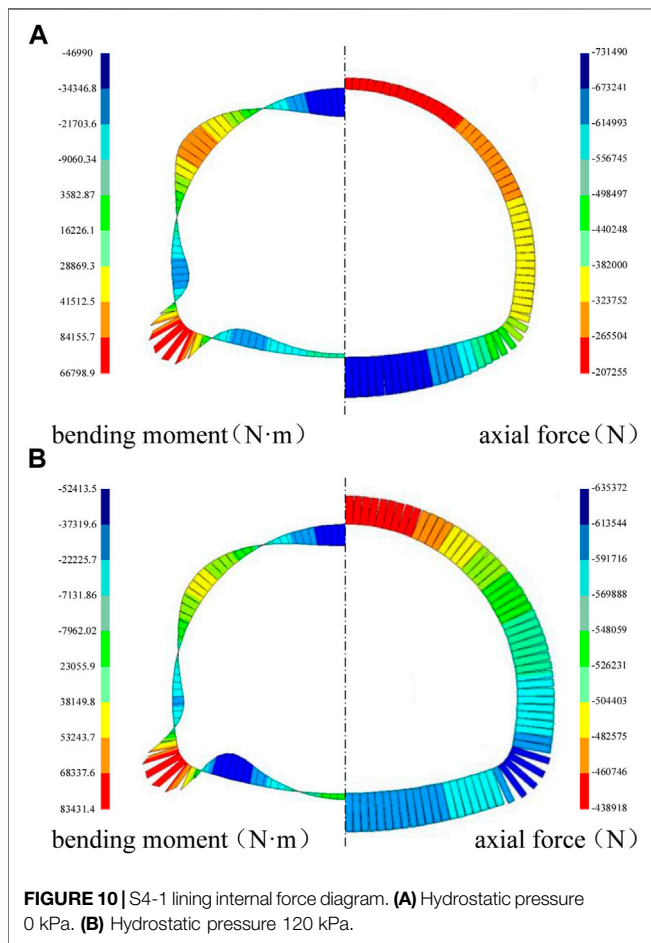
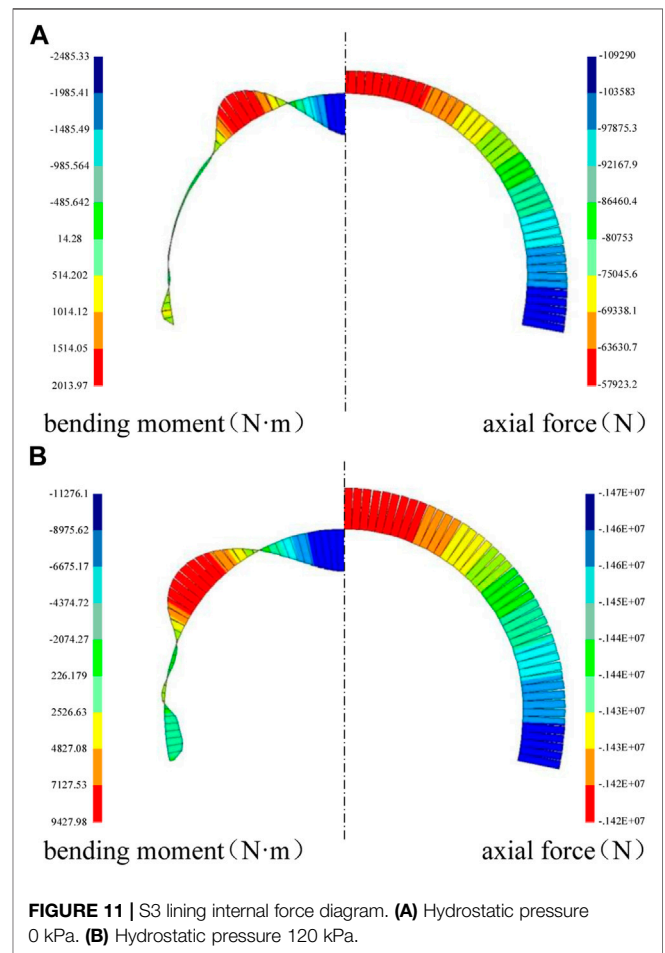
The internal force calculation results of the typical secondary lining of the tunnel are shown in Figures 10, 11. The results are as follows:

(2) With the gradual application of hydrostatic pressure, the internal force of the secondary lining of the tunnel also changes. For the lining with an inverted arch, the structural bending moment and axial force of the arch wall and vault increase gradually and the axial force of the

inverted arch decreases gradually. The bending moment and axial force of the whole section increase gradually for the lining without an inverted arch. Therefore, the effect of hydrostatic pressure increases the internal force of the structure, causing adverse effects. The adverse effect is remarkable, especially for the inverted arch when the bending moment increases as the axial force decreases.
