The Piping Failure Mechanism of a Loess Dam: The 2021 Dam Break of the Yang Village Reservoir in China

Keywords: loess, Yang village reservoir, piping failure, dam break, near-static liquefaction

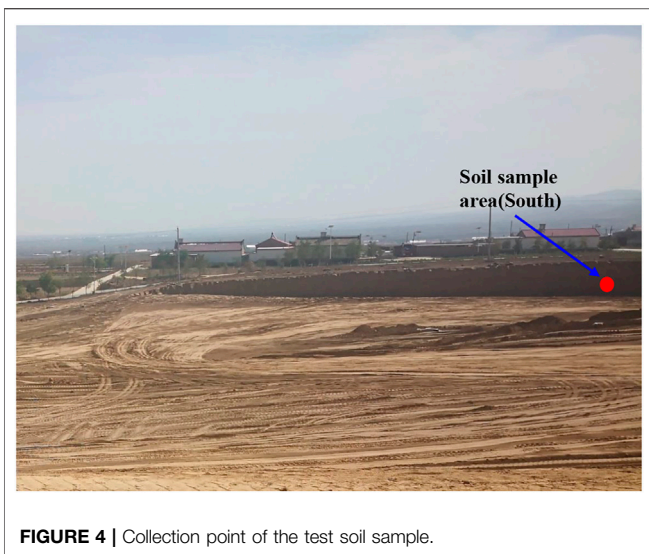
FIGURE 4 | Collection point of the test soil sample.

The filling materials in the south of the reservoir are all from the farmland in the dam’s south. The farmland in the south is a slope land on the Loess Hill. As shown in **Figure 4**, the soil samples were taken from the western slope, located 3 m above the surface. The loess is massive in the dry state and muddy in the saturated state. The basic physical and mechanical properties of loess were measured in the indoor laboratory. **Table 1** gives the specific gravity, natural density, liquid limit, plastic limit, plasticity index, collapsibility coefficient, and permeability coefficient of soil samples.

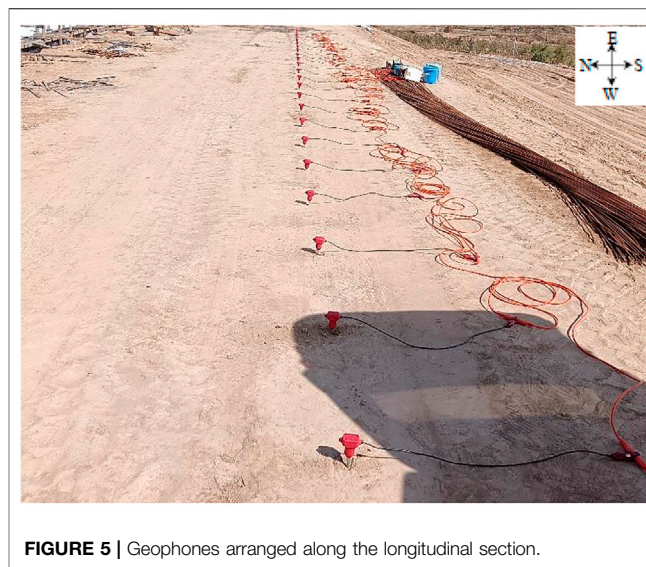
FIGURE 5 | Geophones arranged along the longitudinal section.

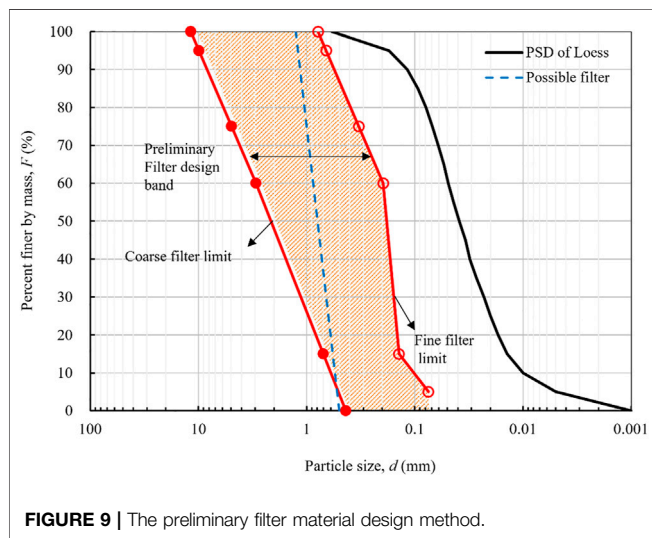
FIGURE 9 | The preliminary filter material design method.

The coupled filter design method for loess is used in the Yang village dam, where the particle size distribution (PSD) of loess (Figure 7) is chosen as an example to verify the proposed method. The process of the proposed method is divided into two steps. First, the possible filter design band curves are designed using the Zhang et al. method (Figure 9). Second, determine the compaction and dispersive condition by choosing a possible filter in the design band curves (Figure 10). Figure 9, possible filter material chosen band intuitively displayed in Figure 9, we can choose one filter PSD for further compaction and dispersion verification. Finally, the chosen possible filter PSD in Figure 8 works well when its compaction exceeds 50% (relative density greater than 50%). Figure 10. The above-mentioned analysis shows that the proposed filter design method for loess can work

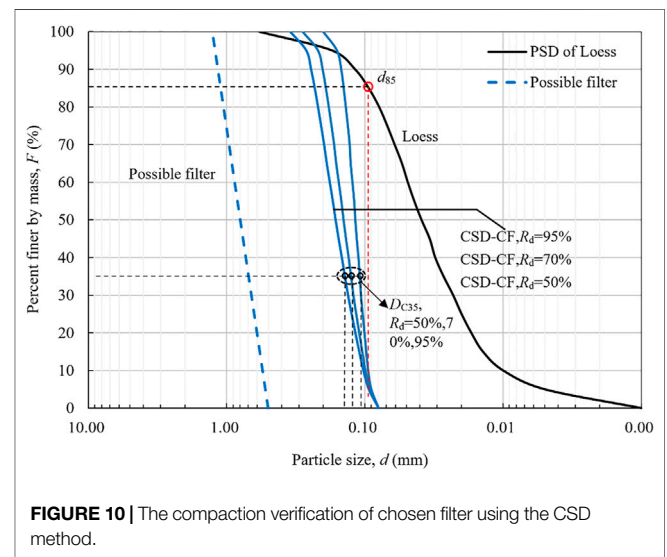
FIGURE 10 | The compaction verification of chosen filter using the CSD method.
