CITATION
Yang H, Xing B, He J, Jiang H and
Cheng Q (2022), The formation
mechanism and failure mode of a talus
slope induced by rockfalls in Nayong
County, Southwest China.
Front. Earth Sci. 10:973528.
doi: 10.3389/feart.2022.973528

The formation mechanism and failure mode of a talus slope induced by rockfalls in Nayong County, Southwest China

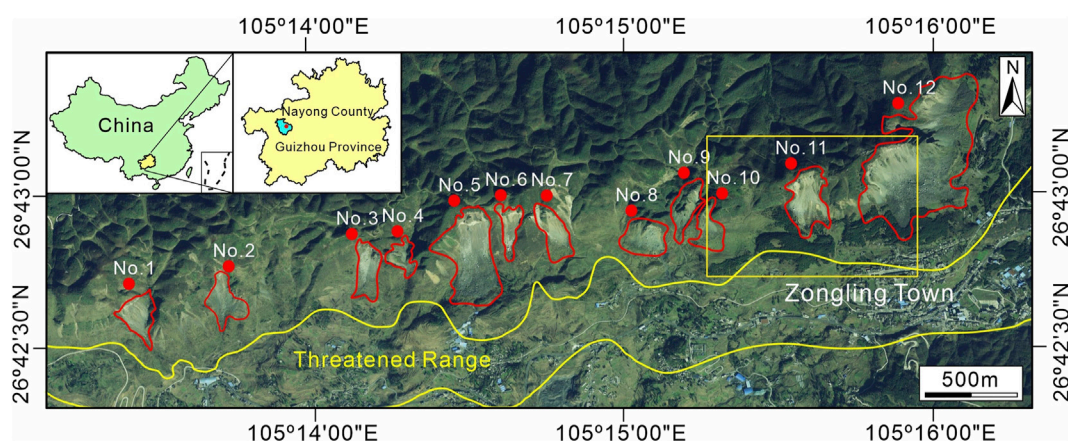
FIGURE 1

Distribution of 12 rockfall-dominated talus slopes in the Zongling rockfall zone (image source: Google Earth).

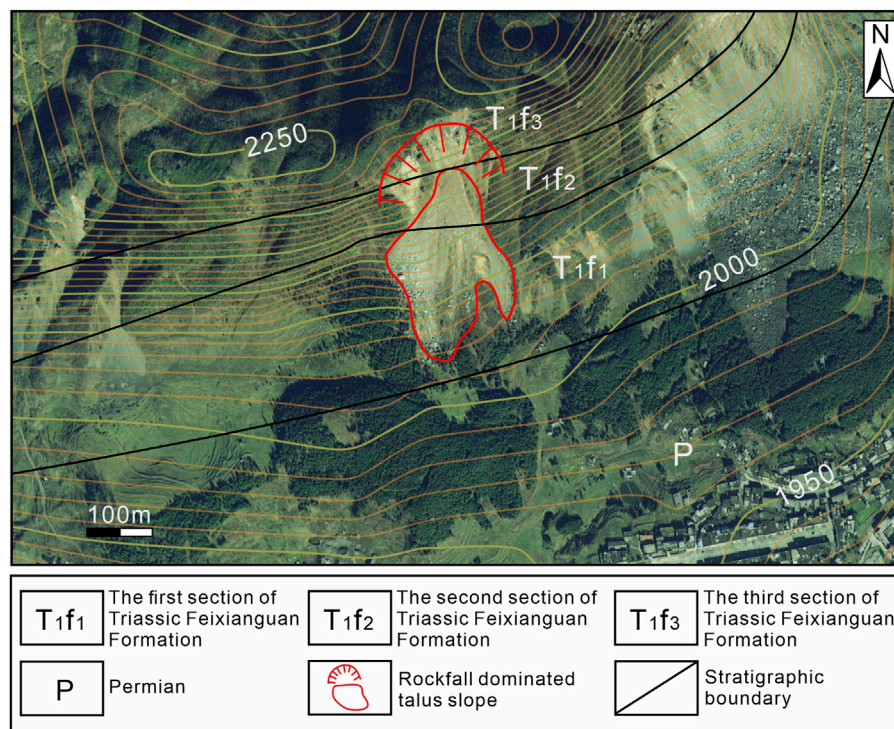
FIGURE 2
Topographic and stratigraphic map of the study site (image source: Google Earth).

distributed along the foot of the gentle slope or by the flat mountain highland (Shen and Li, 2015). The study site is located 500 m northwest of Zongling Town. Here, the rockfall source area is a steep cliff with a slope angle of 60–80°, and the talus slope becomes gentler with a slope angle of 35–45°. The relative height difference between the source area and slope toe was about 240 m (Figure 2).

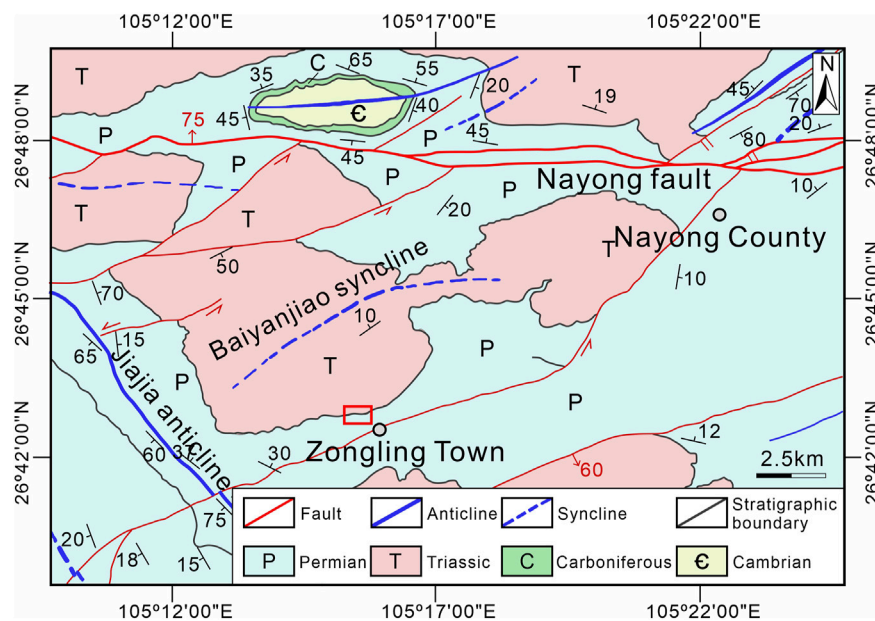
FIGURE 3
Regional tectonic and lithology map (modified from the work of Wu et al., 2019).

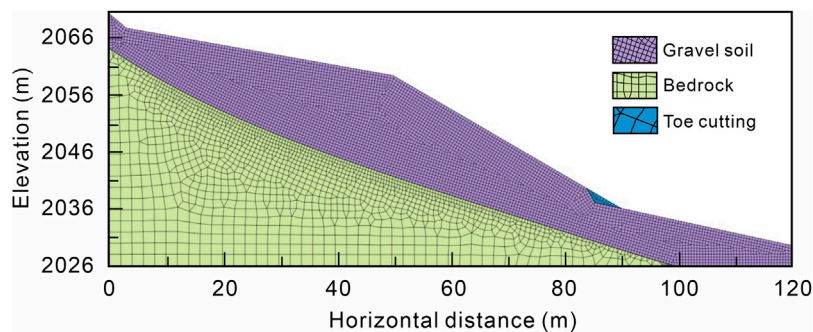
FIGURE 9
Numerical model for SRM.

2002; Zheng et al., 2002). MIDAS/GTS software was used to carry out the slope stability analysis under the following conditions: a) without top loading and toe cutting, b) top loading, c) toe cutting, and d) top loading and toe cutting. The numerical model (Figure 9) was established based on the field investigations and previous research on the Zongling rockfall (Chen et al., 2006). The slope material structure can be divided into two layers: the upper is gravel soil and the lower is bedrock. The basic physical and strength parameters of the gravel soil and bedrock, shown in Table 2, were obtained from a comprehensive review of field geological surveys, laboratory tests, and relevant regional experience (Chen et al., 2006; Cheng et al., 2019). The slope stability was analyzed using the finite element strength reduction method (SRM).

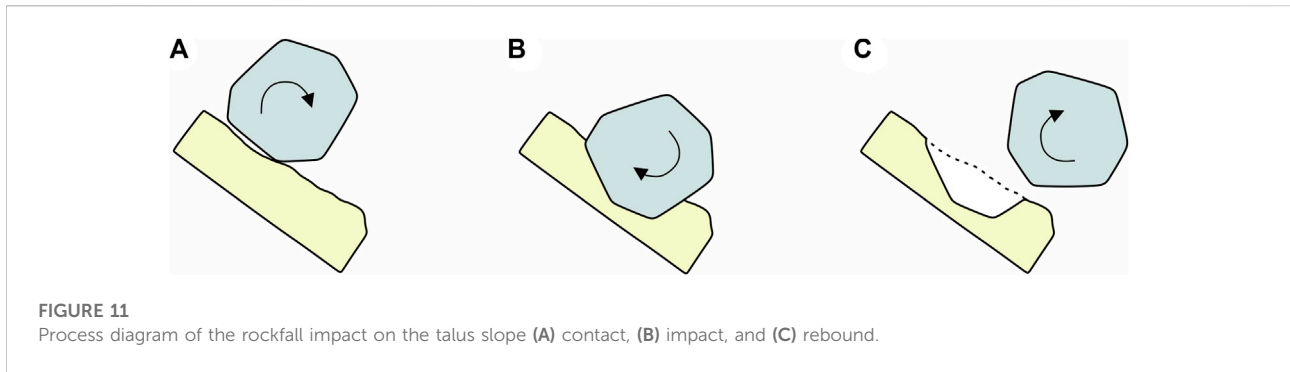
The detached boulders and fragments provide a continuous source of materials for the evolution of this talus slope and gradually change the slope geometry over time. The boulders accumulated on the top of the slope for a long time and continued to load in the upper part of the slope, resulting in creeping deformation of the slope body. In addition, a large boulder on the talus slope reduced the angle of the slope (Evans and Hungr, 1993). Moreover, slope microtopography affected the movement characteristics of the rockfall (Imaizumi et al., 2020; Collins et al., 2022). The relatively flat terrace (Figure 7B) in the middle section of the talus slope increases the jump height of the boulders. The collision process between the beginning of the rockfall and its terminus can be divided into several stages (Dorren et al., 2004; Lu et al., 2019). Figure 11 illustrates the process diagram of the rockfall impact on the talus slope, which

includes the contact, impact, and rebound stages. After the last stage, the rolling boulder remains as a trace on the slope and functions as a toe cutting (Figure 8). According to the numerical simulation analysis, toe cutting has a great influence on slope stability.
