Gureli Netto L, Singha K, Moreira CA, Gandolfo OCB and Albarelli DSNA (2023), Investigation of fractured rock beneath a uranium-tailing storage dam through UAV digital photogrammetry and seismic refraction tomography. *Front. Earth Sci.* 11:1281076. doi: 10.3389/feart.2023.1281076

# Investigation of fractured rock beneath a uranium-tailing storage dam through UAV digital photogrammetry and seismic refraction tomography

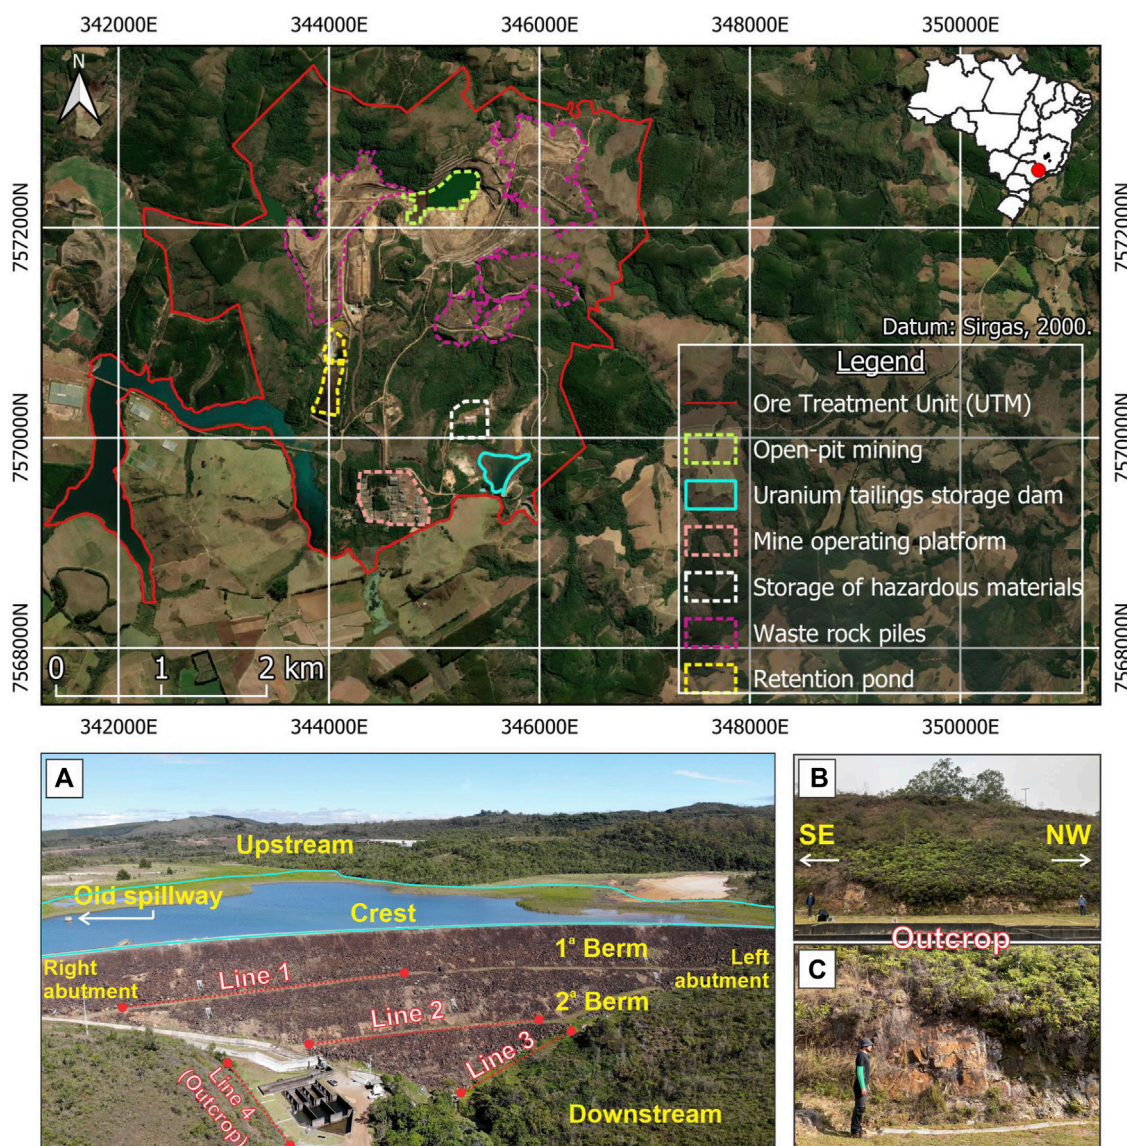
**FIGURE 1** Overview of Ore Treatment Unit, including (A) locations of the tailings storage dam, (B) outcrop used for structural data acquisition and the seismic acquisition lines in the study area where (C) shows the rock mass outcropped in detail, scale: 1.77 m high. Datum: Sirgas, 2000.

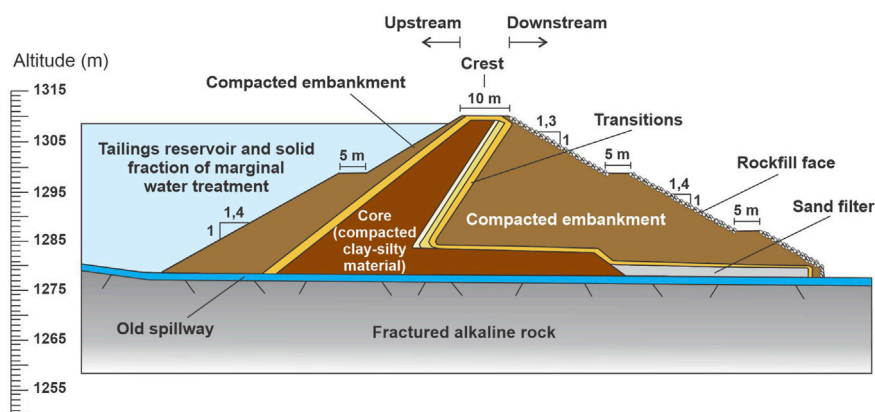
FIGURE 2

Schematic of the cross-section of the tailings dam of the Osamu Utsumi mine with details of the geometry and materials used in the construction of the dam.

The dam body consists of a compacted rockfill massif and a clayey core inclined upstream (Figure 2). The 435-m long structure has a curved axis with a 380-m radius, with concavity facing downstream, and two building levels visible downstream and a 42 m maximum height (Figures 1, 2). The dam has a system of filters and transitions between the clayey core and the upstream and downstream rockfills, both connected to a horizontal drainage mat (Figure 2). This hydraulic system captures the water percolated by the dam body and foundation and transports it downstream in a controlled manner, where it is collected through passage boxes and sent to a system of baffles. During a few years of operation, the dam had a tulip-type spillway. This structure was connected to a concrete gallery installed under the dam body. Water was transported downstream through free-flowing concrete pipes (old spillway in blue in Figure 2) (Arcila et al., 2021). The

inactivated structure was concreted for waterproofing. However, the existence of water stored inside this hydraulic structure that can infiltrate the rock mass of the foundation cannot be ruled out.

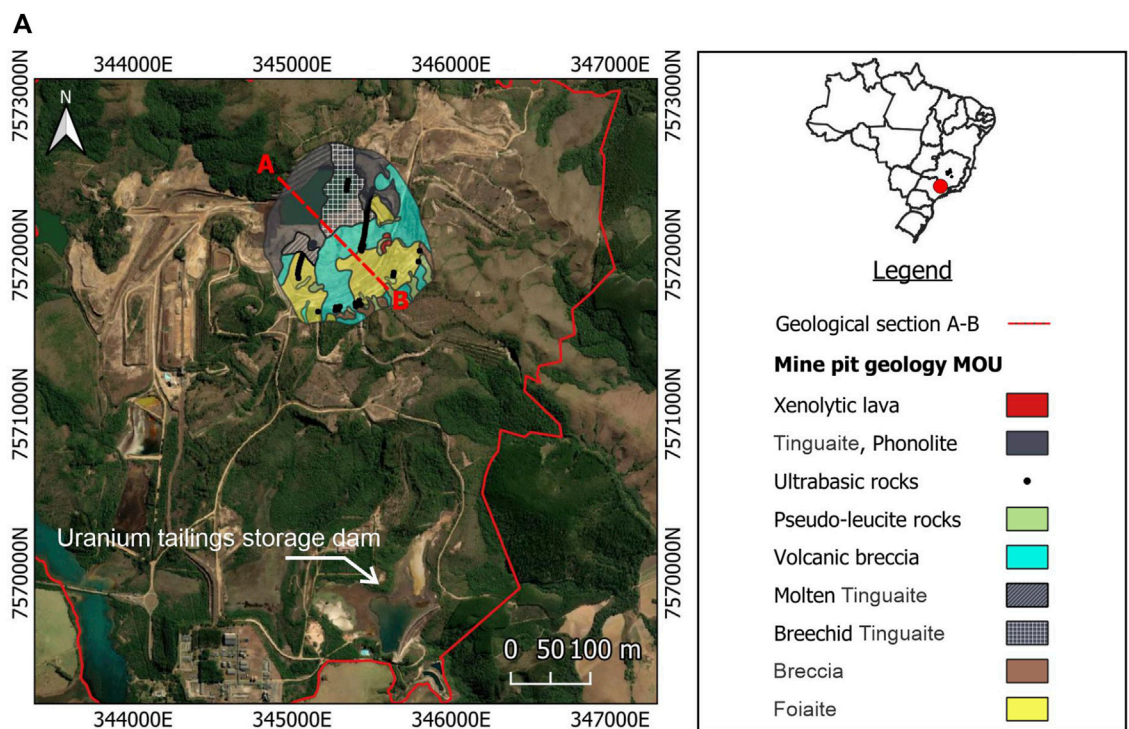
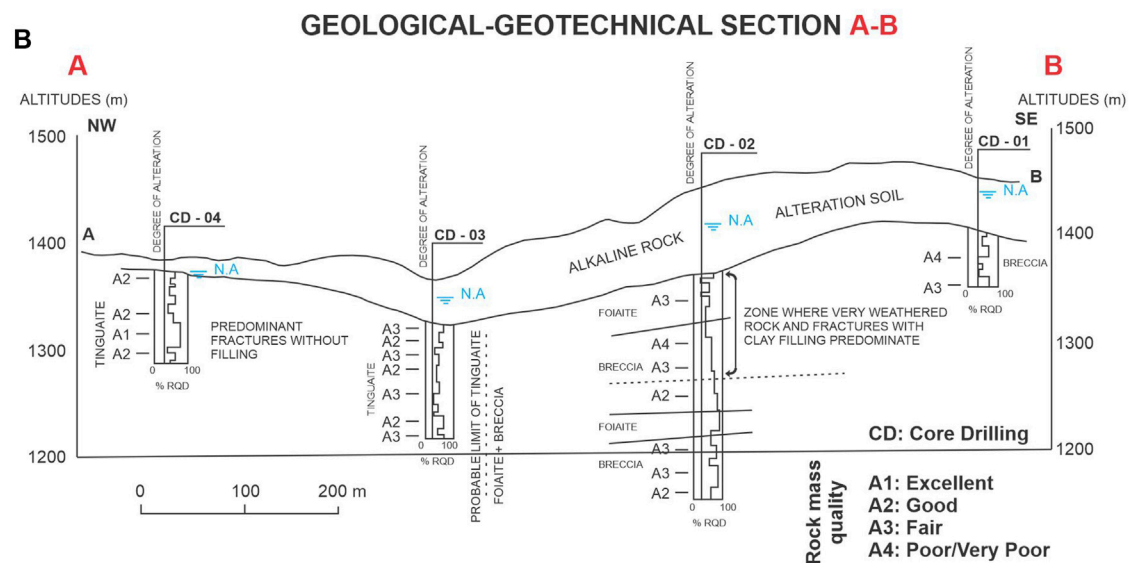
**FIGURE 3** (A) Geological map of the Osamu Utsumi mine pit area. (B) Geological-geotechnical section of the mine pit in the NW-SE direction obtained from core drillings conducted before the start of mining operations (Instituto de Pesquisas Tecnológicas – IPT, 1977).
