Jenkins SF, McSporran A, Wilson TM,
Stewart C, Leonard G, Cevuard S and
Garaebiti E (2024) Tephra fall impacts to
buildings: the 2017–2018 Manaro Voui
eruption, Vanuatu.

Tephra fall impacts to buildings: the 2017–2018 Manaro Voui eruption, Vanuatu

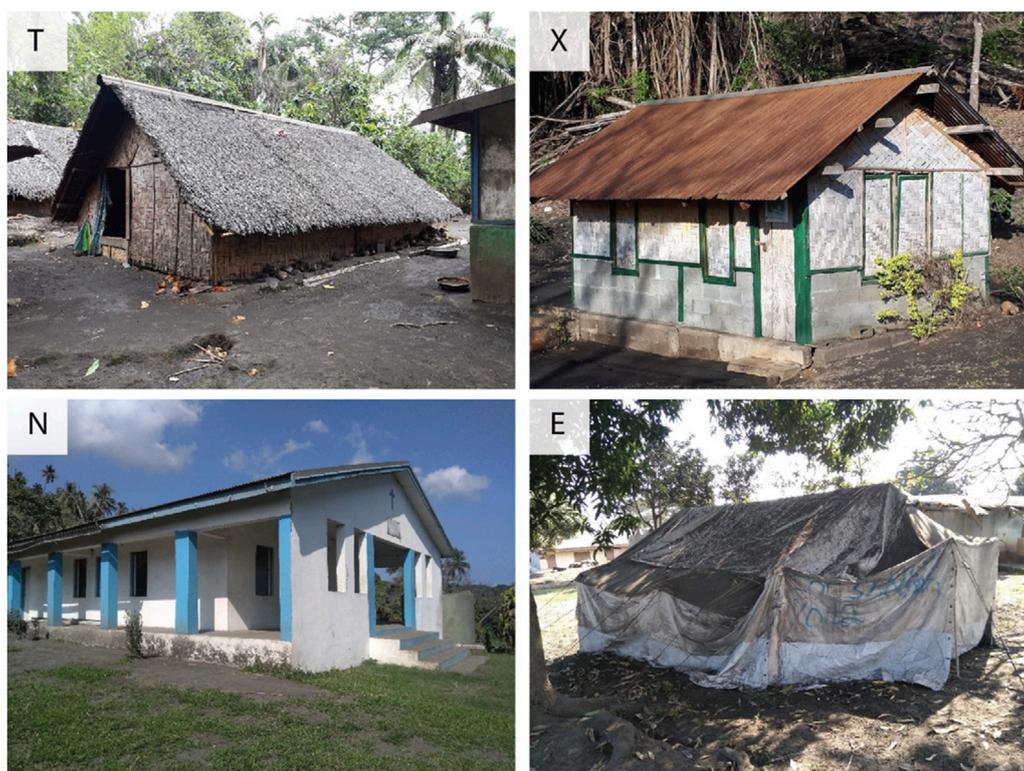
Four broad building construction typologies, and nine subcategories, were identified from field studies and photographs for the 589 surveyed buildings on Ambae (Figure 5; Table 3). In addition to informing our damage assessment, these typologies can be used in developing exposure models for forecasting future impacts. Traditional short-span (Ts) buildings, with locally-sourced timber or bamboo frame, split bamboo wall cladding and a thatched roof, were the most prevalent of the surveyed building types ($n = 255$; 43%), followed by unreinforced breeze block masonry walls with a timber framed roof and corrugated sheet metal roof cover (Nb) ($n = 161$; 27%). Together they comprised 71% ($n = 416$ out of 589) of the surveyed building stock, with mixed construction (Xw, $n = 76$; 13%) and timber frame (Nt, $n = 47$; 8%) representing a further 21%. The remaining 50 buildings (8%) comprised metal sheet-timber hybrid buildings ($n = 27$; 5%), evacuation shelters ($n = 13$; 2%), reinforced concrete frame buildings ($n = 6$; 1%), and traditional outhouses ($n = 4$; <1%). Temporary canvas shelters were erected as evacuation shelters following phases 1 through 3, and assessed in Lo One and near Walaha only during the third field visit in August. All buildings were constructed for the tropical climate, with ventilation pathways observed between external walls and roof.

FIGURE 5
Four principal building construction typologies present on Ambae at the time of the 2017/2018 eruption: Traditional (T), Hybrid construction (X), Non-traditional construction (N) and Temporary (E).

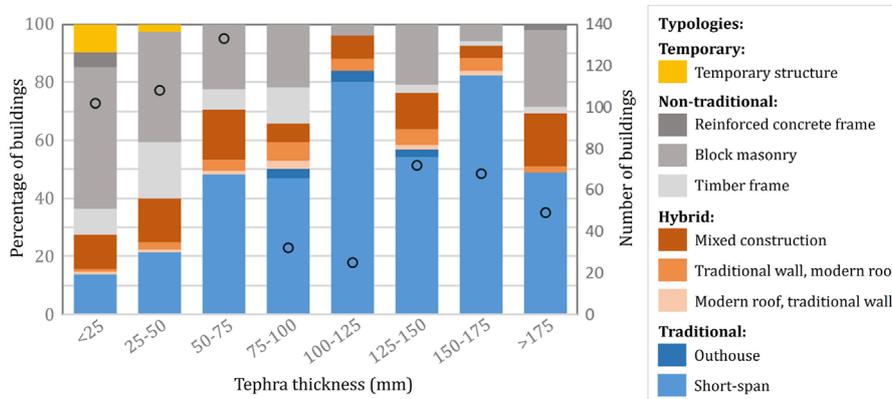
FIGURE 6 Building typology for all 589 assessed buildings, as a function of tephra thickness. Number of buildings are shown on the second y-axis as black hollow circles. Colour groupings - blue, orange, grey, yellow - indicate the main building type categories - traditional, hybrid, non-traditional, and temporary, respectively.

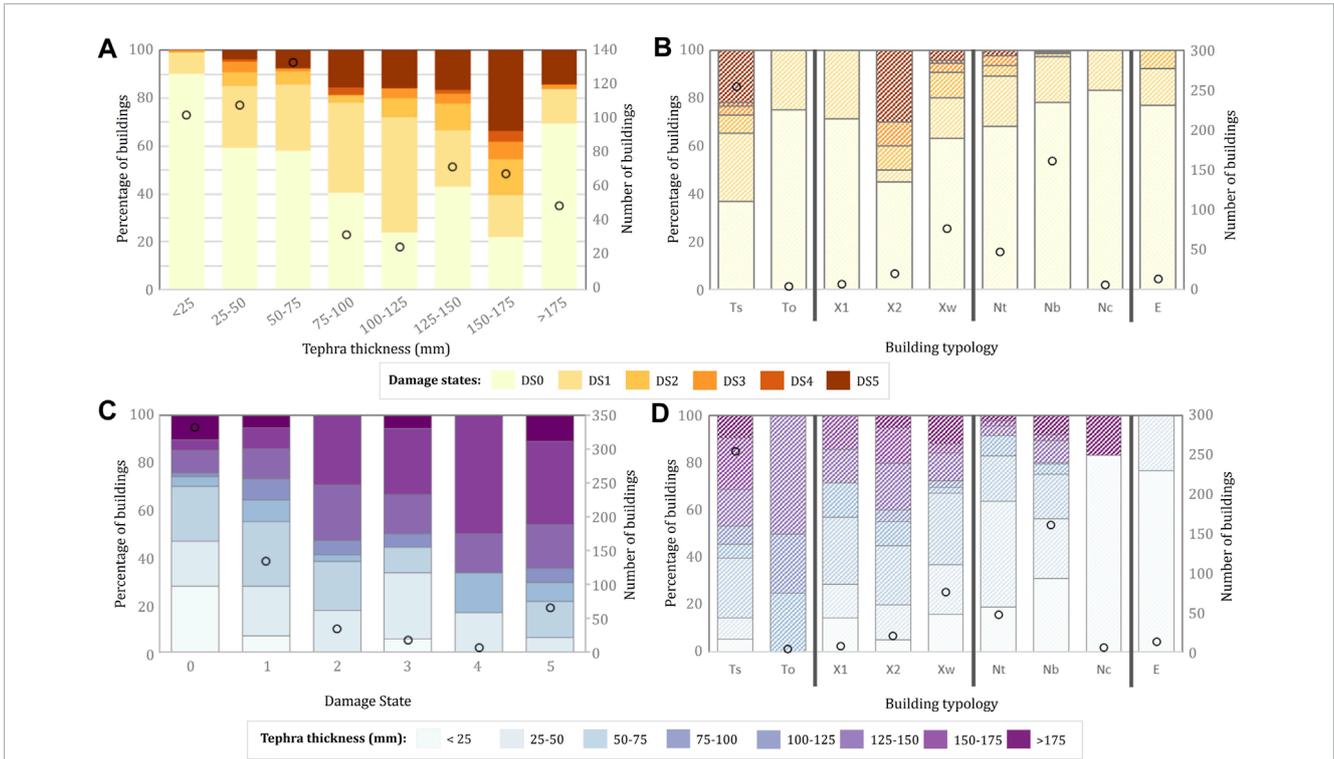
Buildings sustained greater damage in areas that received more tephra fall (Figures 7A, C), with tephra falls ≥ 100 mm associated with 70% (50 out of 71) of the buildings assigned partial or total collapse, DS4/5. Higher damage states were observed for traditional short span buildings (Ts), compared to non-traditional buildings (Nt, Nb, Nc) (Figure 7B) although tephra thicknesses were larger at surveyed traditional buildings (Figure 7D).

FIGURE 7 Damage states relative to tephra thickness and building typology (see Table 3 for code descriptions) for the 589 assessed buildings, shown as (A) the proportion of different damage states with increasing tephra thickness; (B) The proportion of damage states as a function of building typology; (C) Proportion of different tephra thickness bins with increasing damage state, and (D) proportion of different tephra thickness bins as a function of building typology. The bars in plots b and d are hashed to distinguish them from a and c, but follow the same legend. Hollow black circles show the number of data (second y-axis) and vertical black lines in b and d delineate the broad building typologies.

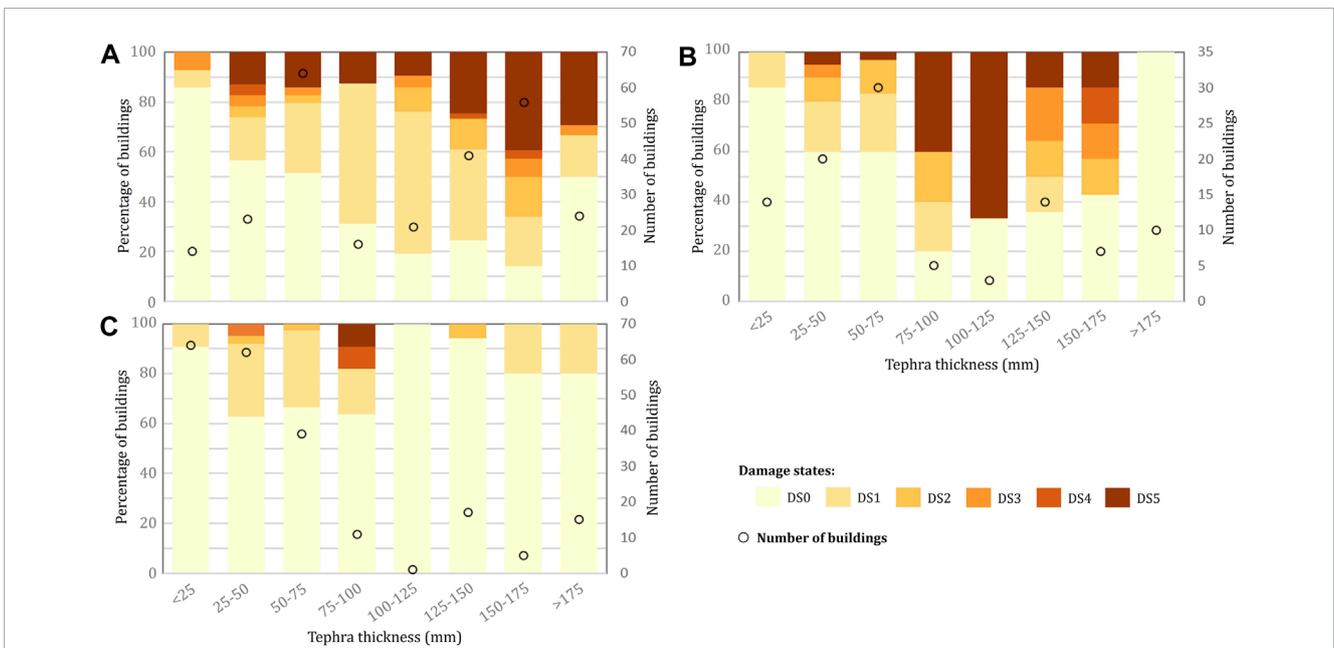
Figure 8 helps to differentiate the influence of tephra thickness on damage from that of building typology on damage, with the proportion of damage states within each tephra thickness bin shown separately for the broad building typologies. We found that different building typologies experienced different levels of damage under the same tephra thicknesses, i.e., that building typology affects a building’s vulnerability to tephra fall loading. However, because of the spatial distribution of building types relative to tephra falls, data are not equally spread between tephra thickness bins and some categories have very few data (e.g., reinforced concrete frame buildings, Nc, $n = 6$: Figures 7B, D).

FIGURE 8 Proportion of damage states as a function of tephra thickness, for the three main typology categories: (A) Traditional (Ts, To); (B) Hybrid (X1, X2, Xw); (C) Non-traditional (Nt, Nb, Nc). Number of surveyed buildings in each bin are shown on the second y-axis as black hollow circles (note the axis limit for number of buildings in b) is half that of (A) and (C)). Temporary shelters (n = 13) are not shown.
