CITATION
Liu X, Lü X, Shao Y, Chen C, Liu G, Li Y, Li M,
Wu X and Chen Y (2024), Monitoring and
disaster prevention of high and steep
sandstone slopes along highways under
construction.
Front. Earth Sci. 12:1444592.
doi: 10.3389/feart.2024.1444592

Monitoring and disaster prevention of high and steep sandstone slopes along highways under construction

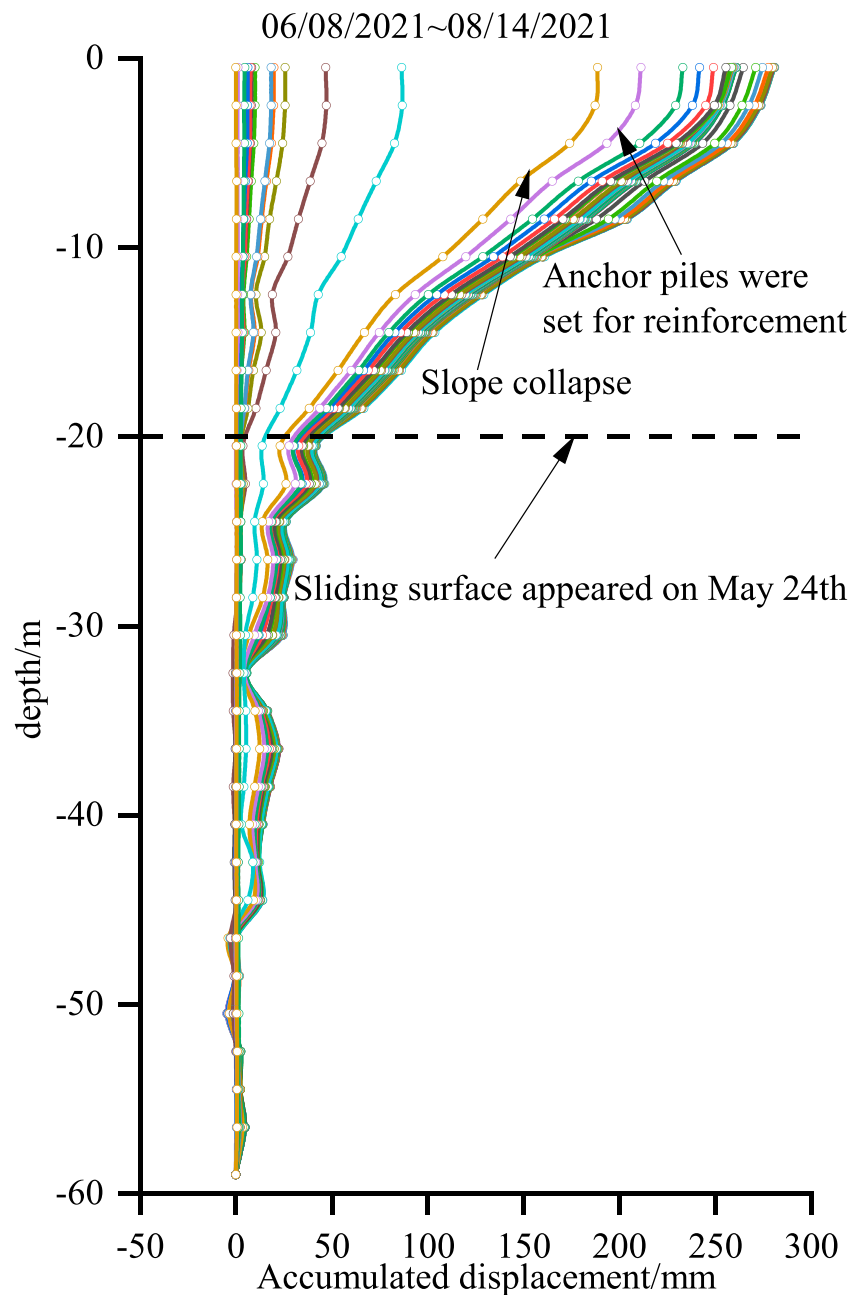
FIGURE 6
The variation law of deformation with depth at 2-CX1.

According to the monitoring data of each deep displacement inclinometer borehole, the cumulative displacement-depth curves (Figure 6; Figure 7) were drawn. Then, the analysis of the deep inclinometer displacement curve of the main monitoring section was obtained (Figure 8). It can effectively guide the rescue construction by accurately inferring the depth and change trend of the sliding surface.

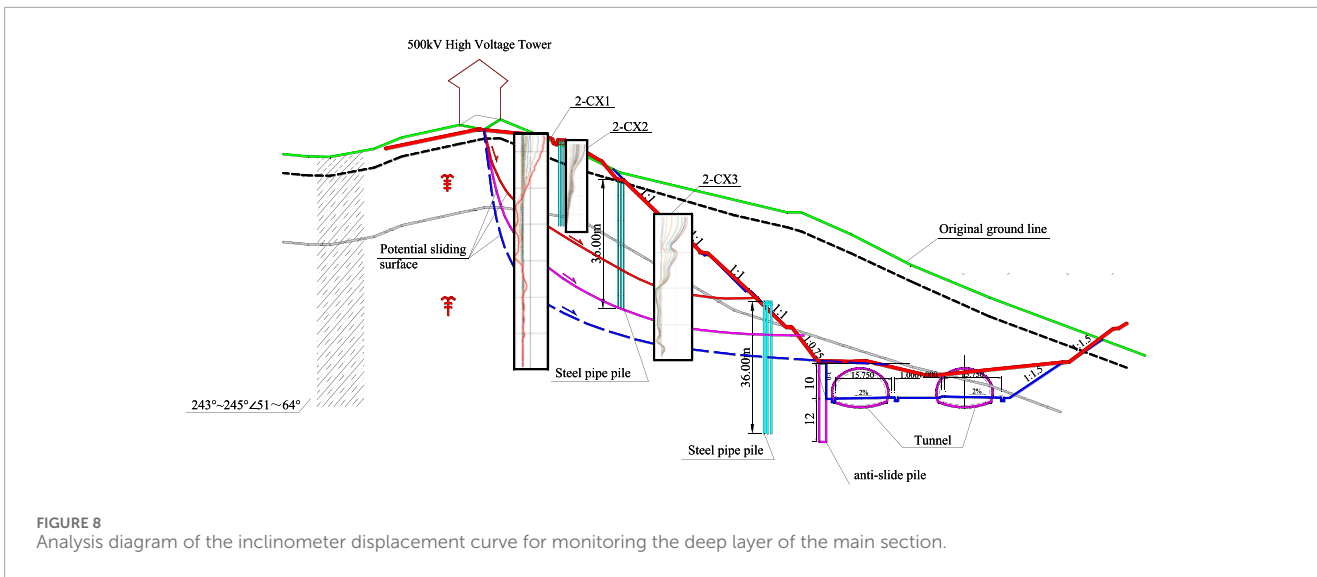
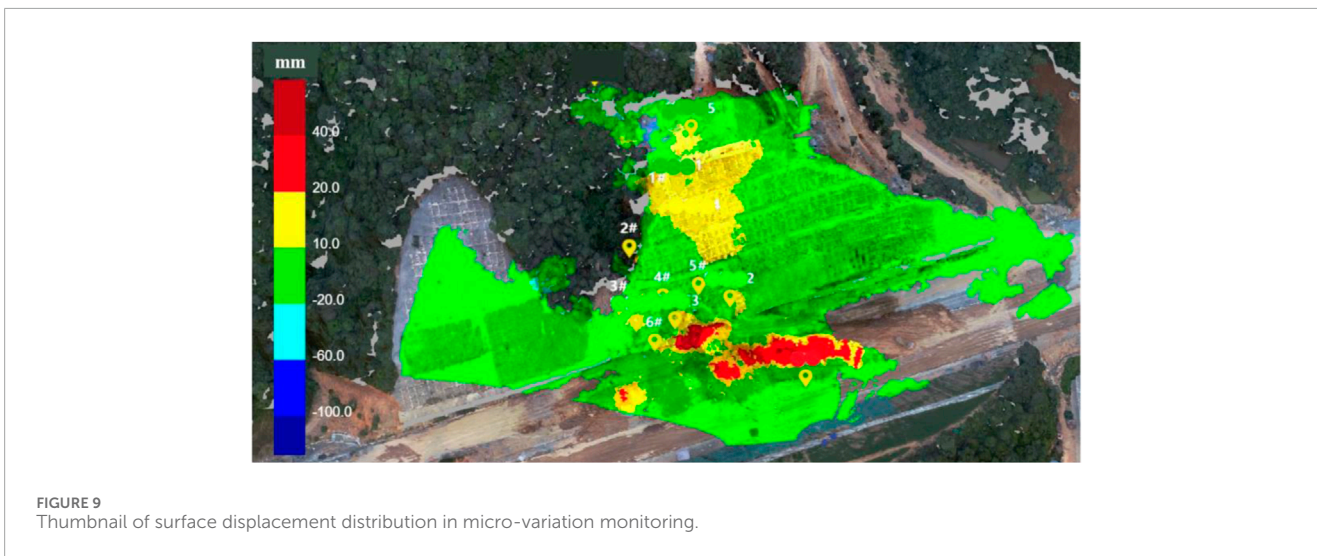
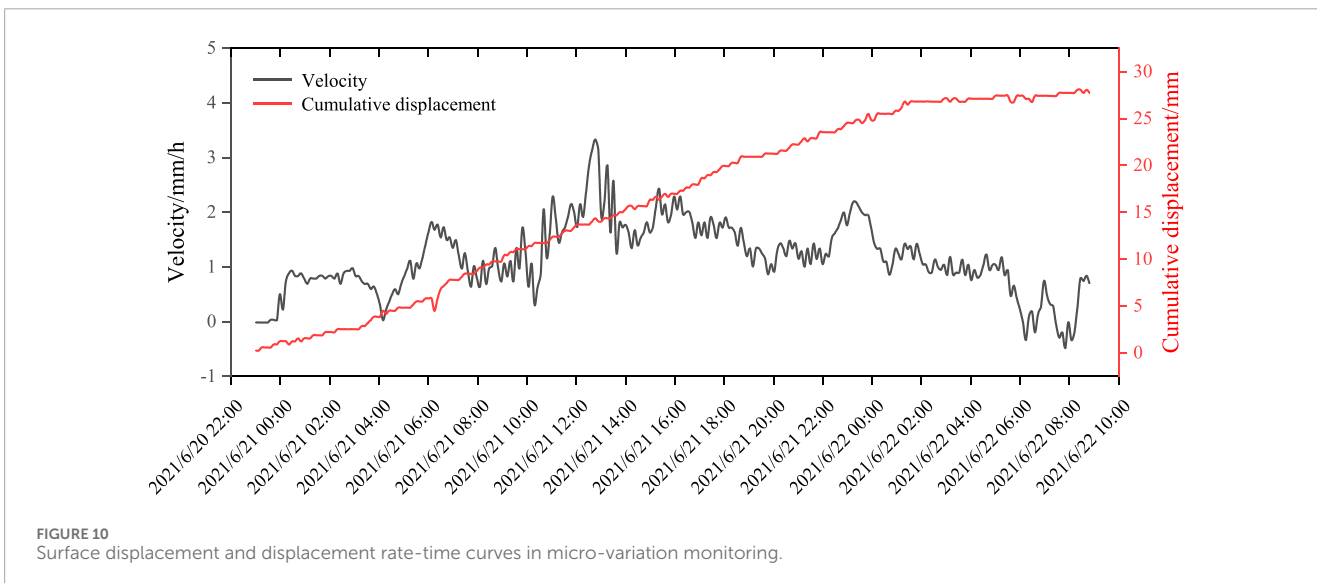
The micro-variation monitoring could obtain an intuitive cloud map about the surface displacement distribution, showing the areas with larger surface displacement (Figure 9). In addition, the surface displacement and displacement rate-time curves of each characteristic point in micro-variation monitoring could also be obtained. The results of typical feature points in the area with larger displacement were selected, as shown in Figure 10. The displacement

rate of the characteristic points decreased to a relatively safe level, the surface displacement-time curve gradually became gentle, and the slope showed no tendency of further failure. The overall results were consistent with the GNSS displacement monitoring results (Figure 10).

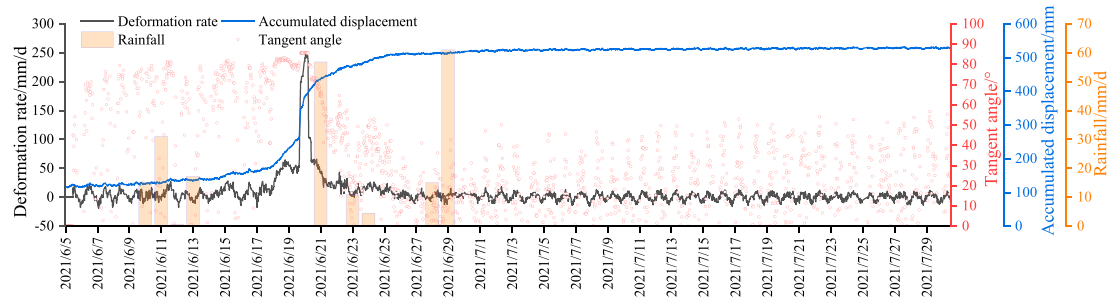
FIGURE 11
Cumulative displacement-time curve of 1-GNSS1.

previous monitoring period. Besides, the vertical displacement rate was -0.97 – 2.11 mm/d, which was the same with the previous period. The horizontal and vertical displacement curves tended to develop horizontally. Affected by the heavy rainfall at the end of July, the slope had a small increase in displacement compared with that before the rainfall. Overall, a low-speed deformation state was presented during this period. The emergency rescue measures positively improved the surface displacement of the slope (Figures 11, 12).

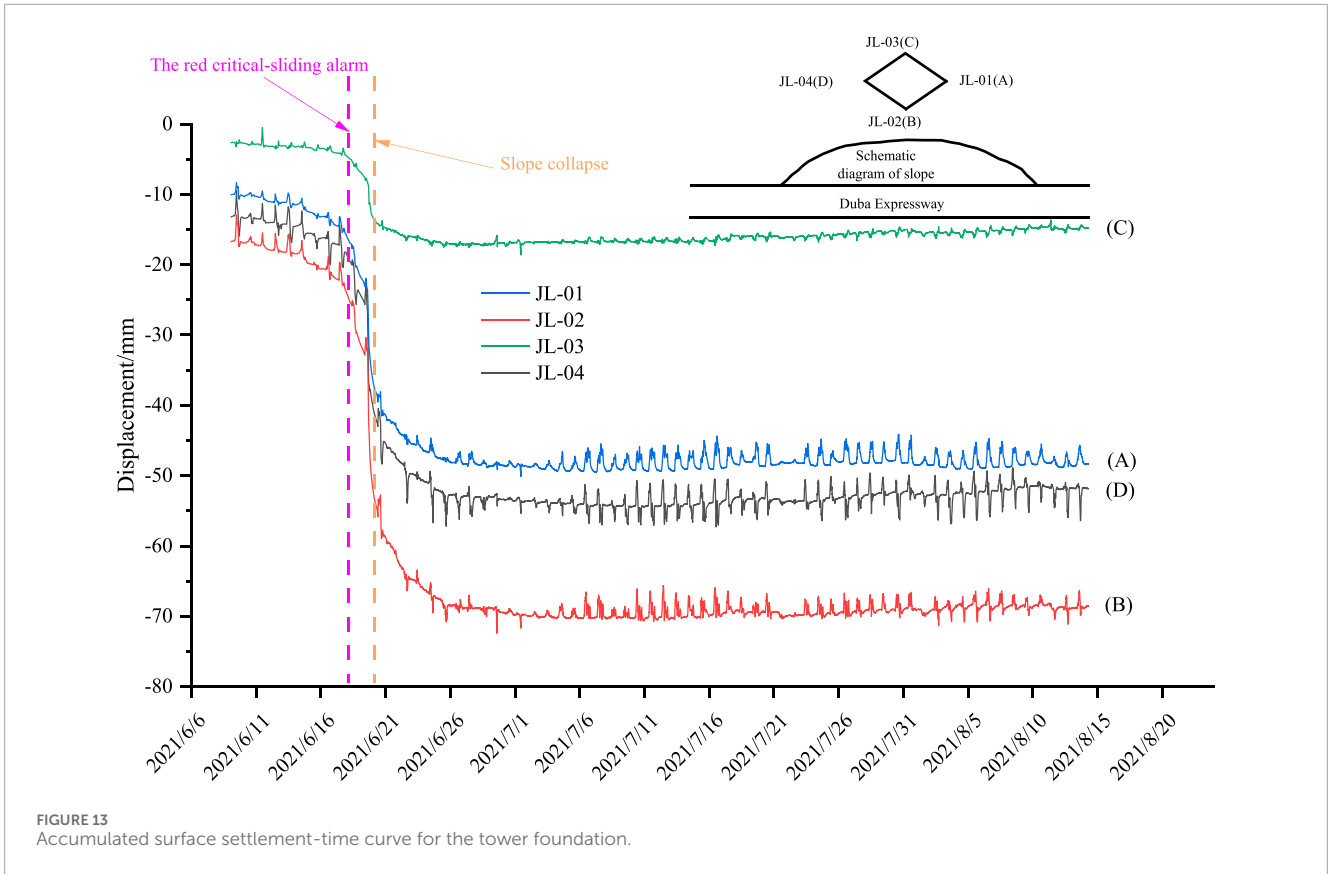
From the implementation of the time before the local failure of the slope, the average settlement rate of each measuring point of the tower foundation at the slope top was less than 1 mm/d. In the process of slope collapse, the tower foundation suffered obvious settlement. The average settlement measuring point of the tower foundation at the top rate of each measuring point was −3.59–12.88 mm/d, 9.74–19.94 times than the value before the collapse, indicating that the tower foundation settlement

was significantly affected by the slope displacement. Since the tower foundation settlement was aggravated due to the rescue construction, the settlement rate of each measuring point was less than −0.30 mm/d. At the same time, the settlement curve had slowed to develop horizontally, indicating that the emergency rescue construction on the slope could effectively prevent the rapid settlement of the tower. Among the four settlement measuring points of the tower, the settlement at JL-03, the farthest from the slope surface, was the smallest, and the settlement at JL-02, the closest to the slope surface, was the largest. That was, the settlement difference between JL-02 and JL-03 was the largest. In combination with the location and distribution of the measuring points, it showed that the tower was mainly inclined towards the subgrade (Figure 13).
