Study of the damage characteristics and corrosion mechanism of tunnel lining in a sulfate environment

Xinrong Liu, Yang Zhuang, Xiaohan Zhou*, Ninghui Liang*, Jinwang Mao and Hai Chen

School of Civil Engineering, Chongqing University, Chongqing, China

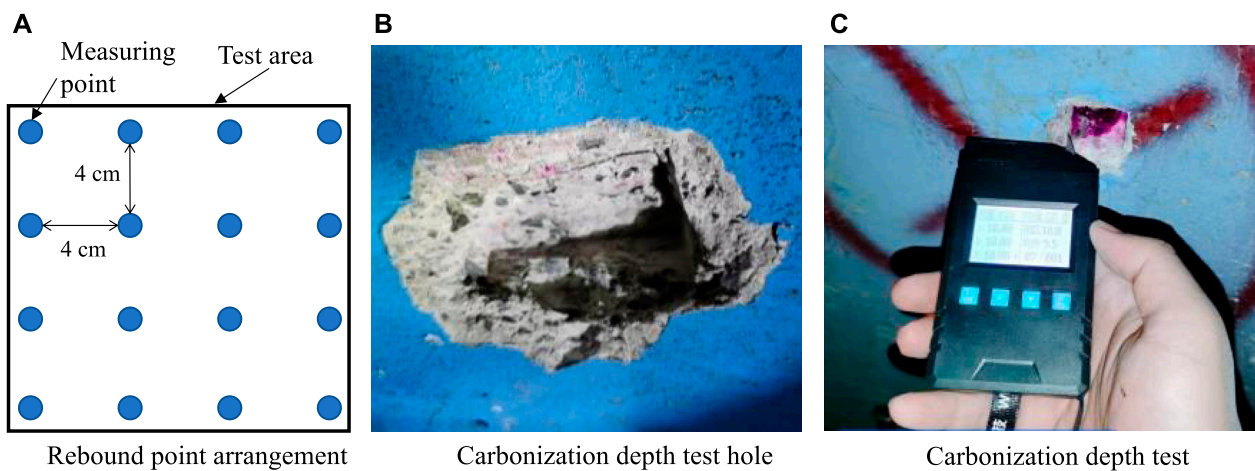
FIGURE 6 Measurement of the tunnel lining strength using the rebound method: (A) rebound point arrangement; (B) carbonization depth test hole; (C) carbonization depth test.

To facilitate the operation process, 40 test samples in the Z1 section and 63 test samples in the Z2 section were tested to determine the rebound strength. The test methods referred to the Technical Specifications for Testing Concrete Compressive Strength by Rebound Method (JGJ/T23-2011). The whole process is shown in Figure 6, and the test results are shown in Figure 7, with the yellow line indicating design strength of the lining. Only 12.6% of the measured samples from the two sections

reached or exceeded the design value in terms of strength. The maximum value was 29.4 MPa; this may be due to the initial stage of sulfate corrosion and carbonation, which made the reaction products fill the pores of the concrete, thereby reducing the porosity, and increasing the density and strength. The lowest strength was only 10.9 MPa, which was lower than the design value.

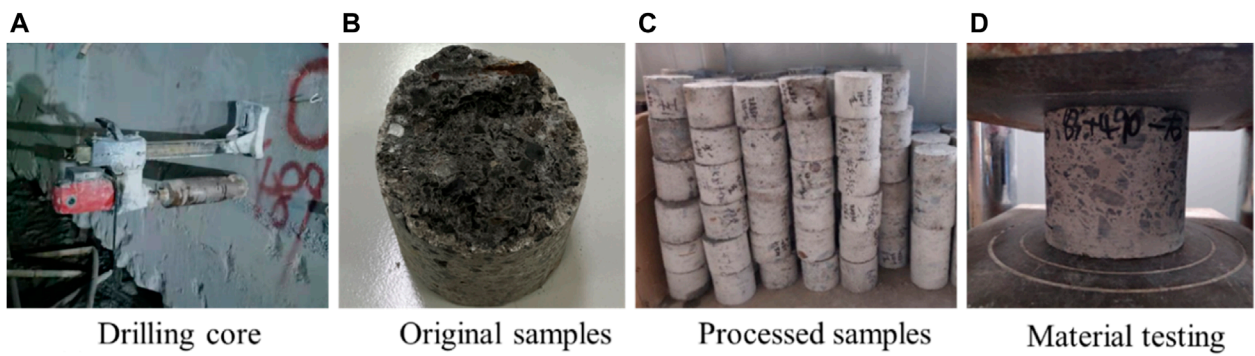
FIGURE 8
Drill core test of the corroded lining: (A) drilling core; (B) original samples; (C) processed samples; (D) material testing.

In the zones of Z1 and Z2 where the lining was seriously corroded or the surface could not be easily measured using the rebound method, a core drilling machine was used to test the strength of core, as shown in Figure 8; 60 test samples in Z1 and 88 in Z2 were tested. The test results after removing the data with a large degree of discretization are shown in
