Franzoni E and Pizzigatti C (2024), Onsite and laboratory assessment of repair mortars for reinforced concrete floor slabs in heritage buildings.

Onsite and laboratory assessment of repair mortars for reinforced concrete floor slabs in heritage buildings

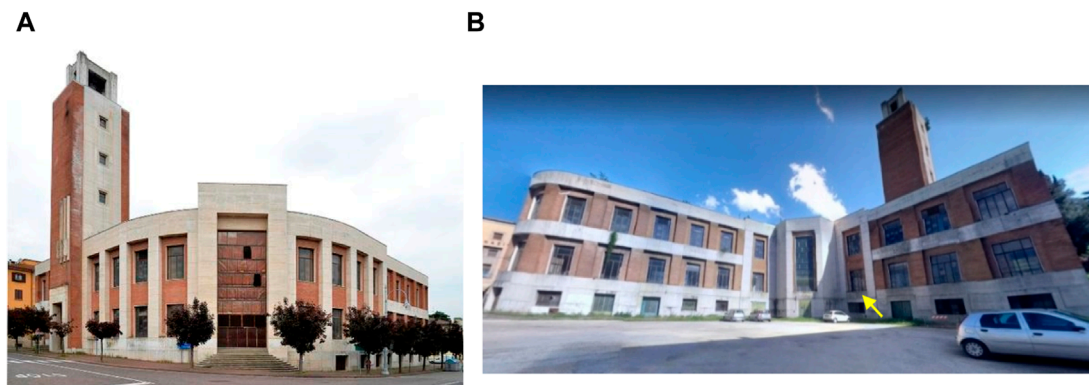
FIGURE 1
The former “Casa del Fascio”: (A) front view facing the central square; (B) rear view (the arrow indicates the location of the slab under testing).

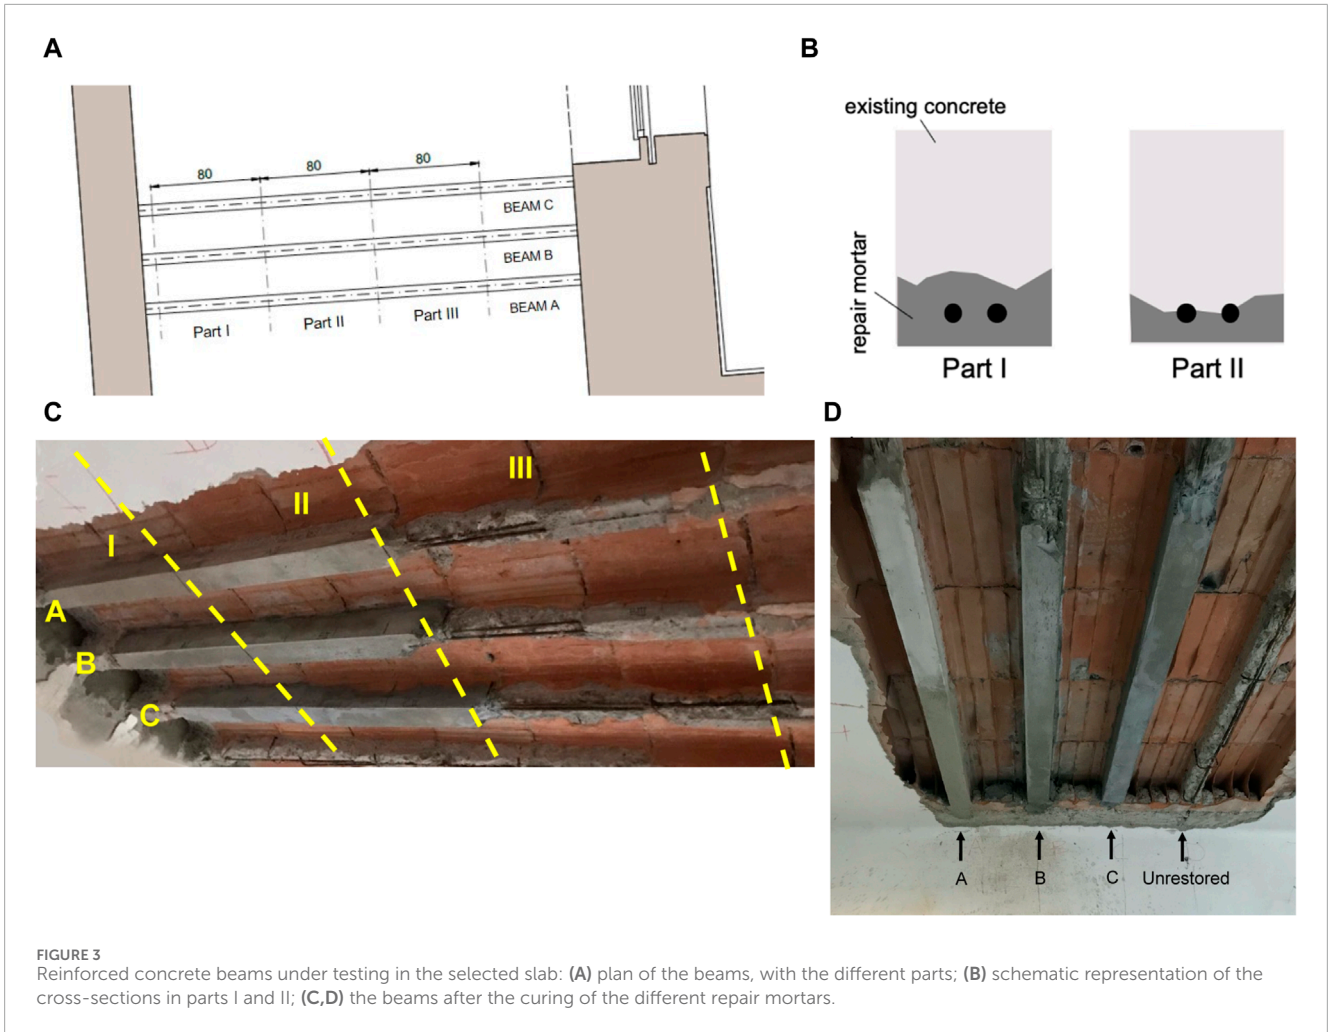
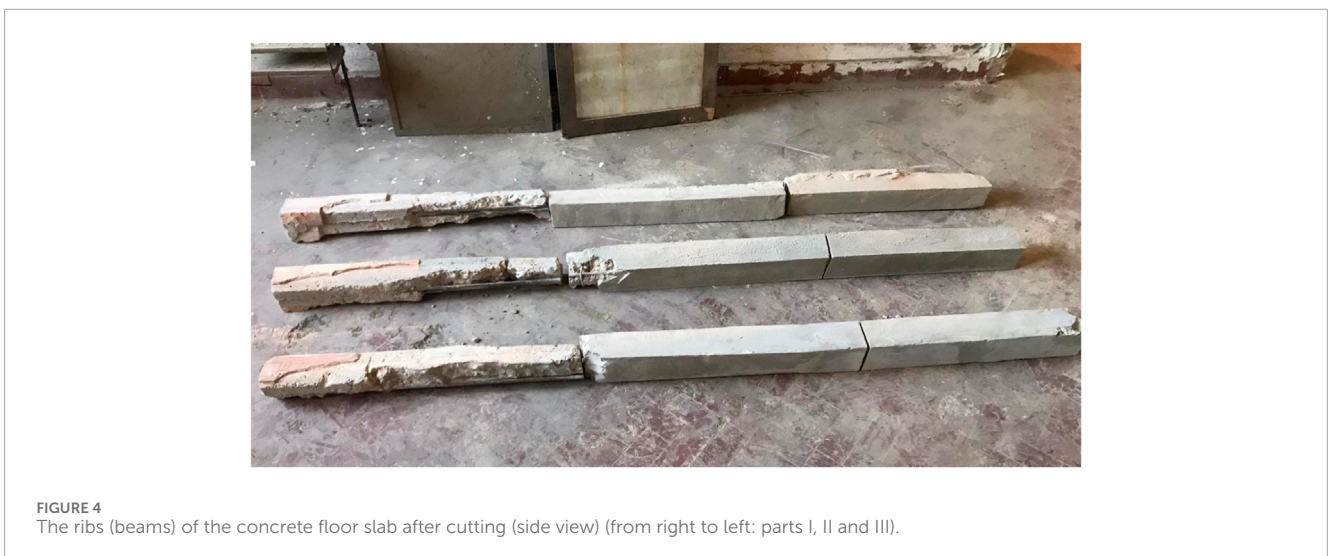
layers of thin hollow brick and plaster were demolished and four reinforced concrete ribs (beams) were entirely exposed (Figure 2A). These beams were characterized by exceptionally large aggregates (size up to 8 cm, Figure 2A), totally unfitting to the cross section of the beam, which is 8 cm large. In fact, visible gaps and voids were observed in the beams, confirming that casting the fresh concrete into the formworks was difficult. Likely, at the age of construction the provincial workers were not familiar with concrete yet. At the bottom of each beam, two plain rebars having diameter 10 mm were present (Figures 2B, C). These rebars were placed in a very inaccurate way, i.e., not symmetrically and directly on the formworks, resulting in an almost nonexistent concrete cover. Rust was observed over the rebars' surface.

- In Part I, concrete was removed all around the reinforcing bars, and rust was manually cleaned by steel brush (Figure 3B). Then, the original profile of the beam was recreated by applying a repair mortar.
- In Part II, concrete was removed only in the cover part, i.e., below the steel rebars, and rust was manually cleaned by steel brush only from the exposed surface of the bars (Figure 3B). This condition was investigated to mimic what could happen in practice, if a less radical demolition is carried out. Then, the original profile of the beam was recreated by applying a repair mortar.
- Part III was left without any mortar application, for reference.

The repair materials were repeatedly wetted for the first day after the application, then they were let cure at room condition up to 28 days (Figures 3C, D). After curing, the bar corrosion potential was measured onsite (Section 2.2). Then, the vertical portions of the three T-shaped concrete beams were cut by an angle grinder (Figure 4) and transported to the laboratory for further testing. The remaining floor slab was sustained by a purposely designed steel profiles structure.

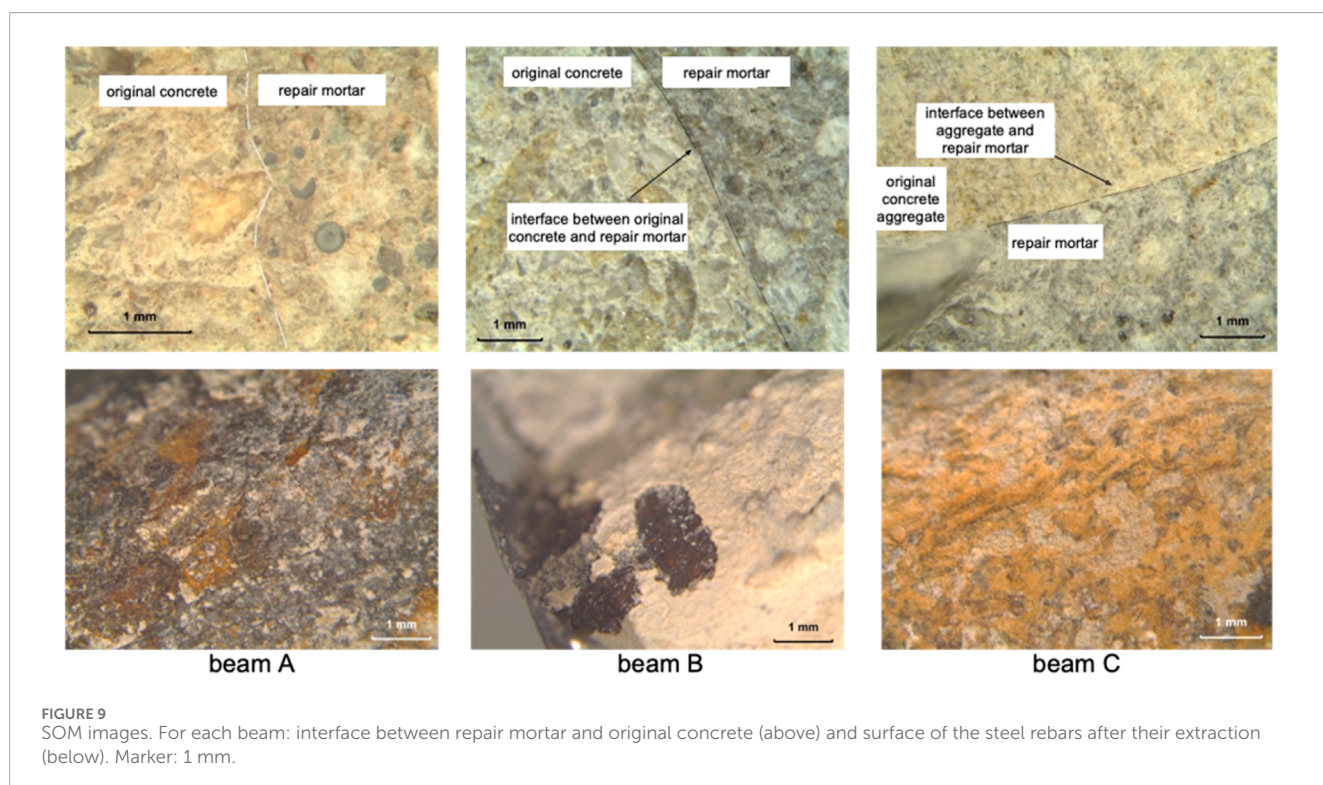
Based on microscopic observation of the interface between concrete and repair mortars, all the new products seem able to provide a good adhesion to concrete (Figure 9, above) and steel (Figure 9, below). However, from a macroscopic point of view, several gaps are visible between the new and the original materials (Figure 10). The insufficient filling ability of the repair mortars seems due to their low flowability, necessary for ceiling application but counterproductive for the filling ability. An alternative application technology should be developed, involving the casting of the mortar (Ana Bras et al., 2013). Figure 10 shows that the original concrete exhibits very coarse aggregates, large voids and an asymmetric arrangement of the steel rebars, as observed onsite.

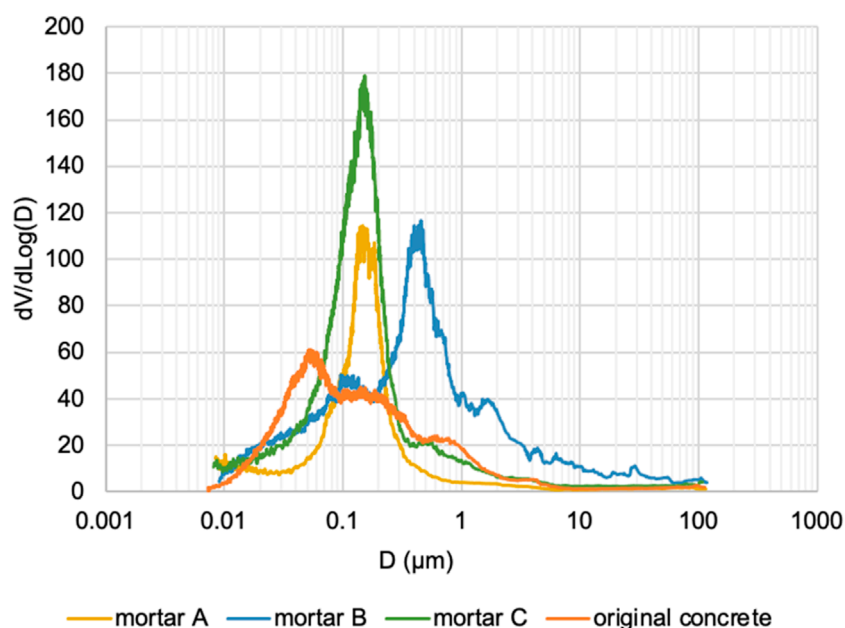
The pore size distribution of the mortars in terms of differential curves obtained by MIP is reported in Figure 12. Pores are generally larger in the three mortars than in the mortar fraction collected from the original concrete, which is consistent with their light weight. However, as large air voids are not properly detected by MIP analysis (Franzoni et al., 2017), SOM observations were performed too. Large and round-shaped air bubbles were found in all the repair mortars (Figure 13), suggesting the use of air-entraining agents for lightweight purposes. The MIP analysis carried out on the repair mortars' samples adjacent to the original concrete are not reported for brevity's sake, as they showed no significant difference. Thus, the wetting of the original concrete was sufficient and no water depletion occurred in the repair mortars close to the interface.

FIGURE 12 Differential MIP curves of the three repair mortars and the original concrete (mortar fraction only).
