Operational and structural diagnosis of sewerage and drainage networks in Côte d'Ivoire, West Africa

In Cote d'Ivoire, the failure of urban sewage systems is a crucial problem for the drainage of wastewater and rainwater. This failure is due to many factors and therefore, calls for diagnostic studies. The present study aimed at analyzing these networks in order to identify the different factors that contribute to the operational and structural degradation in selected sewerage and drainage networks in Abidjan, Cote d'Ivoire. The method used in the study involved semi-structured interviews, video camera inspection and socio-environmental field surveys (geographical survey and household survey), followed by descriptive statistics. The results revealed that many structural, environmental and behavioral practice contribute to the progressive degradation of urban sewage systems. These factors are essentially those that prevent the normal flow of wastewater in the pipes such as the illegal dumping of solid waste, the unauthorized connection of wastewater networks, unsustainable urban agricultural practices, as well as the high concentration of vegetation on both sides of the network and

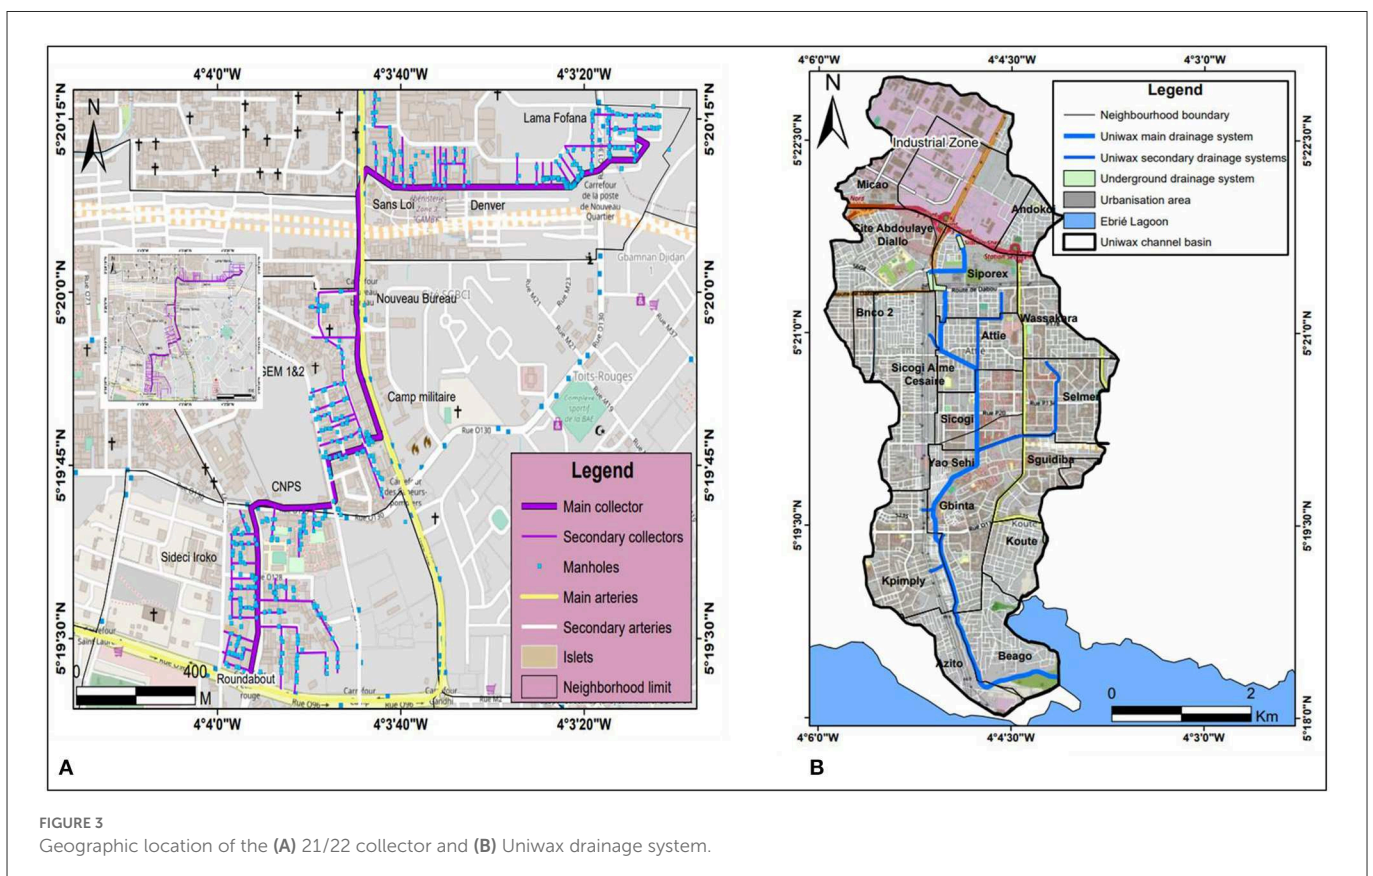
FIGURE 3 Geographic location of the (A) 21/22 collector and (B) Uniwax drainage system.

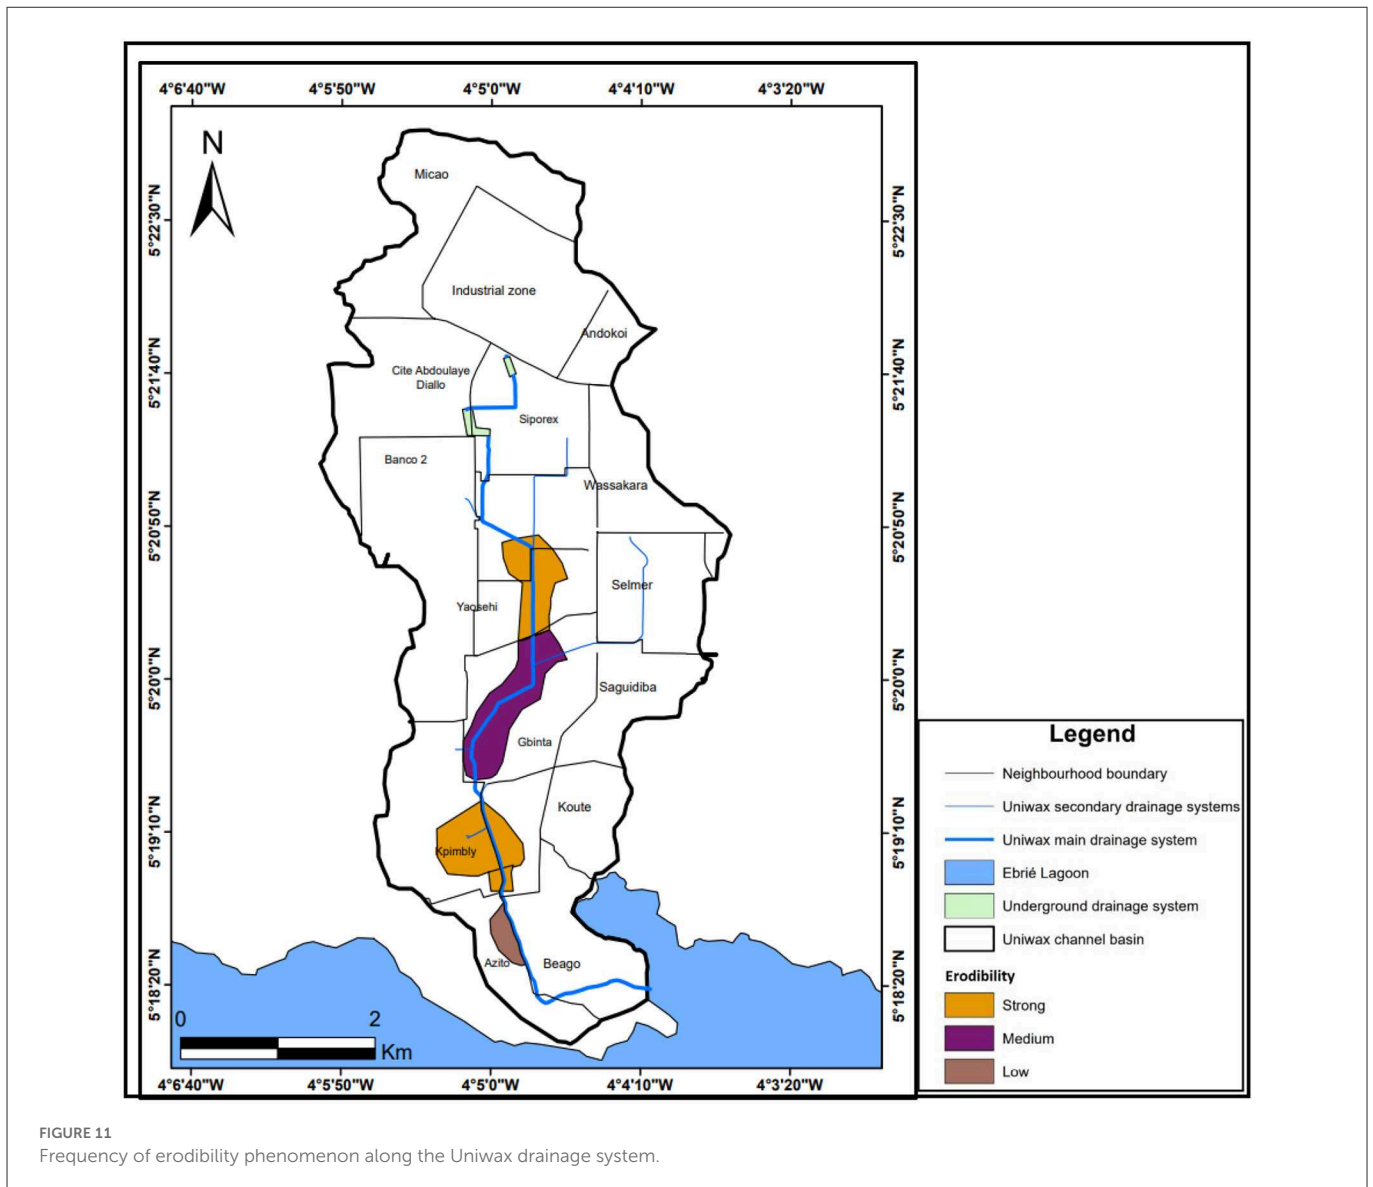
Inadequate management of urban drainage was noted in precarious neighborhoods. The worrying phenomena of erosion, landslides and flooding were observed in the districts. These phenomena were located along the water drainage channels, which were, for the most part, undeveloped. From the point of view of water erosion of the soil, three different forms of erosion were observed in the different districts located along the drainage system: (i) regressive erosion, characterized by a detachment of the soil preferentially from downstream to upstream following the direction of the water flow in the channel (see Supplementary Figure 13). This form of erosion caused scarping and very steep slopes (>5%). In the developed part of the canal and the undeveloped part, it caused the progressive destruction of the structure; (ii) Lateral erosion, characterized by a pronounced detachment at the level of the slopes of the canal (see Supplementary Figure 14). This caused the canal to widen at these points. These phenomena were largely observed in Banco 2, Gbinta, and Yaosehi. The width of the channel measured at the different locations where lateral erosion occurred, varied between 36

and 44 m and (iii) gully or depth erosion, where the detachment of soils follows a depth gradient (see [Supplementary Figure 15](#)). Under these conditions, the underlying formations were soils with a poor resistance to water erosion. The depths measured in these areas of the canal during the field visits varied between 15 and 17 m. [Figure 11](#) below show the frequency of erodibility phenomenon along the Uniwx drainage system.

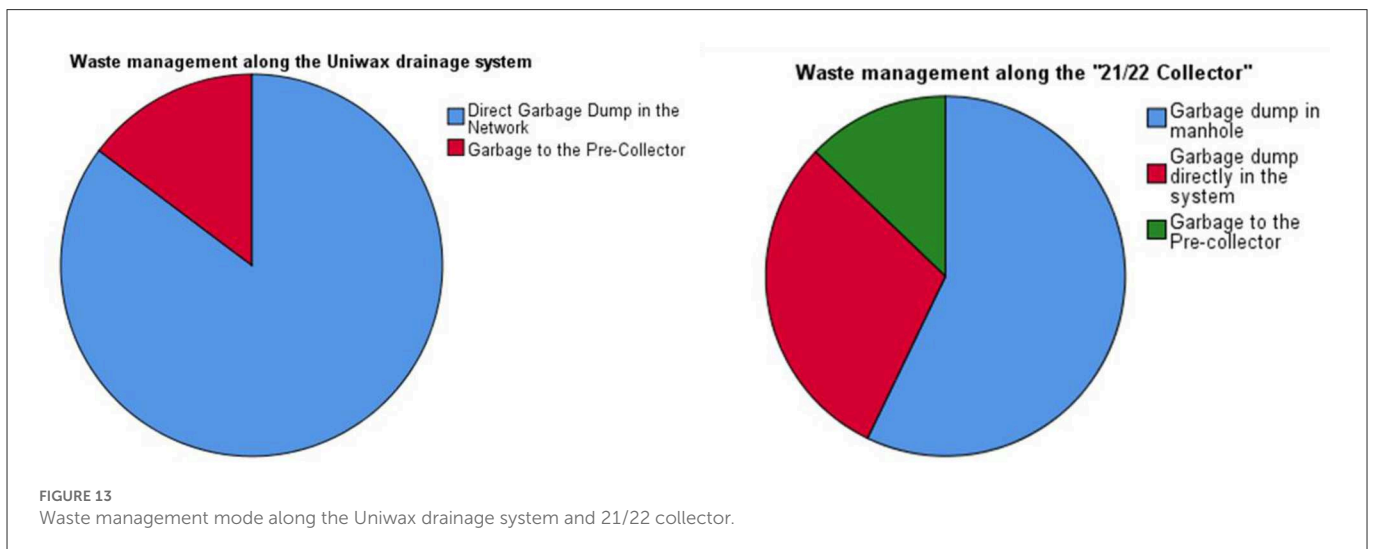
Among the households visited along the Uniwax drainage system, 85.21% (n = 209) did not have any garbage containers and dump

their garbage directly into the network on a daily basis (Figure 13). Of the remaining households with garbage cans, 14.79% ($n = 36$) empty them two to three times a week, alternating between collection trucks and other modes of disposal (pre-collectors, garbage bins, and the network).
