Experimental Investigation on Failure Modes and Progressive Failure Process of Earthen Check Dam Triggered by Upstream Flow

Yanbo Zhu^{1*}, Futong Li¹, Fanfan Yang¹, Yuxuan Zhang¹, Wanghui Tian¹ and Hengxing Lan^{1,2*}

¹College of Geological Engineering and Geomatics, Chang'an University, Xi'an, China, ²Institute of Geographic Sciences and Natural Resources Research, CAS, Beijing, China

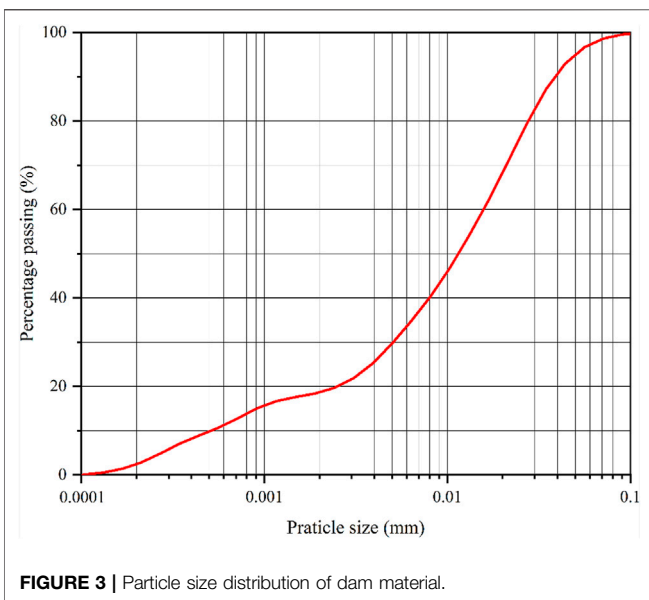
FIGURE 3 | Particle size distribution of dam material.

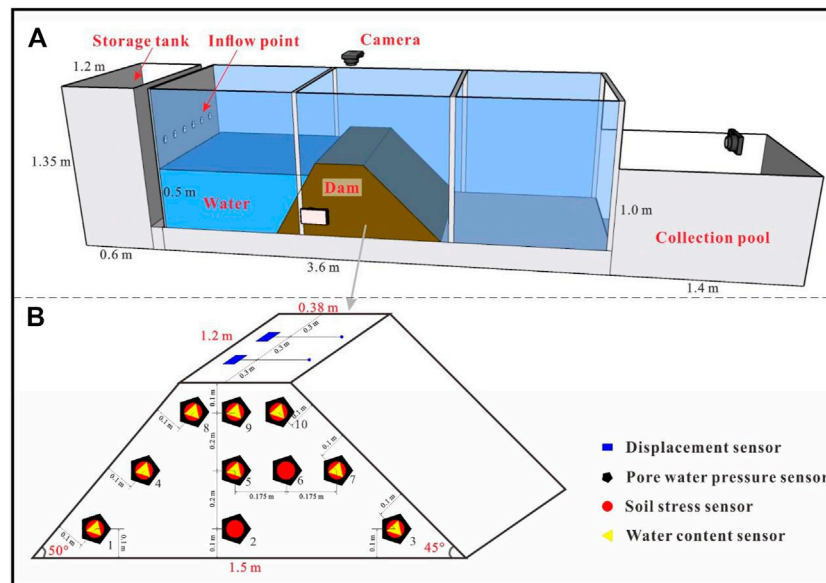
FIGURE 4 | Schematic diagram of the experimental setup. **(A)** Developed model test chamber and **(B)** sensors layout in the test model.

The physical model test was carried out by a specially designed chamber in the Geological Hazard Simulation Laboratory at Chang'an University (**Figure 4A**). The chamber was 3.6 m in length, 1.2 m in width, and 1.35 m in height. The gradient of the bottom of the model chamber made of welded steel was zero. On clear reinforced glass installed on both sides of the model chamber, $5 \times 5\text{-cm}$ grids were drawn to assist in the

arranged fully inside the model dam, and all but two displacement sensors were located on the central axis of the dam; the locations of the sensors are shown in **Figure 4B**. Each monitoring point contained one pore water pressure sensor (ATJ-6007, with a measurement range of 0–20 kPa, accuracy = $\pm 0.5\%$), one soil stress sensor (ATJ-7002, with a measurement range of 0–200 kPa, accuracy = $\pm 0.5\%$), and one water content sensor (EC-5, with a measurement range of 0–100%, accuracy = $\pm 0.25\%$). Besides, there were two displacement sensors (MPS-S-2000MM-V1, with a measurement range of 0–2000 mm, accuracy = $\pm 0.1\%$) at the crest of the model dam, which monitored the generation and evolution of crevices at the dam crest. All sensors have factory calibrations that give us the needed conversion formulas. Sensors automatically send pore water pressure, soil stress, water content, and displacement through an iDAQ-1800 dynamic data acquisition instrument. The data acquisition rate was five per second. All of the sensors connected to the corresponding data acquisition instruments were calibrated before the test. To capture the deformation evolution of the check dam, three digital video cameras collected side, front, and vertical views, as shown in **Figure 4A**. Based on the images of the dam morphology change, the deformation strain field of the model dam can be analyzed by the image processing technique DIC (He et al., 2020).

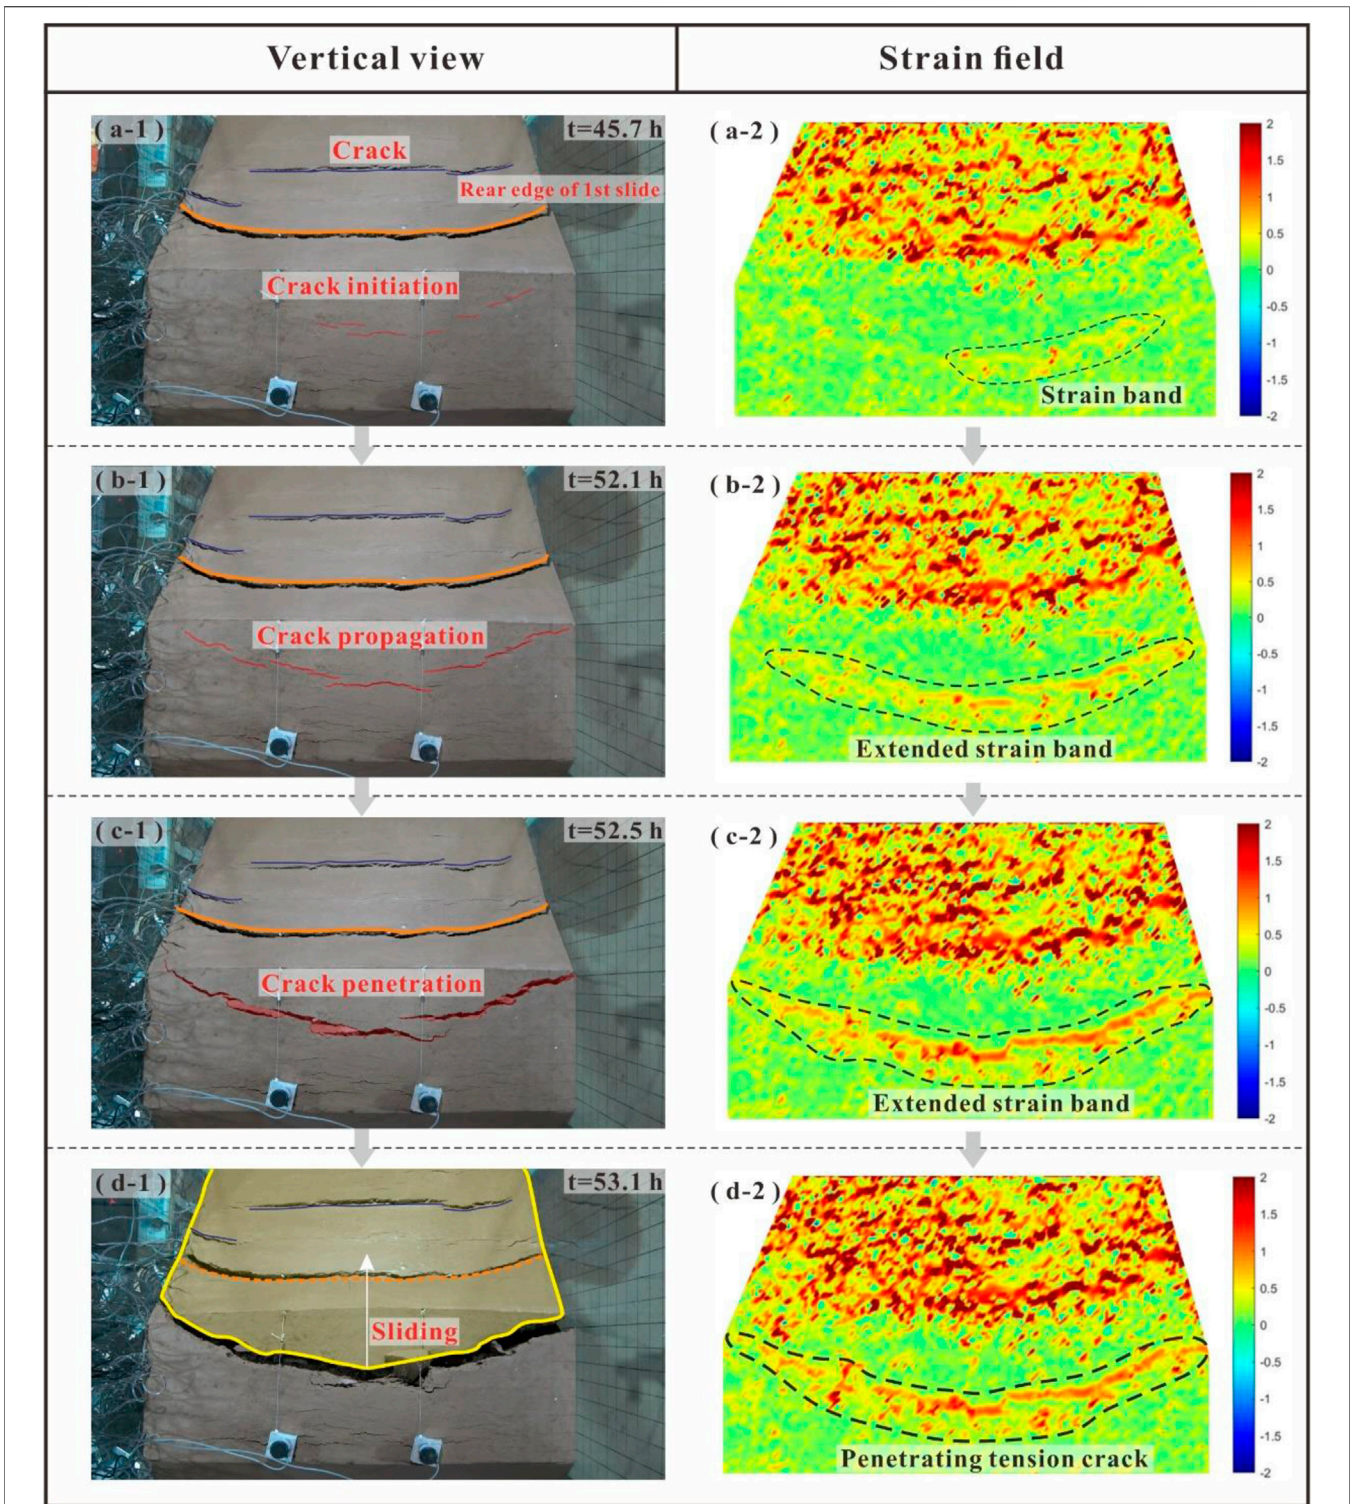
FIGURE 9 | Progressive process of the second slide from the vertical view. **(A)** Crack initiation, **(B)** crack propagation, **(C)** crack penetration, and **(D)** sliding.

due to the squeezing of the sliding body, resulting in an increase in the pore water pressure. The pore water pressure of the sensor P-10, located at the rear edge of the sliding body, rose sharply before sliding (at 52.5 h) and dropped after sliding (at 53.5 h) (Figures 9B-2 and Figure 10C). In this case, the tensile cracks on the dam crest concentrated the seepage flow before sliding, thus the pore

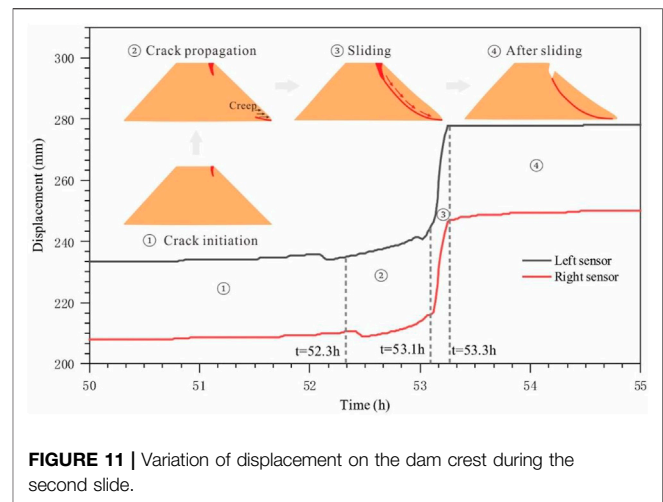
FIGURE 11 | Variation of displacement on the dam crest during the second slide.

The sensors that monitor the displacement of the dam crest respond only during the second slide, as shown in Figure 11. The sliding process is divided into four stages, including crack initiation, propagation in the dam, sliding, and stable stage. At the initiation stage (before 52.3 h), the cracks on the dam crest nucleated at low speed, and there was no obvious displacement on the dam crest. At the crack propagation stage (52.3–53.1 h), the cracks at the dam crest expanded gradually, resulting in an increasing displacement with a slow rate of increase. Then, the displacement of the dam crest increased sharply, with a maximum growth range of 33.8 mm in only 0.2 h, marking the occurrence of the sliding. After sliding (after 53.1 h), the changes in the two displacement sensors tend to be stable, with a maximum displacement of 46.5 mm, indicating the end of the sliding.

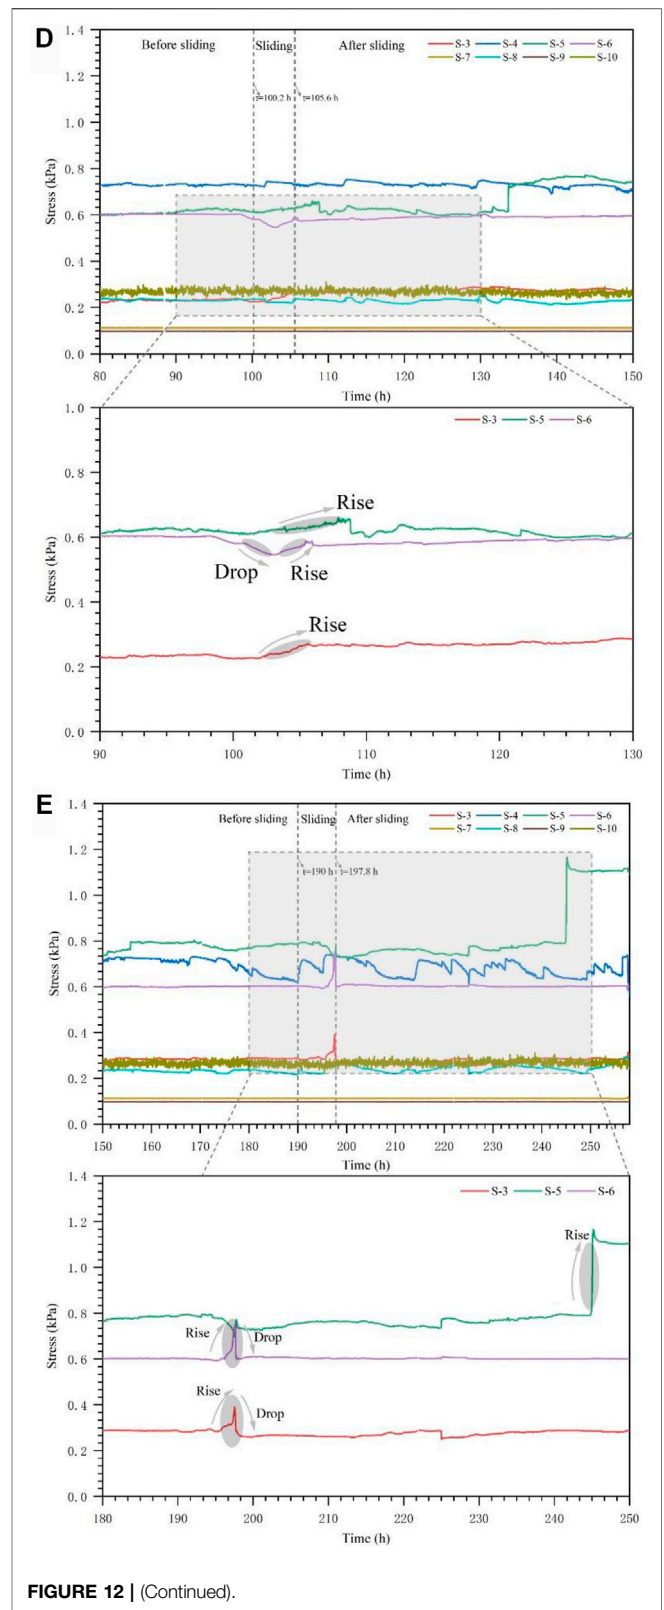
FIGURE 12 | (Continued).

FIGURE 12 | Variation of soil stress during slope failure. **(A)** Soil stress during the whole sliding, **(B)** soil stress during 1st slide, **(C)** soil stress during the 2nd slide, **(D)** soil stress during the 3rd slide, and **(E)** soil stress during the 4th slide.

Figure 12A shows the response of the sensors S-3, S-5, and S-6 representing the soil stress in the sliding body, at the sliding surface, and at the back of the sliding body, respectively. The soil stress of the sensors S-3 and S-6 shows fluctuating changes in response to each sliding, especially during the second slide. The soil stress of sensor S-5 shows a decreasing trend in the first two slides and increases in the third slide and fourth slide stages. This is because the lateral stress in the dam soil decreases due to the first two slides, resulting in a reduction in soil stress. After the third and fourth slides, the massive sliding caused a loss of support at the rear of the dam, resulting in an increase in the lateral soil stress inside the dam. Therefore, the soil stress pressure of the dam shows an increasing trend. **Figure 12B** shows the variation of soil stress during the first slide. Because the sliding volume is small, the soil stress changes little. The soil was soaked at the back of the dam for a long time, so the soil stress values at S-4 and S-8 fluctuate only slightly. During the second slide, the soil stress at S-6 rises sharply at 53.1 h with the occurrence of sliding (**Figure 12C**). This is because the sliding made the rear of the dam lose its front support, resulting in an increase in the lateral soil stress. During the third and fourth slides, the sliding process lasts for about 5–8 h, during which the pore water pressure and soil pressure continuously rise and drop (**Figures 12D,E**).

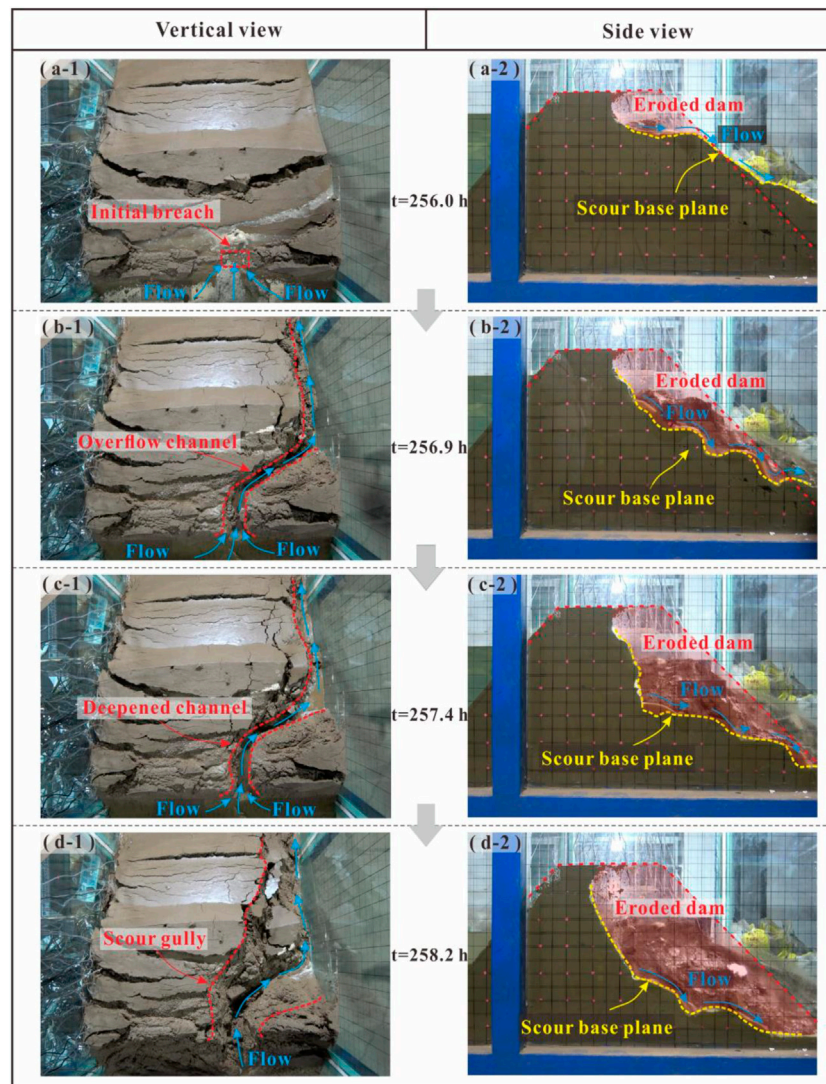
FIGURE 13 | Progressive process of overtopping from vertical view and side view.

The multi-sliding of the downstream slope caused sufficient structural damage to the dam and overtopping occurred at 256 h. **Figure 13** shows the overtopping process from vertical and side views. The sliding of the downstream slope reduced the height of the dam crest, and overflowing water gradually eroded the dam crest (**Figures 13A–1**). As the soil material on the dam crest constantly eroded away (**Figures 13A–2**), some slender overflow channels appeared there, and the slope beside the overflow channel collapsed under the action of erosion (**Figures 13B–1**). The scour base plane continued to develop

downward, and different flow velocities in gullies led to the stepped multi-level scarps, as shown in **Figures 13B–2**. Continuous erosion deepened and widened the initial crest breach as well as the overflow channel (**Figures 13C–1**). When the water flowed through the scarp, a waterfall torrent was formed, which quickly cut down and eroded the upstream, forming a still larger scarp (**Figures 13C–2**). Then, the gully deepened continually, and the dam soil on the sides collapsed and was washed away by the water flow (**Figures 13D–1**). The erosion flows exacerbated the undercutting of the upstream, making the scour base plane develop rapidly to the bottom of the model container. With the decline of the reservoir water level, the overtopping process stopped gradually. **Figures 13D–2** show the final shape of the broken dam.

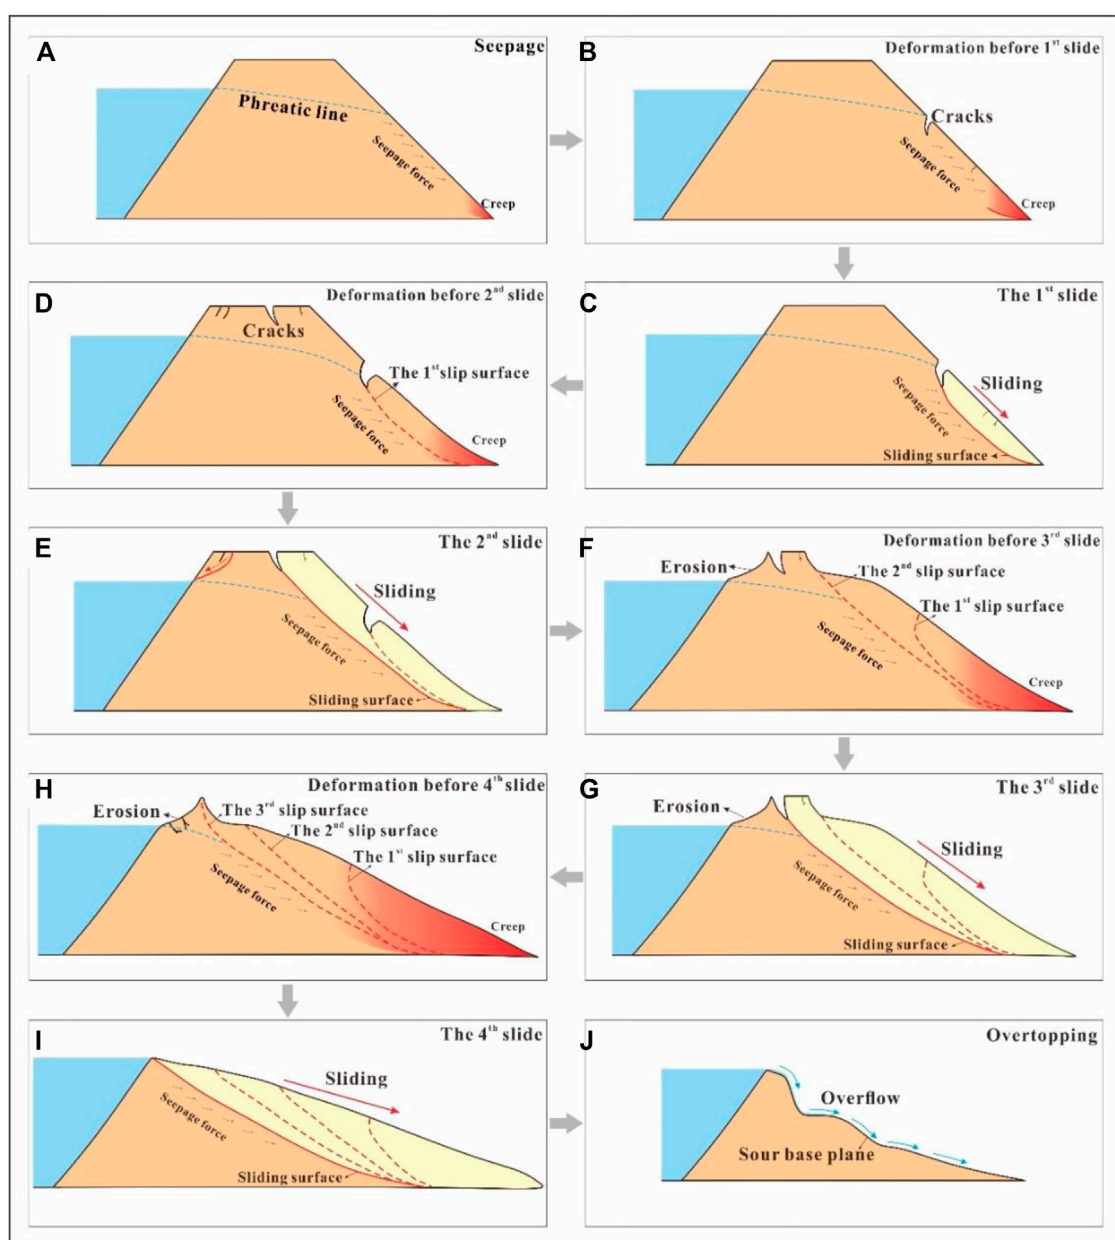
FIGURE 15 | Formation mechanism of the progressive failure of model dam. (A) Seepage, (B) deformation before the 1st slide, (C) 1st slide; (D) deformation before the 2nd slide, (E) 2nd slide, (F) deformation before the 3rd slide, (G) 3rd slide, (H) deformation before the 4th slide, (I) 4th slide, and (J) overtopping.
