Wan J, Li B, Gao Y, Tan C and Li Z (2023),
Pumping-induced reactivation of a pre-
existing normal fault: insights from a
centrifuge model test.
Front. Earth Sci. 11:1289568.
doi: 10.3389/feart.2023.1289568

Pumping-induced reactivation of a pre-existing normal fault: insights from a centrifuge model test

groundwater pumping, fault reactivation, pre-existing normal fault, centrifuge model test, deformation, ground fracture

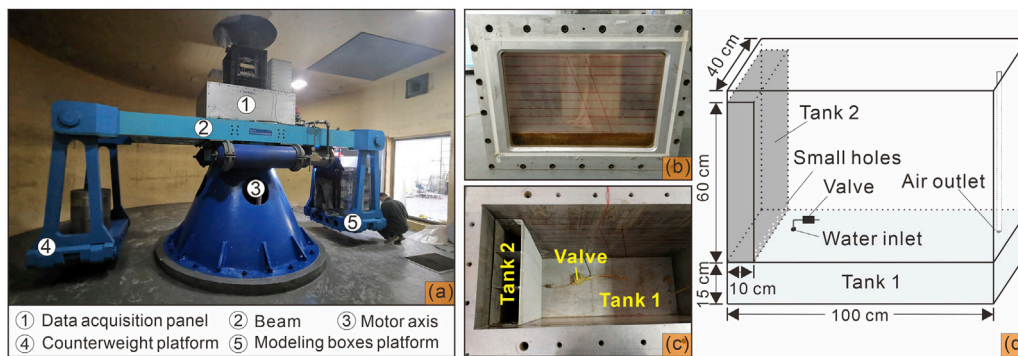
FIGURE 2 Geotechnical centrifuge and model box used in this paper. (A) Overview of the centrifuge. (B) Front side of the box. (C) Open top. (D) Perspective view of the model box and critical components.

The modeling box used for the tests had dimensions of $1 \text{ m} \times 0.8 \text{ m} \times 0.4 \text{ m}$ in length, height, and width. It was mainly made of thick high-strength stainless steel plates, except for the front wall containing a transparent plexiglass plate so that the internal deformation of the model materials could be directly observed (Figures 2B, C). Tank 1, with a volume of 0.06 m^3 , was situated at the bottom of the box for water storage (Figures 2C, D). A water inlet, controlled by a solenoid valve, and an air outlet, connected with a long tube, were set on the top of Tank 1. Using Tank 1 and the valve, we could electrically control the water table decline in the model during the test. Tank 2, with a volume of 0.024 m^3 , was placed on the left side of the modeling box for water pressure observation and monitoring (Figures 2C, D). Two rows of small holes were set on the bottom of the right wall of Tank 2, enabling water inflow and outflow.

- 3) Put the modeling box and counterweight onto the platform of the geotechnical centrifuge (Figure 2). Install the laser displacement sensors and digital cameras according to the model test design (Figure 3B). Connect the transducers, sensors, and cameras to the data acquisition panel of the centrifuge.

- 5) After the initial deformation caused by the acceleration increase becomes stable, turn on the valve (Figure 2) to cause a water table decline. The model test can be ended when the model deformation has essentially ceased.

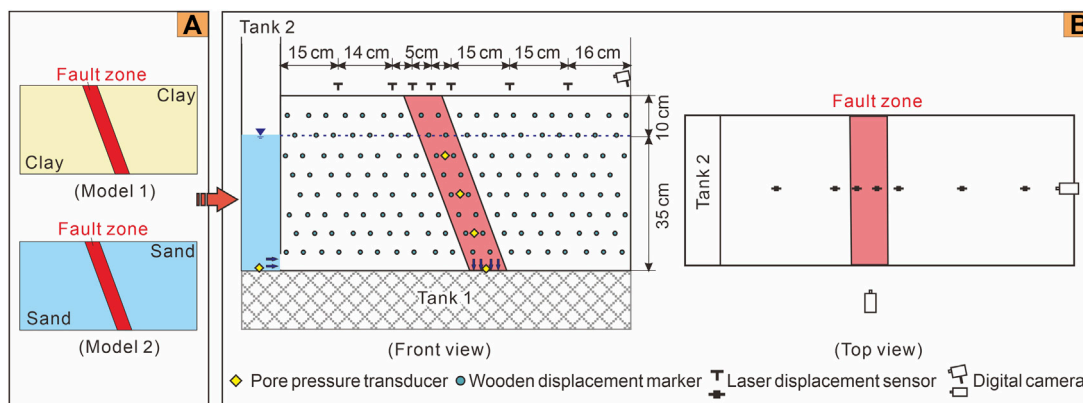
FIGURE 3 Design of Models 1 and 2 in the test. (A) Conceptual models. (B) Layout of the measurement and monitoring system. The initial water table was at the height of 35 cm. The blue arrows indicate the direction of the water flow since the testing began. From left to right, the laser displacement sensors were coded LD1~LD7 in sequence. Pore pressure transducers in the fault zone were coded PP1~PP4 along the upward direction, while that in Tank 2 was PP5.

the plexiglass plate on the front wall. Both the horizontal and vertical spacings of the displacement markers were 5 cm. The vertical displacements of the top surface were also monitored by seven laser displacement sensors installed above the model box. Both the water pressure and laser displacement sensor values were recorded once per second. The deformation phenomenon was observed using two high-definition digital cameras from the top and front views. A data acquisition system affiliated with the beam geotechnical centrifuge automatically recorded these monitoring results. The layout of the measuring and monitoring devices is shown in Figure 3B.

The monitoring results of the pore pressure transducers in Model 1 are shown in Figure 4. The PP1~PP4 transducers were buried in the fault zone in sequence at heights of 0–30 cm with a vertical spacing of 10 cm, and PP5 was immersed in pure water in Tank 2 (Figure 3B). The change in the pore pressure is affected by the centrifugal acceleration and water table decline according to the classical fluid pressure equation considering the scaling factor (Table 2) as follows:

Model 2 had a similar structure to Model 1 except that the hanging wall and footwall were made of sand (Figure 3A). The model test lasted for 4,681 s, and the procedure still contained five stages of centrifugal acceleration increase (20 g, 40 g, 60 g, 80 g, and 100 g). The acceleration reached 100 g at 2,130 s. Subsequently, the centrifuge rotated at a constant speed until 4,681 s.

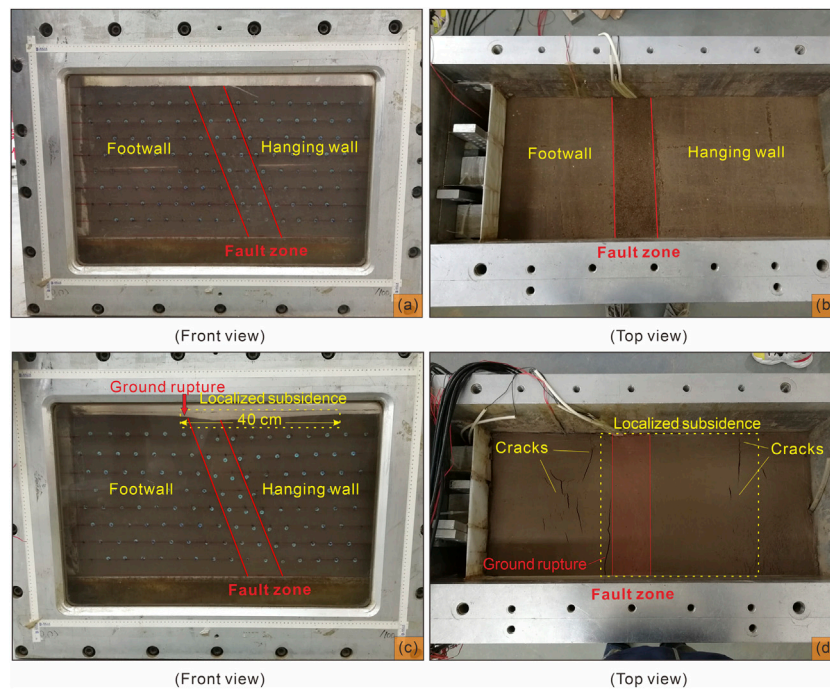
FIGURE 5 Deformation and failure patterns of Model 1. (A,B) Model 1 before the centrifuge model test. (C,D) Model 1 after the centrifuge model test.

As shown in Figure 5, every layer of Model 1 evidently deformed in the centrifugal model test. The surface subsidence was 1–3 cm, which was calculated using the measuring tape with wooden displacement markers. The deformation was caused by the compaction of unconsolidated soils due to the vertical effective stress increase, according to Terzaghi's effective stress principle as follows:

The most intense compaction occurred in the pre-existing fault zone, leading to the upper and surrounding areas dramatically deforming. The deformation pattern of the soils was three-dimensional but was dominated by subsidence. In addition, a small amount of horizontal movements toward the fault zone occurred in both the hanging wall and footwall. On the model surface, a localized subsidence area covering an area of 40 cm × 40 cm formed along the pre-existing fault zone and largely on the hanging wall (Figures 5C, D). The largest subsidence was approximately 3 cm, measured using the measuring tapes pasted on the model box. A 25-cm-long ground rupture, or earth fissure, formed accompanying the uneven subsidence along the left boundary of the localized subsidence area adjacent to the fault zone (Figure 5D). The new rupture and localized subsidence on the right side were controlled by the pre-existing fault zone. This uneven deformation pattern in the model indicated that the pre-existing fault was reactivated to a certain extent. These findings agreed with our previous numerical simulations regarding the Shunyi fissures (Wan et al., 2021). Moreover, several short cracks with different shapes and trends formed close to both edges of the

Moreover, the video showed that water continuously seeped out of Model 1 and accumulated in the localized subsidence area during the model test, which agreed with the pore pressure results shown in Figure 4. The maximum height of the standing water was approximately 0.5 cm. The standing water increased the water content and plasticity of the shallow soils, allowing the model to become deformed without cracking or fracturing. After the centrifuge stopped rotating, the water on the model surface infiltrated down, facilitating ground fracture propagation. This is why the ground rupture in the photo (Figure 5D) was more significant than that in the video screenshot (Figure 6).

the Model 1 surface increased with regularity, and no runtime error occurred. The variations in the vertical displacements of the Model 1 surface were primarily controlled by the centrifugal acceleration but were also influenced by the water table decline (Figure 7A). The subsidence of the model ranged from 17.69 to 36.36 mm. The pre-existing fault zone and part of the hanging wall experienced the most significant deformation, whereas the edges of the model, which were far from the fault zone, deformed by less than half. This result agreed with the photos taken after the model test (Figure 5) and the video screenshots at $t=3,613$ s (Figure 6).

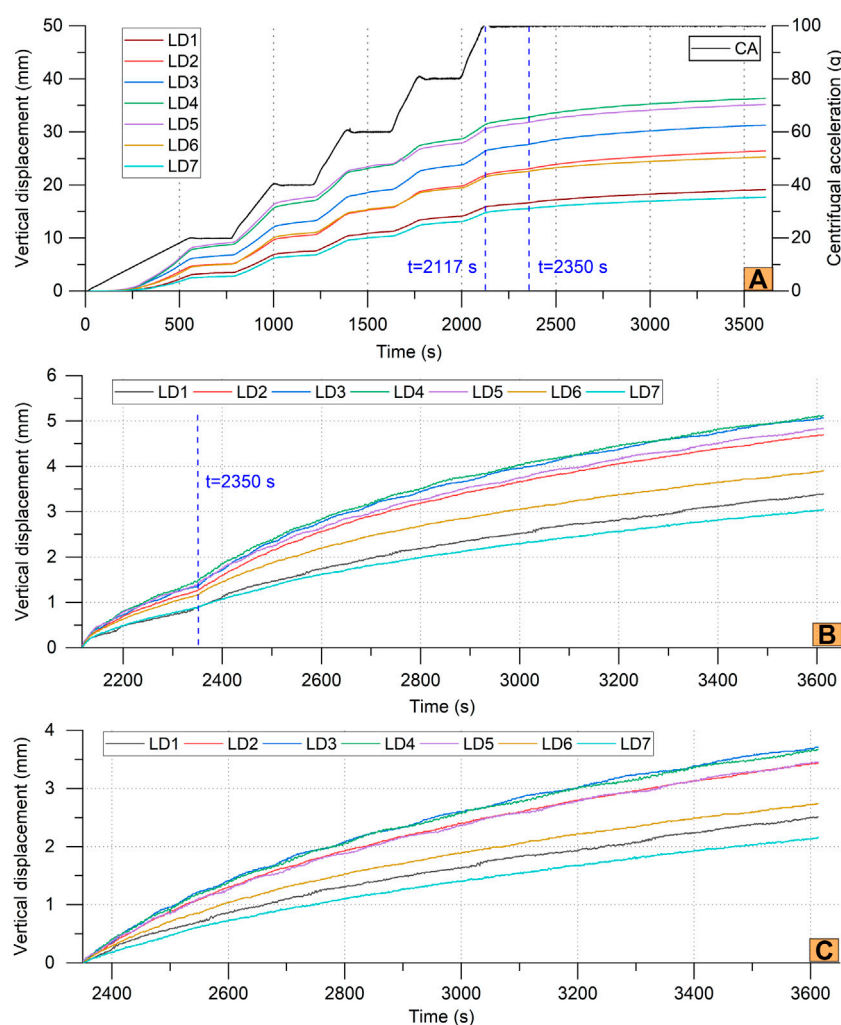
FIGURE 7

Vertical displacements of the Model 1 surface, monitored by the laser displacement sensors. (A) Displacements in the whole test period. (B) Incremental displacements when the centrifugal acceleration was 100 g ($t \geq 2,117$ s). (C) Incremental displacements when the water table was declining ($t \geq 2,350$ s).

The results shown in Figure 7 proved that the laser displacement sensors performed well during the test. The vertical displacements of

The monitored vertical displacements verified that the uneven deformation of Model 1 was reactivated by the water table decline. After the centrifugal acceleration was maintained at 100 g ($t \geq 2,117$ s), the increase rate of the vertical displacement initially slowed and then suddenly accelerated after the water table began to decline ($t=2,350$ s), as shown in Figure 7B. During the water table decline, the incremental vertical displacement ranged from 2.16 mm to 3.71 mm (Figure 7C). The fault zone and part of the hanging wall still experienced more significant deformation than other places. The fault zone subsided most intensely, based on the LD3 and LD4 sensors obtaining the largest displacement (Figure 7C), due to its higher permeability coefficient, which facilitated the pore pressure decrease during this period. This was unlike the subsidence pattern before the water table declined and proved the substantial effect of groundwater pumping on the model deformation.

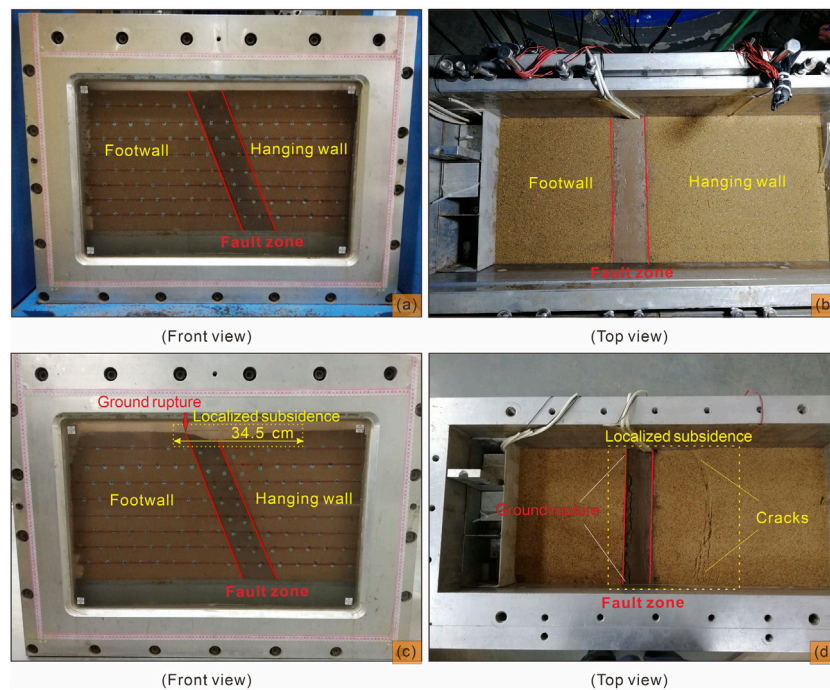
FIGURE 9 Deformation and failure patterns of Model 2. (A) and (B) Model 2 before the centrifuge model test. (C,D) Model 2 after the centrifuge model test.

The uneven subsidence and ground fracture in Model 2 were more significant than those in Model 1 because the model materials of the hanging wall and footwall were replaced by sand in Model 2, which had a higher compression modulus (Table 2). The unconsolidated soils of the hanging wall and footwall in Model 2 therefore slightly compacted under the same water table decline conditions. Meanwhile, the fault zones in Models 1 and 2 deformed to similar degrees due to their identical material properties. Thus, the uneven subsidence became more significant in Model 2, and then, the ground fracture propagated through the whole model.

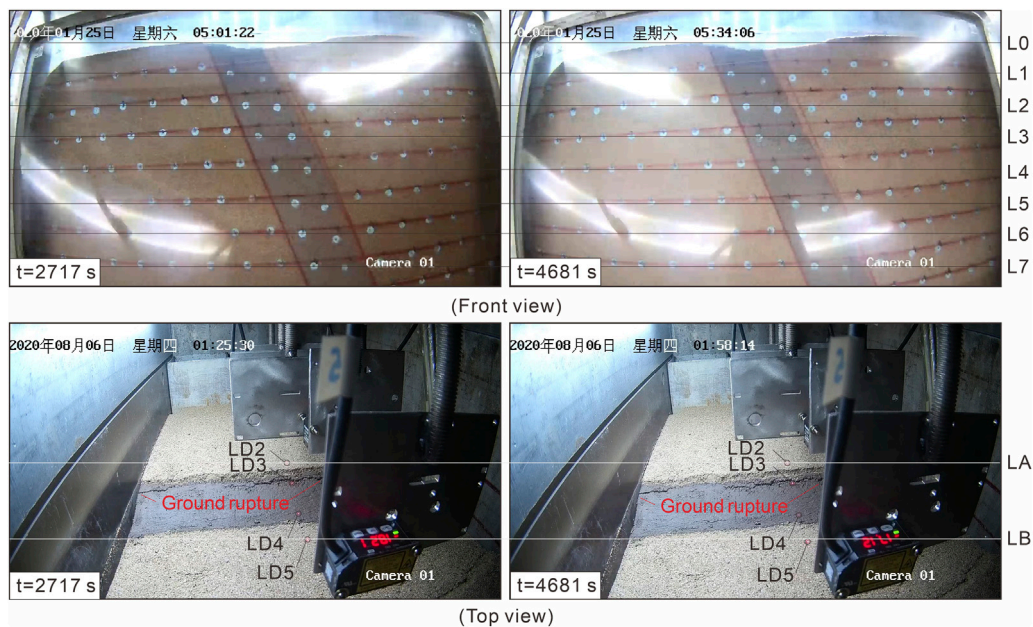
FIGURE 10 Monitoring results of two high-definition digital cameras from the front and top views of Model 2. L0~L7 and LA~LB on the images are the codes of the horizontal reference lines. LD2~LD5 are the codes of the laser displacement sensors, and the red dots in the black circles mark the monitoring locations.

The mechanical behavior of Model 2 was recorded by two digital cameras installed in front of and above the model box. The video showed that dramatic localized subsidence and extensive ground fracture formed before the groundwater declined ($t < 2,718$ s), and the uneven deformation intensified after the water table fell (Figure 10). The pumping-induced subsidence was more evident in the fault zone and adjacent hanging wall, whereas it was very slight in the footwall, as measured by using the reference lines on the

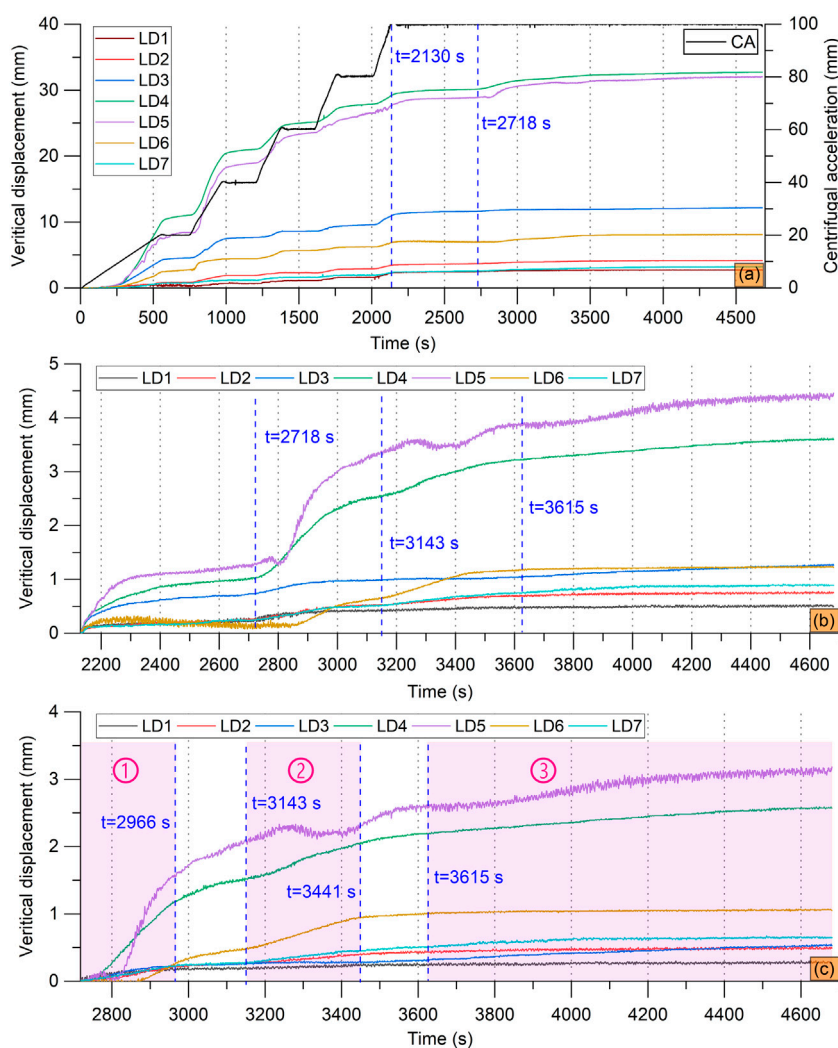
FIGURE 11

Vertical displacements of the Model 2 surface, monitored by laser displacement sensors. (A) Displacements in the whole test period. (B) Incremental displacements when the centrifugal acceleration was 100 g ($t \geq 2,130$ s). (C) Incremental displacements beginning at the first water table decline ($t \geq 2,718$ s). The numbers ①, ②, and ③ with light purple bands indicate the first, second, and third water table declines in the model test, respectively.

valve of Tank 1 was opened. The vertical displacements from the LD4 and LD5 sensors dramatically changed due to the water table decline, whereas the displacements at other locations of Model 2 slightly increased. A displacement decrease occurred twice in the LD5 records because of the horizontal movements of the sand grains on the model surface, as shown in the photos (Figure 9) and video screenshots (Figure 10). The incremental displacements during $t \geq 2,718$ s ranged in 0.27–3.18 mm (Figure 11C). Then, the hanging wall subsided 2.91 mm relative to the footwall, which was more significant than the result in Model 1 (Figure 7C). The dramatic pumping-induced subsidence of the hanging wall, behaving similar to normal faulting, indicated that the pre-existing fault zone in Model 2 had been reactivated.

Furthermore, the three water table decline times induced different degrees of normal fault reactivation in Model 2 (Figure 11C), although they had similar height drops. The water table first dropped from 35 cm to 23 cm in the model, then from 23 cm to 12 cm, and lastly from 12 cm to approximately 0. The vertical displacements of the hanging wall adjacent to the fault, shown in the LD4 and LD5 curves, soared during the first decline

and evidently increased during the second decline. In contrast, the increase rate was less marked during the last decline. Thus, the uneven deformation of Model 2 mainly occurred in the first two

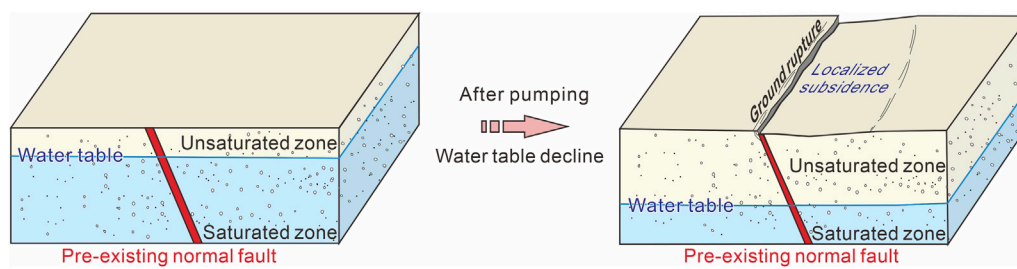
FIGURE 12

Pattern of pumping-induced subsidence and normal fault reactivation based on the results of the centrifuge model tests.

The shallow part of the pre-existing normal fault was reactivated in the model test, which resulted in uneven surface deformation and new ground fracture formation (Figure 12). The new fractures were long and straight due to the control of the fault zone lying beneath, unlike the common short cracks formed adjacent to pumping-induced surface subsidence boundaries. The surface subsidence of the hanging wall was much more significant than that of the footwall, indicating that the models experienced uneven subsidence. The significant subsidence was mainly in a localized area, and the scale may be influenced by the depression cone and the pre-existing fault zone. The normal faulting occurring in the faulted models was inherited from the pre-existing normal fault but less related to the location of the pumping well, which has been verified by our previous numerical simulations (Wan et al., 2021).

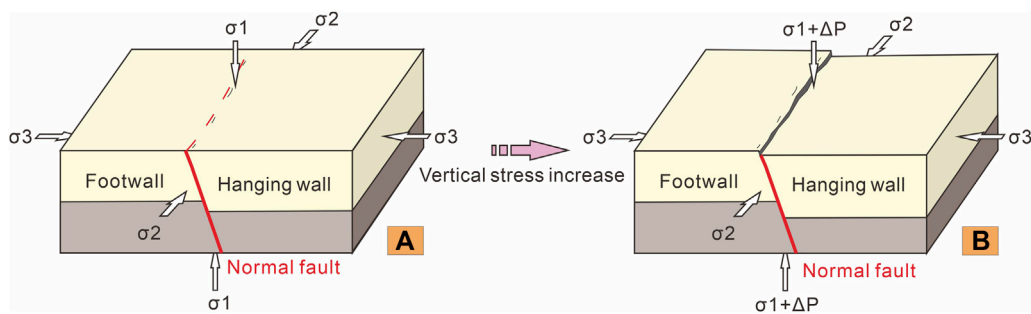
FIGURE 13

Stress state of the models in the tests and mechanism of normal fault reactivation. σ_1 , σ_2 , and σ_3 are the maximum, intermediate, and minimum principal stresses, respectively. ΔP is the incremental stress. Yellow and brown blocks represent different sedimentary layers to distinguish the dislocation. (A) Stress state after the centrifugal acceleration increased. (B) Stress state after the water table declined.

Our centrifuge model tests satisfied the aforementioned assumption. During the test, the increased centrifugal acceleration caused a surge of pressure in the vertical direction perpendicular to the surface of Models 1 and 2. The maximum principal stress, accordingly, became vertical, and the intermediate and minimum principal stresses became horizontal (Figure 13A). This stress state conformed with Anderson's normal faulting model. As a result, the pre-existing normal fault was reactivated, accompanied by localized subsidence of the hanging wall. The pumping-induced water table decline in the further test steps increased the effective stress, leading to the addition of vertical stress and the resultant intensification of normal faulting (Figure 13B). These results revealed that the normal fault reactivation in the model testing and the actual normal fault formation basically have identical mechanisms in that both are triggered by the vertical stress addition. Furthermore, groundwater pumping would cause normal fault reactivation due to the appropriate principal stresses, similar to tectonic movement, except that the reactivation progress caused by human activity is largely limited to a localized area.
