# Microstructure Refinement on Crevice Corrosion of High-Speed Rail Steel U75V Visualized by an *In Situ* Monitoring System

Rail foot covered by a fastener will suffer from crevice corrosion, leading to thinning and localized attack of crevice interior posing a risk of failure. This work investigated crevice corrosion behavior of a typical pearlitic high-speed rail steel U75V, focusing for the first time on the effect of pearlitic microstructure refinement achieved by heat treatment with different cooling rates 2, 5, and 10°C/s. Under anodic polarization, localized dissolved spots presented on the as-received sample, where crevice corrosion mostly initiated from. For cooling rates 2 and 5°C/s, localized dissolved spots were also observed but crevice corrosion was mostly presented as general corrosion instead of from local spots, ascribed to enhanced tendency of uniform dissolution due to microstructure refinement and homogenization. For cooling rate 10°C/s, crevice corrosion expanded flocculently, ascribed to preferential dissolution of pearlitic nodules with entangled cementite due to over refinement. Crevice corrosion was obviously accelerated by microstructure refinement. Cooli

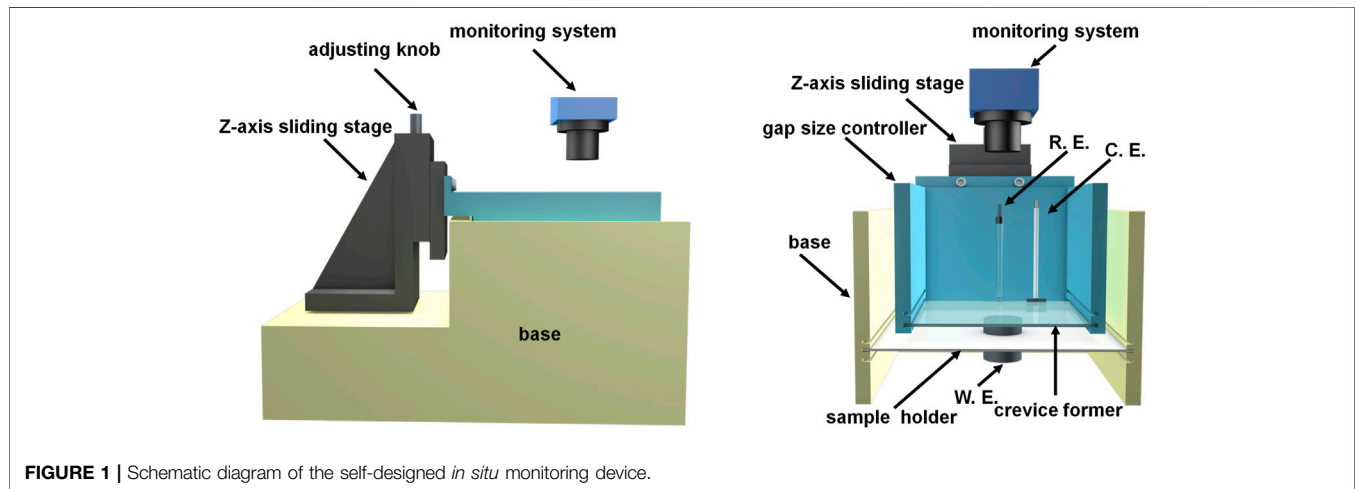
**FIGURE 1** | Schematic diagram of the self-designed *in situ* monitoring device.

corrosion morphology development. A piece of transparent glass was used as a crevice former, fixed in a frame with grooves, and connected to a Z-axis sliding stage (with a micrometer) as a crevice gap size controller, so that the gap size can be adjusted as required. The combination of electrochemical methods and real-time corresponding images is important, so this device incorporated an optical system with a vertically placed Navitar microscope, coupled using a CCD camera connected to a computer. The lens was above the surface of the working electrode (working distance ca. 7 cm) and fixed on a stage which allowed movement in *X* and *Y* directions. A ring illuminator was fixed around the lens. The magnification was 50X–400X. A schematic diagram illustrating this device is shown in **Figure 1**. The disc samples were immersed in 0.1 M NaCl after grinding with a 50  $\mu\text{m}$  crevice gap. Considering surface roughness and machining tolerance regarding the contact surface between the rail foot and fastener (Xu et al., 2021), a gap size of 50  $\mu\text{m}$  is regarded as a reasonable value in this work. Similarly, open circuit potential was measured to achieve stable OCP ( $\Delta\text{OCP}/\Delta t < 3 \text{ mV}/\text{min}$ , ca. 50 min from the start of immersion), and polarization tests were carried out afterward when required.

The macrographs of the as-received sample and after heat treatment with cooling rates 2, 5, and 10°C/s, taken during the anodic polarization process shown in **Figure 4** using a self-designed *in situ* monitoring device (see **Figure 1**), are presented in **Figures 5–8** respectively, with some local sites compared. 0 h means the start point of anodic polarization after free immersion (stable OCP was achieved).

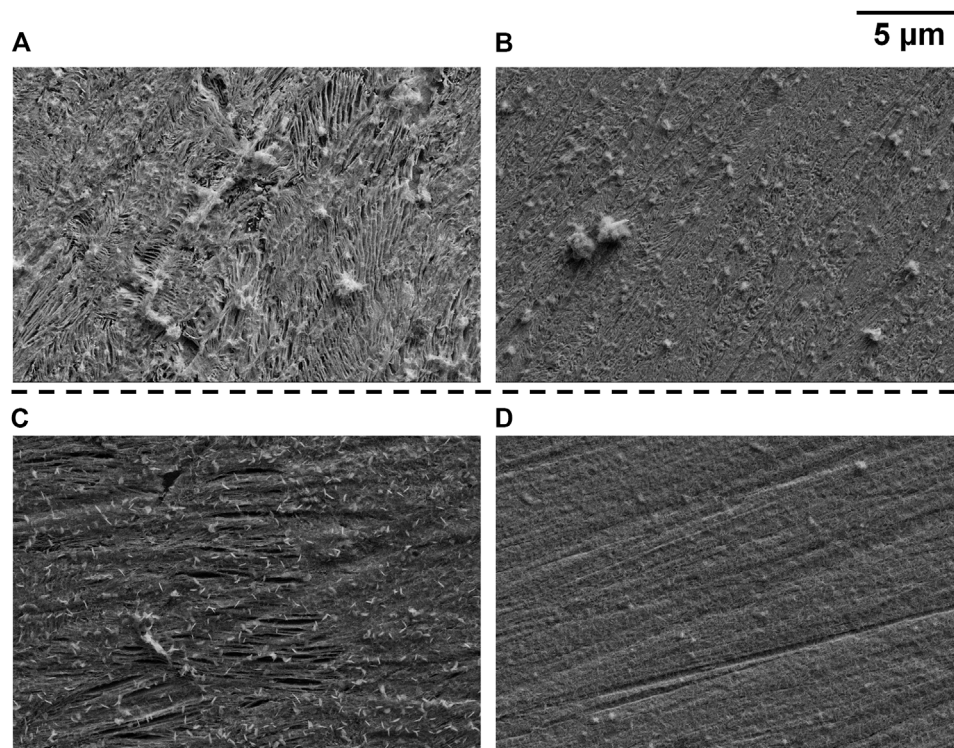
**FIGURE 9** | SEM micrographs taken on samples after heat treatment with cooling rates 2°C/s [(A) fully dissolved/dark area; (B) boundary area] and 5°C/s [(C) fully dissolved/dark area; (D) boundary area].

Micrographs of some typical local sites after identical anodic polarization tests (crevice gap 50 µm) were obtained by SEM to further investigate crevice corrosion behaviors of different samples. During the expansion of the creviced area, there were basically three areas according to the macrographs shown previously, i.e., fully dissolved area (appeared dark), non-corroded area, and the boundary between the two (presented as light color before turning dark, clear in **Figures 6, 7**). Therefore, SEM images of the fully dissolved area and boundary area of samples after heat treatment with cooling rates 2 and 5°C/s are shown in **Figure 9**. **Figure 9A** (fully dissolved area for 2°C/s) clearly shows the cementite skeleton due to preferential dissolution of ferrite. In the boundary area (**Figure 9B**), preferential dissolution of ferrite can also be observed but not as clear as **Figure 9A**; in addition, the scratches due to grinding still appear which is not presented in **Figure 9A**. Therefore, the generalized corrosion for 2°C/s was still based on preferential dissolution of ferrite. In comparison, **Figure 9C** (fully

dissolved area for 5°C/s) does not show the typical pattern of the cementite skeleton but only some elongated cavity (ferrite lamella dissolution), and the scratches due to grinding can still be seen. The boundary area (**Figure 9D**) also does not show the typical pattern of the cementite skeleton. Therefore, the dissolution depth of 5°C/s was generally less than that of 2°C/s, although the expansion rate of the dissolved area (dark area) for 5°C/s was obviously higher than that of other samples (**Figures 5–8**). This is related to the observation that those dark spots formed during free immersion can still be seen even after the expanding corroded area crossing them (**Figure 7**, 1 h). The appearance of dark color on the dissolved area (observed in macrographs) was mainly due to cementite, either detached from the surface or remained as a skeleton, which has been reported before on localized corrosion of industrial pure iron (Xu et al., 2017) and carbon steel (Xu et al., 2019).

Distribution of the surface profile for the cooling rate 5°C/s appears to be uniform, indicating small dissolution depth. It agrees with the results shown in **Figures 7, 9**, where preferentially dissolved local spots and scratches due to grinding were still observed, respectively, in the dissolved area. As to the sample regarding the cooling rate 10°C/s, the edge region of the disc clearly shows darker color, indicating large dissolution depth near the edge. In addition, flocculent dissolution behavior can also be observed since some bright spots appear in the darker region near the edge.

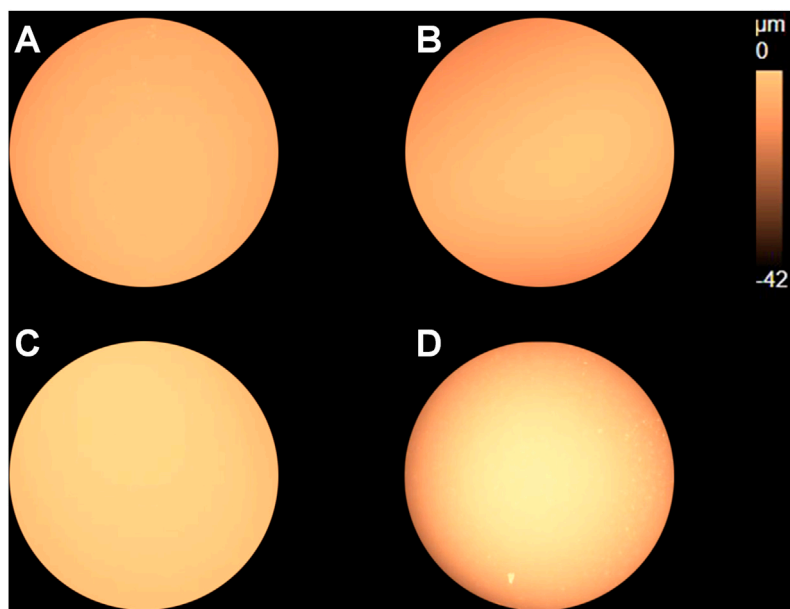
**FIGURE 11** | Surface profile mappings of the (A) as-received sample and samples after heat treatment with cooling rates (B) 2°C/s, (C) 5°C/s, and (D) 10°C/s after anodic polarization at 0.15 V vs. OCP stopped when the electric charge reached 0.2 C.

Since the rate of metal loss varied substantially between different samples, surface profiles need to be compared based on the same amount of metal loss instead of time. According to **Figure 4B**, the electric charge 0.2°C was a reasonable value (the surface would not be completely dissolved for all four samples), so the potentiostatic polarization at 0.15 V vs. OCP was carried out on each of the four samples and stopped when the electric charge reached 0.2°C. The surface profile mappings presenting dissolution depth and height information are shown in **Figure 11**.

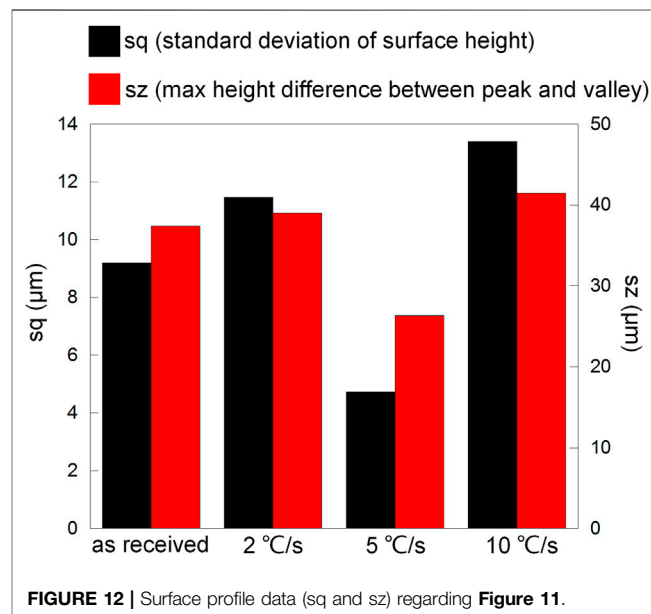
**FIGURE 12** | Surface profile data (sq and sz) regarding **Figure 11**.

To show the difference more clearly, **Figure 12** presents surface profile data including sq (standard deviation of surface height, presenting the degree of surface height uniformity) and sz (maximum height difference between the peak and valley, representing the largest corrosion depth). The most uniform height distribution and smallest height difference between the peak and valley regarding the cooling rate 5°C/s should be resulted from small corrosion depth and generalized corrosion. In comparison, the least uniform height of the surface and biggest height difference between the peak and valley regarding the

cooling rate 10°C/s should be resulted from the seriously corroded region near the edge, and the expansion of the dissolved area was slow (metal loss was mainly concentrated near the edge). This phenomenon was also observed in **Figure 8**, where the flocculently dissolved area was still near the edge until about 2 h (the whole surface was completely dissolved in 2 h as shown in **Figure 7**). The difference between the as-received sample and the sample after heat treatment with the cooling rate 2°C/s was negligible. It implies that the dissolved area based
