A Novel Method to Quantify Self-Healing Capabilities of Fiber-Reinforced Polymers

The present work investigates a novel and practical method to evaluate the healing efficiency of carbon-reinforced polymer composites. The method should be representative of damage occurring during the lifetime of a composite part, should tend to damage the healable matrix mostly and yet be simple and cost-effective to set up. Thus, the capacity to recover low-velocity impact damage has been evaluated *via* three-point bending flexural tests. Carbon-reinforced composite laminates were produced using HealTech™ T300-TW200-42RW-1250, a commercial healable resin pre-impregnated Torayca T300 3K twill 2 × 2 fabric with an aerial weight of 200 g/m². Fibers were oriented at ± 45° or at 0°–90°, and the laminates were impacted at different energy levels. Flexural properties of undamaged, damaged, and healed samples were compared, and the healing efficiency was calculated as the ratio of healed and undamaged ultimate flexural strength or modulus. Since matrix healing efficiency is the value to characterize, it was shown that ±45° laminates could be tested without major fiber damage and, thus, provide the best m

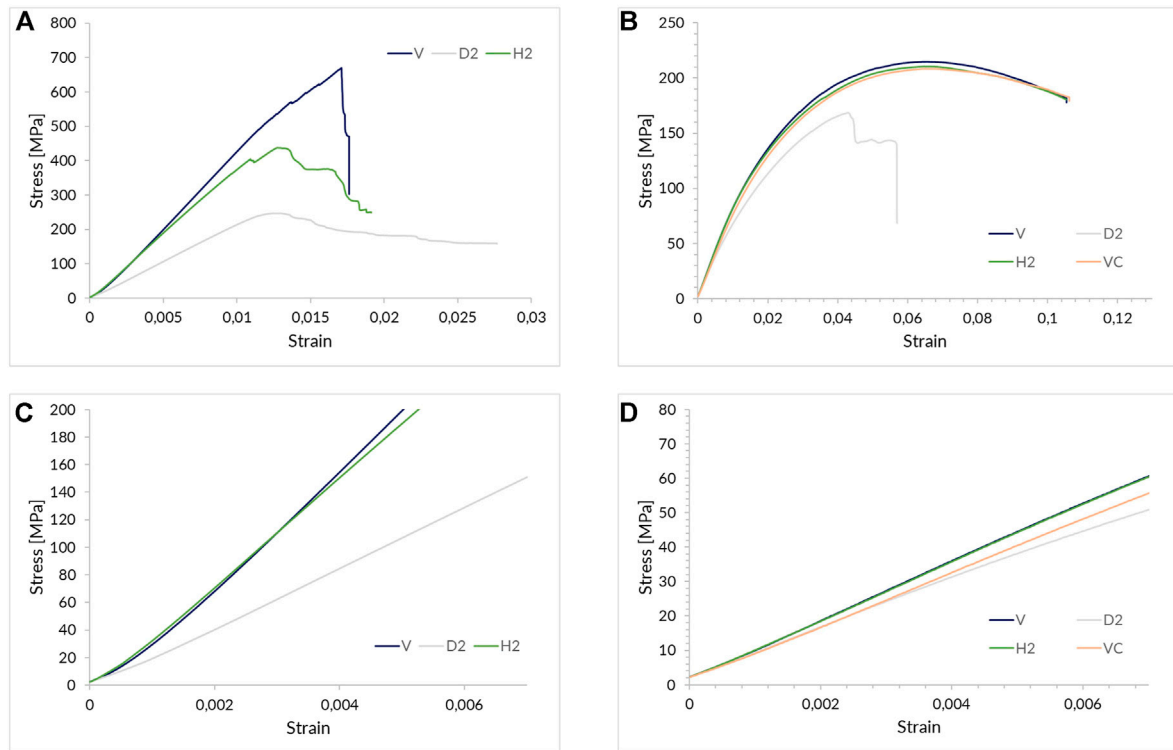
FIGURE 3 | Examples of 3-point bending test curves for **(A)** $[(0/90)]_{18}$ V, D2, and H2 samples and **(B)** $[(+45/-45)]_{18}$ V, VC, D2, and H2 samples. **(C)** and **(D)** depict a zoom on the curves' areas representative of the flexural modulus, respectively, for samples with fibers oriented at $0/90^\circ$ and $\pm 45^\circ$.

Figure 3A shows the typical 3-point bending curves obtained for the V, D2, and H2 specimens with fibers at $0/90^\circ$. In this case, the difference in mechanical behaviour between the three types of samples is already obvious from an observation of these curves and from pictures displaying the side surface of the samples during 3-point bending tests

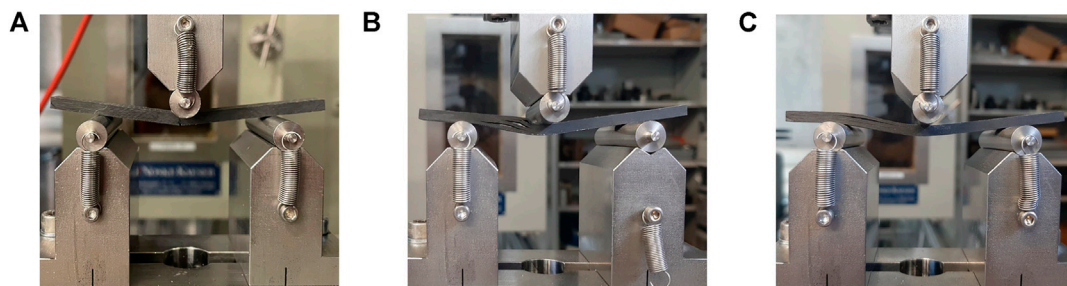
FIGURE 4 | Pictures of the side surface of $[(0/90)]_{18}$ samples during the flexural tests depicting the typical failure of **(A)** V, **(B)** D2, and **(C)** H2 samples.

(**Figure 4**). For V samples, failure starts with fiber breakage at the outer top surface plies which are solicited in compression and is followed by the rupture of other fibers in lower plies solicited in traction, resulting in an abrupt loss of strength (**Figure 4A**). In the case of D2 samples, delamination and cracks induced by impact damage act as sites for the initiation of interlaminar fracture during the flexural test (**Figure 4B**). H2 samples behave in an intermediate way. As observed in **Figure 4C**, an interlaminar fracture is present to some extent, but it is less relevant than in damaged samples, and fiber breakage also takes place, as it is also visible from the step decrease in strength throughout the flexural test (**Figure 3A**). **Figures 3C and D** show a zoom on the curves' areas representative of the flexural modulus for both samples with fibers oriented at 0/90° and ±45°. For samples with fibers oriented at ±45°, it can be similarly observed that the failure mode changes depending on whether they are V, VC, D2, or H2. As observed on both bending test curves (**Figure 3B**) and pictures taken throughout the flexural tests (**Figure 5**), D2 specimens underwent interlaminar fracture,

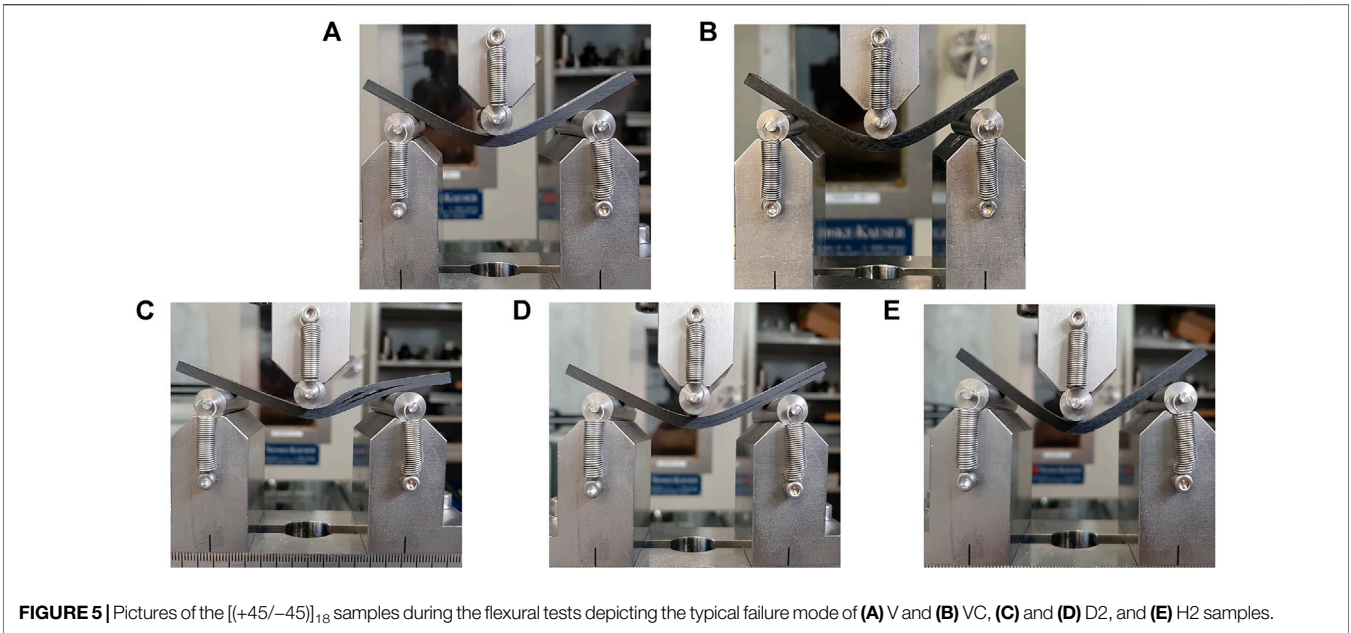
FIGURE 5 | Pictures of the $[(+45/-45)]_{18}$ samples during the flexural tests depicting the typical failure mode of (A) V and (B) VC, (C) and (D) D2, and (E) H2 samples.

which was either localized close to the impact area, the center of the sample (**Figure 5C**), or propagated until the edge of the sample (**Figure 5D**). Unlike D2 samples, V, VC, and H2 specimens all displayed the same failure behaviour, and the interlaminar fracture was not visible after healing, which can be considered the first proof of efficient healing.

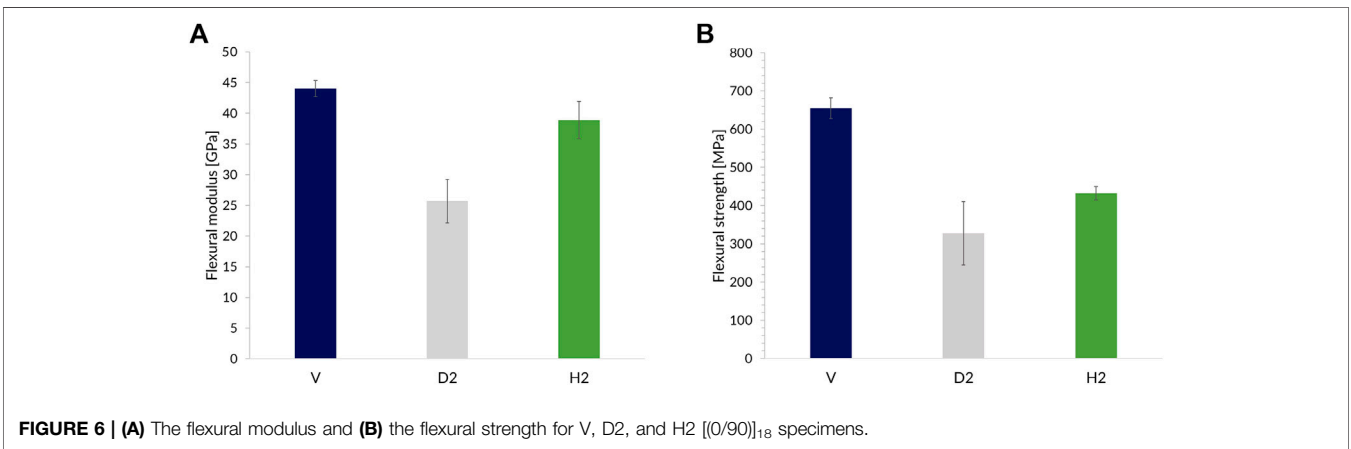
FIGURE 6 | (A) The flexural modulus and (B) the flexural strength for V, D2, and H2 $[(0/90)]_{18}$ specimens.

Figure 6 shows the average flexural strength and flexural modulus for the V, D2, and H2 specimens with fibers at 0/90°. The average healing efficiency was computed according to **Eq. 1**, and it resulted to be 72.1% with respect to the flexural modulus and 32.1% with respect to the flexural strength. Using **Eq. 2**, healing efficiency was 88% and 66%. The healing process is more beneficial to restore the initial flexural modulus rather than the initial flexural strength, and this is probably connected to the fact that when fibers are oriented at 0/90°, they are broken by the impact procedure (morphological characterization is presented in the next section). This indicates that for the test to be meaningful with respect to matrix healing efficiency, minimal fiber damage should be sought.

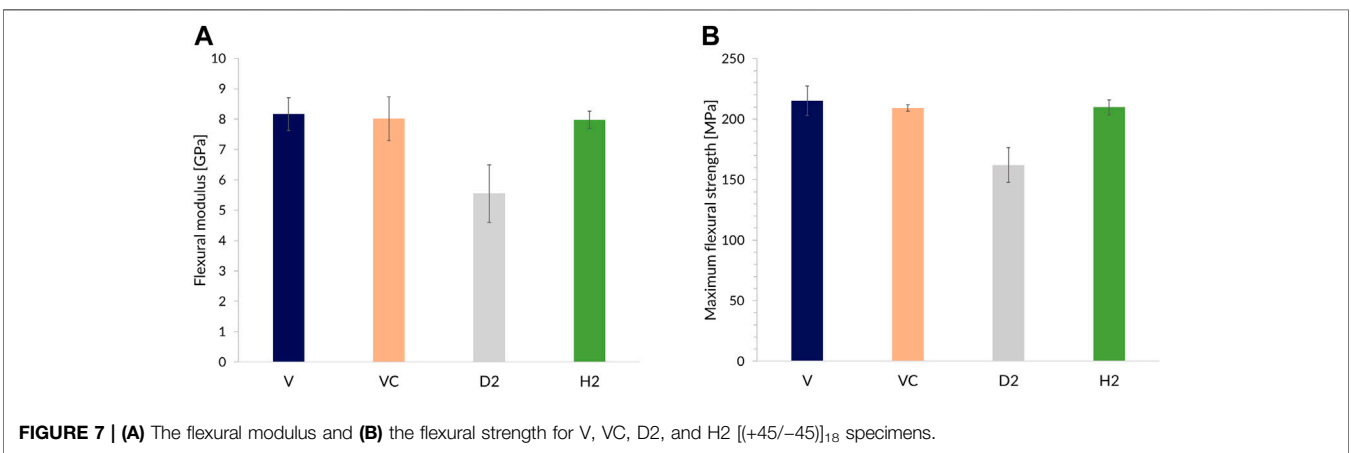
FIGURE 7 | (A) The flexural modulus and (B) the flexural strength for V, VC, D2, and H2 $[(+45/-45)]_{18}$ specimens.

Figure 7 outlines the average flexural strength and flexural modulus for the V, VC, D2, and H2 specimens with fibers at ±45°. In this case, the average healing efficiency computed according to **Eq. 1** resulted in higher values: 92.8% with respect to the flexural modulus and 90.1% with respect to the flexural strength. Using **Eq. 2**, a 97.5% healing efficiency is obtained for both modulus and strength. The angled fiber orientation, in samples with such a small width, prevented extensive damage to the fibers themselves and favored matrix cracking and delamination, that is, exactly the type of defects the healable matrix of HealTech™ enables to mend. **Figures 3B, 7** also highlight that there is no detrimental effect on the mechanical performances due to the healing treatment. In fact, the mending cycle temperature has been chosen to be sufficiently lower than the T_g of HealTech™ T300-TW200-42RW-1250, which is 170°C, so as not to degrade the crosslinking degree.

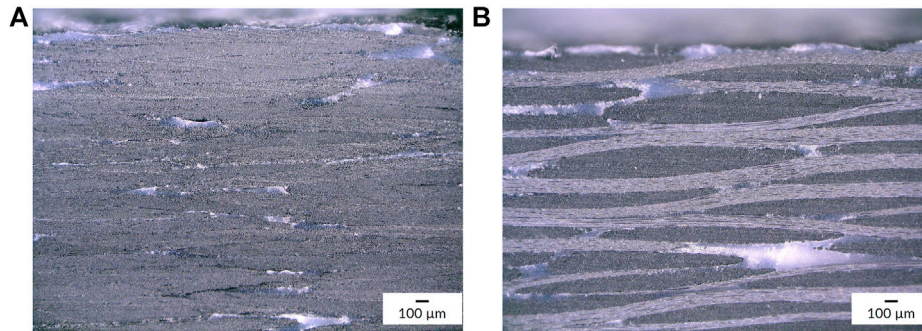
FIGURE 10 | (A) Optical microscopy image of the cross-section of a D2 [(+45/-45)]₁₈ sample showing signs of delamination and cracks; **(B)** a D2 [(+45/-45)]₁₈ sample was cut along fiber direction at the impact location and the obtained cross-section was observed *via* optical microscopy: No broken fibers can be observed.

Figures 9 and 10 show optical microscopy images of the cross-section of a [(0/90)]₁₈ sample and a [(+45/-45)]₁₈ D2 sample, respectively. The impact damage process leads to fibers rupture in laminates with fibers oriented at 0/90°, while this is not the case when fibers are oriented at ±45°, a layup which allows a much more extensive fiber deformation before rupture and hence favors damage to the matrix rather than to the fibers. This confirms why much higher healing efficiencies can be attained with such fiber orientation, as HealTech™ healing ability resides in the polymeric resin. However, the fact that fiber rupture or delamination is visible in optical microscopy images of the cross-section of samples entails that the damage area diameter is at least 13 mm (the width of the specimens). Consequently, the reservoirs of the healing agent, which can flow and fill the cracks might be sufficient along the length of the samples but not across the width. The healing agent might preferentially flow out of the sample's cross-section instead of toward the internal cracks. This might explain the impossibility to demonstrate full healing capabilities even when fibers are not broken. HealTech™ enables to heal cracks up to 100 μm thick (Cohades and Trigueira, 2020), and none of the cracks observed *via* optical microscopy (**Figure 10**) exceeds this thickness.
