# Corrosion fatigue performance of modified 17-4PH in simulated geothermal environment

Corrosion fatigue behavior of a new candidate material for geothermal turbine blade, modified 17-4PH, was investigated in detail. The environmental acceleration of crack growth rate was discussed in terms of  $\Delta K$ . Fracture surface and side surface were observed by SEM. The crack path on side surface was also analyzed by EBSD. Then, the corrosion mechanism was discussed. Striation width on the fracture surface was compared to the crack growth per cycle. Since pitting occurred during the corrosion fatigue test, anodic polarization test was exercised to measure the pitting potential, and the cause for the pitting was also discussed. The hardness was also characterized by micro-hardness test and auger electron mapping.

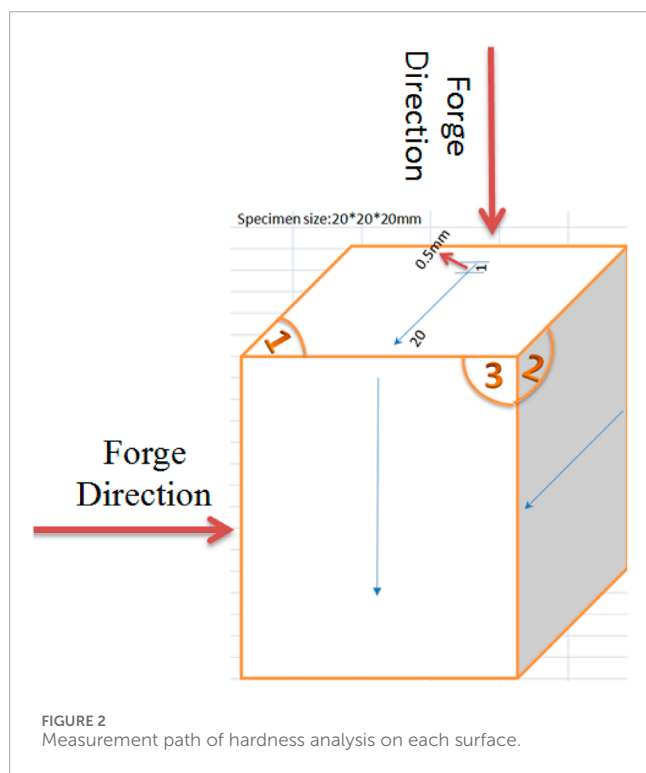
FIGURE 2 Measurement path of hardness analysis on each surface.

Initially, the specimen underwent grinding with waterproof silicon carbide papers, progressing up to 2,400 grits. Subsequently, hardness assessments were conducted using a Shimadzu micro-Vickers hardness tester, applying a 2 Kg load with a 15-s holding time. A set of 20 points, spaced at intervals of 0.5 mm on each surface (as illustrated in Figure 2), were measured, and the resulting average value was employed as the ultimate hardness measurement.

The contoured double cantilever beam (CDCB), which was based on the design by Mostovoy et al. (1967) was the specimen that was employed. Figure 3 depicted the CDCB specimen's geometry. The specimen was constructed so that surface 3 in Figure 2 would receive the imposed loading. The overall crack propagation during pre-cracking in air was approximately 2 mm, and the mechanical notch (aCDCB) measured 22 mm. Within a specific crack-length, the specimen was subjected to constant loading (CL) at a constant value of K (CK). The following Eqs 1–3 express the crack driving force G:

average values of 295.5, 295.3, and 294.3, in that order. Surfaces 1 and 2 had nearly identical values, while Surface 3 had the lowest value. In the meantime, surface 1, 2, and 3's measured data had standard deviations of 2.76, 2.74, and 3.50. It is evident that surface 3's hardness fluctuated more than the others. That distinction of surface 3 from surface 1 and 2 was attributed to the hot forging on surface 1 and 2, as shown in Figure 2.

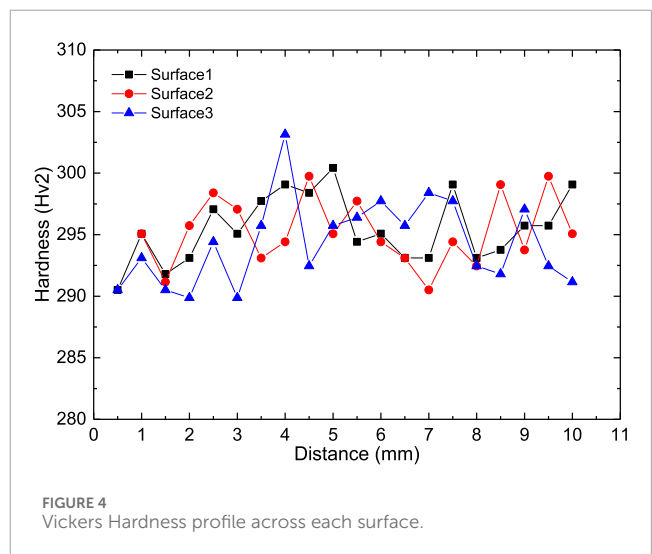
Figure 4 displayed the hardness profile on each surface. It should be mentioned that only 19 surface 2 points were saved because of a measurement error. That missing point should not, however, have a significant impact on the final outcome. Surfaces 1, 2, and 3 had

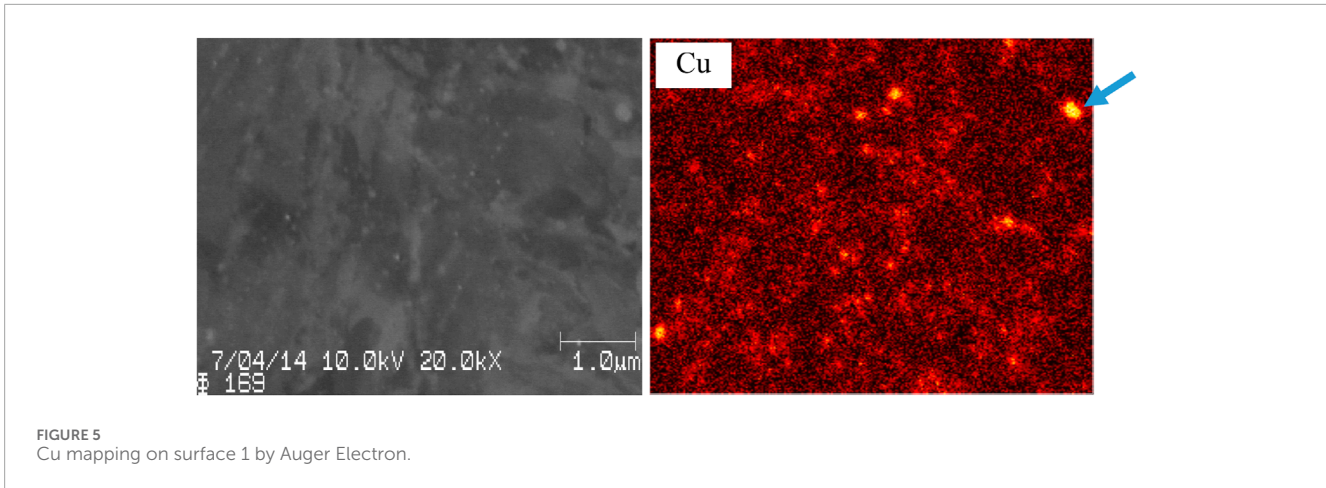
FIGURE 5 Cu mapping on surface 1 by Auger Electron.

Usually, the HV of 17-4PH was higher than 350, much higher than the value of present material (Hsiao et al., 2002). The root of this sharp reduction of hardness was the coarsening of Cu-rich precipitates (JPO, 2008). The Auger Electron's Cu mapping on surface 1 provided evidence in favor of that claim. Cu-clusters could be seen clearly in the Cu mapping in Figure 5. The arrow's Cu-cluster measured in the order of  $\mu\text{m}$ , which was significantly larger than the typical Cu-rich precipitate size of 20 nm. (Wang et al., 2006). This decrease in hardness had been explained, but the working performance related to hardness was still within an acceptable and

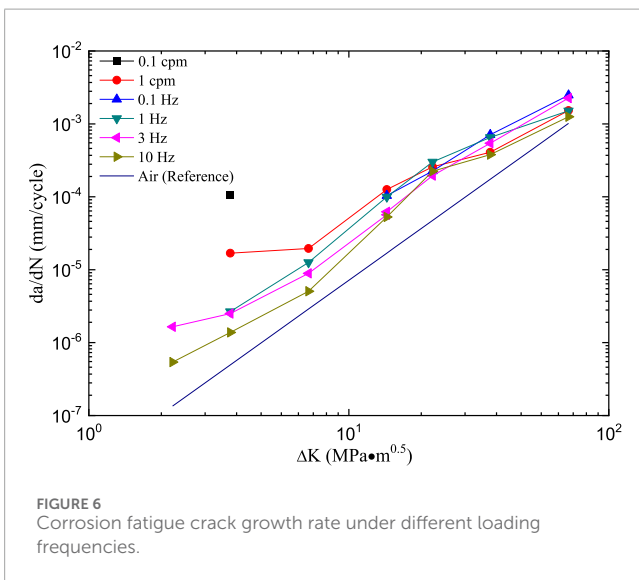
FIGURE 6 Corrosion fatigue crack growth rate under different loading frequencies.

Figure 6 showed the cycle-base corrosion fatigue crack growth rate as a function of  $\Delta K$  at various frequencies. Although the data for 0.1 cpm, 1 cpm, and 10 Hz were previously published, they are still used for comparison and discussion in this context. (Wu et al., 2017). When the measured results and the Paris law plot diverged, the linear line served as a reference point to assess the environmental assistance in accelerating crack growth.

With respect to frequency, the environmental acceleration decreases with increasing frequency at any given  $\Delta K$  below 14  $\text{MPa}\cdot\text{m}^{0.5}$ . This is because the duration of each cycle is shortened to allow the time-dependent corrosion process to proceed. On the other hand, when  $\Delta K$  exceeded 14  $\text{MPa}\cdot\text{m}^{0.5}$ , the variation in the crack growth rate (CGR) per cycle with frequency was inconsistent, particularly for 1 cpm, where the acceleration was approximately equal to or lower than that of other frequencies. In terms of  $\Delta K$ 's impact on acceleration, 14  $\text{MPa}\cdot\text{m}^{0.5}$  appears to mark a turning point. The acceleration generally increased from 70 to 14  $\text{MPa}\cdot\text{m}^{0.5}$  with decreasing  $\Delta K$ , then decreased to 7  $\text{MPa}\cdot\text{m}^{0.5}$  with further decreasing  $\Delta K$ , and finally strengthened again at  $\Delta K$  below 7  $\text{MPa}\cdot\text{m}^{0.5}$ , as indicated by 1 cpm. The complex interaction

between the mechanical and corrosion processes was strongly suggested by the changing effect of  $\Delta K$  on both environmental acceleration at each given frequency and the influence of frequency on environmental acceleration. In modified 17-4PH, there is a certain correlation between the influence of environment on crack growth and  $\Delta K$ . When  $\Delta K$  decreases, the environmental influence on crack growth increases gradually, which means that environmental factors play an important role in the process of crack growth. In this case, the relative contributions of mechanical and environmental factors to CGR are denoted by the letters CM and CE, respectively. Table 4 provided an overview of the acceleration variation of the environment with CM and CE.

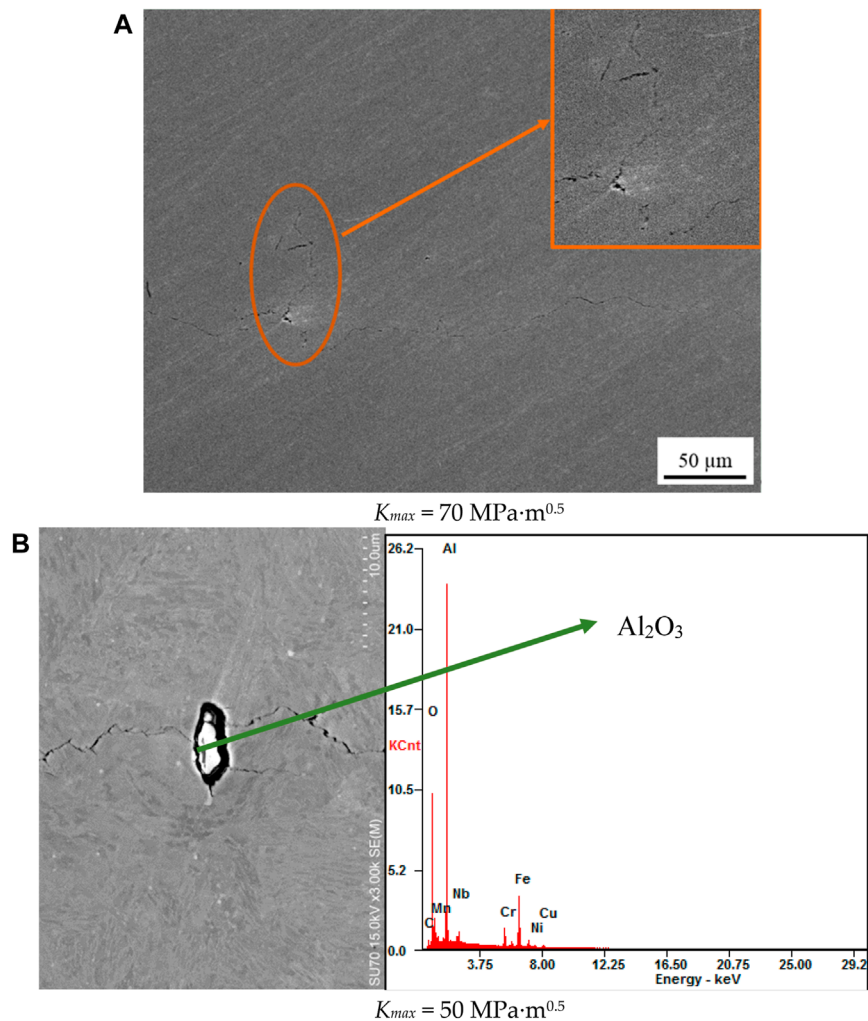
FIGURE 7 Side surfaces after fatigue tests in air, (A) specimen with  $K_{max} = 70 \text{ MPa}\cdot\text{m}^{0.5}$ ; (B)  $K_{max} = 50 \text{ MPa}\cdot\text{m}^{0.5}$ .

Figures 7, 8 show examples of SEM images following fatigue tests in the air. One example of a side surface image was displayed in Figure 7. On the side surfaces, very noticeable secondary cracks were discovered, and the oxide inclusion—which EDX identified as  $\text{Al}_2\text{O}_3$ —was discovered to be obstructing the crack's

path. Two mechanisms of secondary crack formation have been proposed by Bo et al. (1) Localized high tension stress during the blunting or resharpener process may cause a microcrack to form along the blunted border, particularly in areas with sub-grain or grain boundaries or defects. (2) An inclusion that is sufficiently near the primary fracture path to cause void nucleation and stress concentration (Bo and Chen, 1988). Herein, the secondary formation mechanism in Figures 7A should be mechanism (1), in Figures 7B mechanism (2).

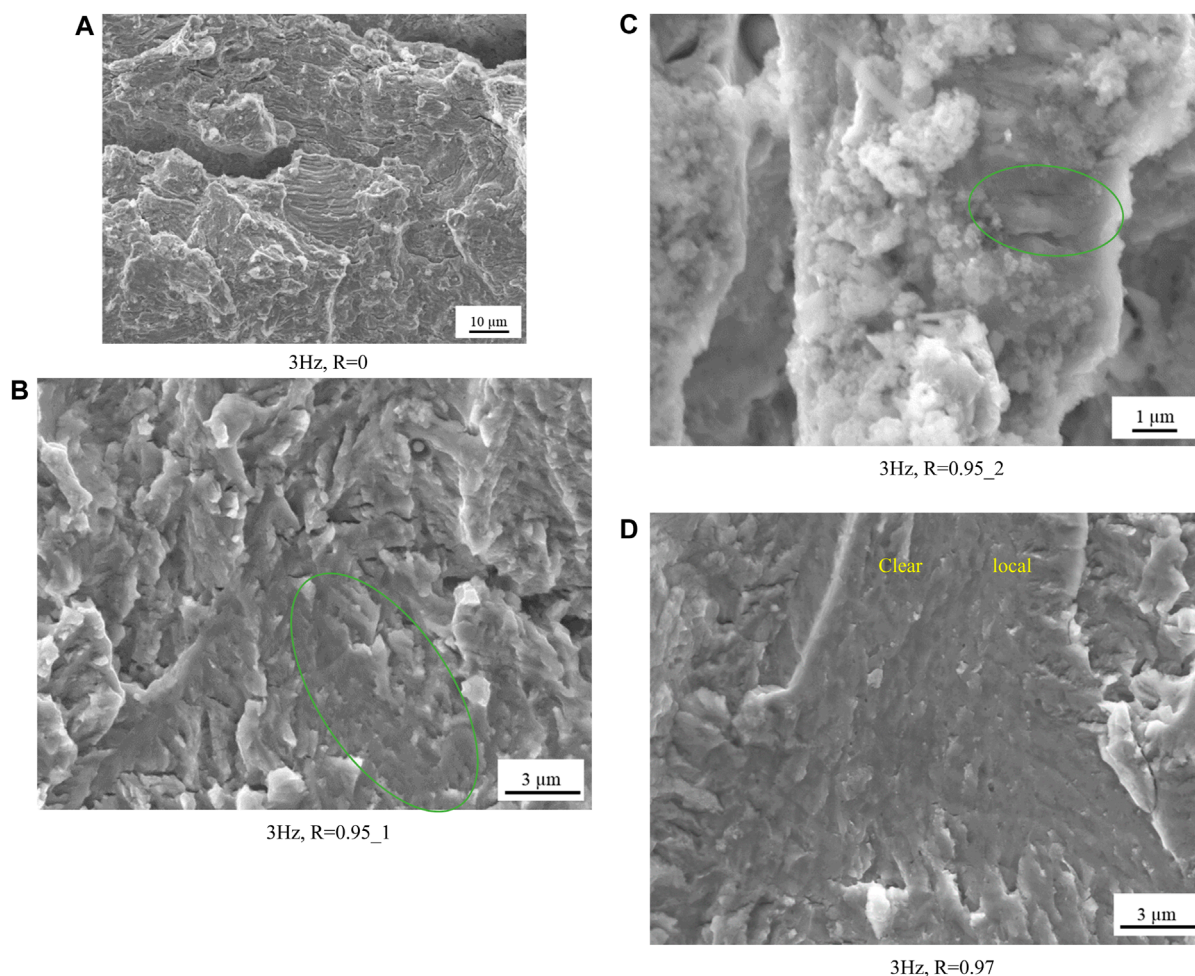
**FIGURE 11**  
Fracture surface of specimen under the frequency of 3 Hz (A) R = 0; (B) R = 0.95\_1; (C) R = 0.95\_2; (D) R = 0.97.

Below are some typical SEM photos of the fracture surface following corrosion fatigue tests at different loading ratios and frequencies. The images of 3 Hz, 1 cpm, and 0.1 cpm were displayed in Figures 11–13, respectively. Although some areas were blurred by corrosion products, ductile striation was still visible throughout the surfaces in Figure 11A. Instead of HE, which was identified by brittle striation and cleavage, it was deduced that metal dissolution was the environmental acceleration mechanism (Milella, 2013b). As the loading ratio increased to 0.95, resulting in  $\Delta K$  falling to  $3.5 \text{ MPa}\cdot\text{m}^{0.5}$ , Figure 11B illustrates the quasi-brittle cleavage on the entire surface. Brittle cleavage was also discovered in the

circled region; this was not seen in the air as Figure 8B illustrates. However, as indicated by the circle in Figure 11C, ductile striation was still present in a very small area, and it was less widespread than Figure 8C. As the loading ratio was increased to 0.97, as seen in Figure 11D, the brittle cleavage area grew larger and the ductile striation became more elusive. The air experienced a similar phenomenon as well. The loading ratio stopped being ductile at 0.96, having passed 0.95. It seemed that when  $\Delta K$  in the range of  $3.5 \text{ MPa}\cdot\text{m}^{0.5}$ – $2.8 \text{ MPa}\cdot\text{m}^{0.5}$  the propagation shifted from ductile striation mechanism to brittle cleavage.
