Copeland-Johnson TM, Murray DJ,
Cao G and He L (2022), Assessing the
interfacial corrosion mechanism of
Inconel 617 in chloride molten salt
corrosion using multi-modal advanced
characterization techniques.
Front. Nucl. Eng. 1:1049693.
doi: 10.3389/fnuen.2022.1049693

Assessing the interfacial corrosion mechanism of Inconel 617 in chloride molten salt corrosion using multi-modal advanced characterization techniques

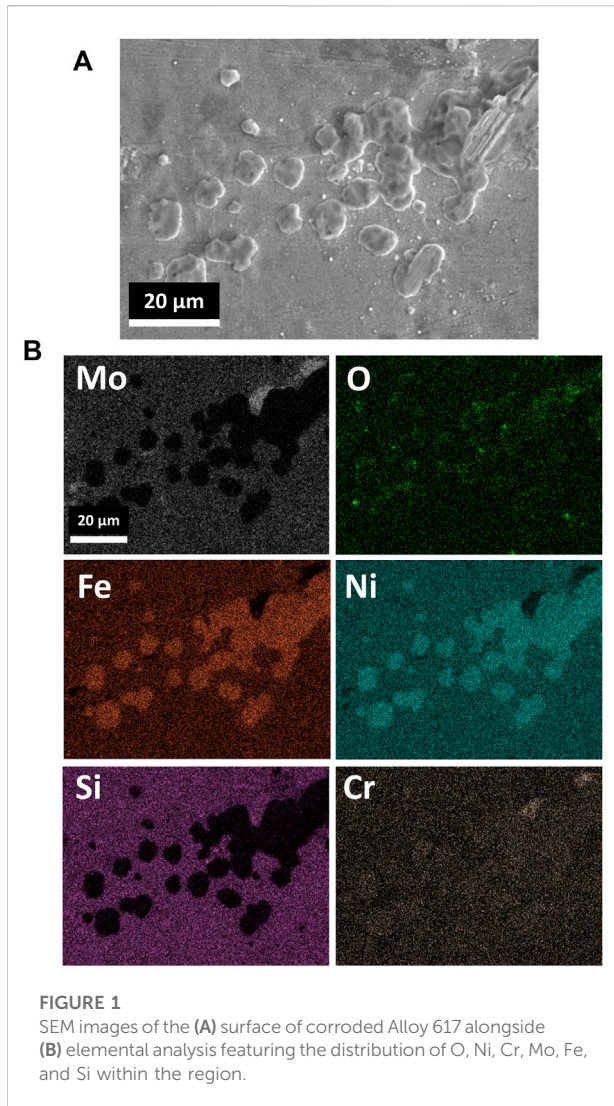
FIGURE 1 SEM images of the (A) surface of corroded Alloy 617 alongside (B) elemental analysis featuring the distribution of O, Ni, Cr, Mo, Fe, and Si within the region.

the alloy matrix, featured in [Supplementary Figure S1](#). Mo-enriched precipitates were concentrated near grain boundaries. Surface analysis of the corroded Alloy 617, [Figure 1](#), revealed the development of Ni-Fe-enriched globules with respect to the surrounding surface, contributing to an inconsistent, rough morphology over the surface of the material. SEM EDS analysis also cited slight enrichment in Cr and O and depletion of Mo and Si within the globules, with respect to the surrounding area. Traversing into the bulk of the material, [Figure 2](#), reveals that the globules are connected to a porous network, depleted of Cr, Ni, and Fe, with segments of remnant alloy residing within the void structure. Fe enrichment is observed around the porous network and Si enrichment within the porous network, corresponding to the remnant alloy pieces. Finally, highly

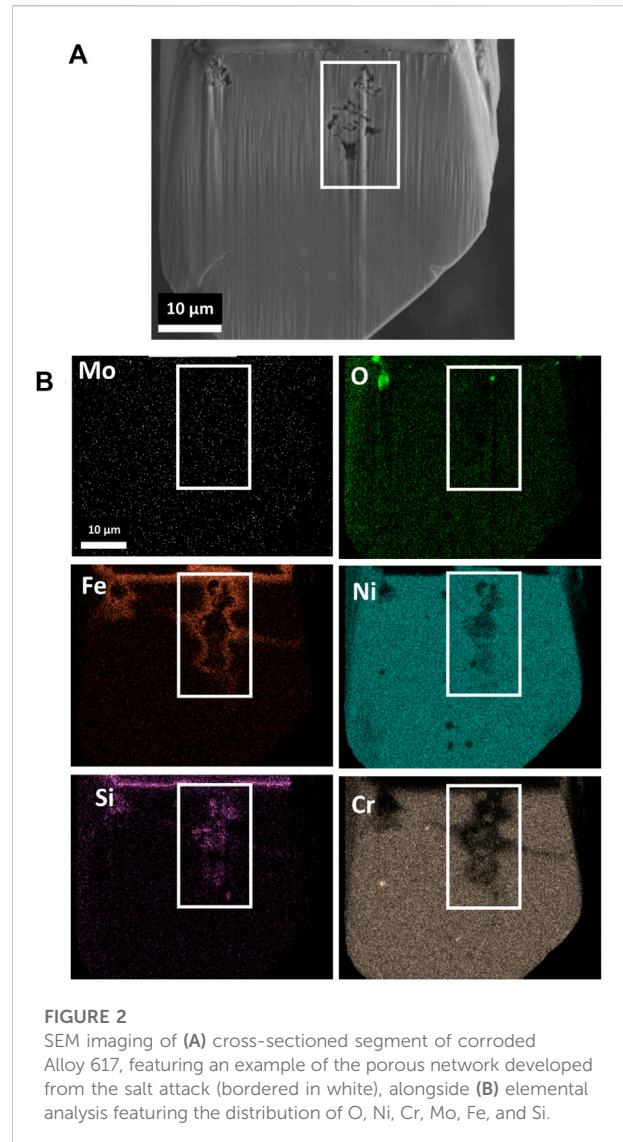
FIGURE 2 SEM imaging of (A) cross-sectioned segment of corroded Alloy 617, featuring an example of the porous network developed from the salt attack (bordered in white), alongside (B) elemental analysis featuring the distribution of O, Ni, Cr, Mo, Fe, and Si.

localized O enrichment resides within the porous network with no distinction in the distribution of Mo within and surrounding the porous network.

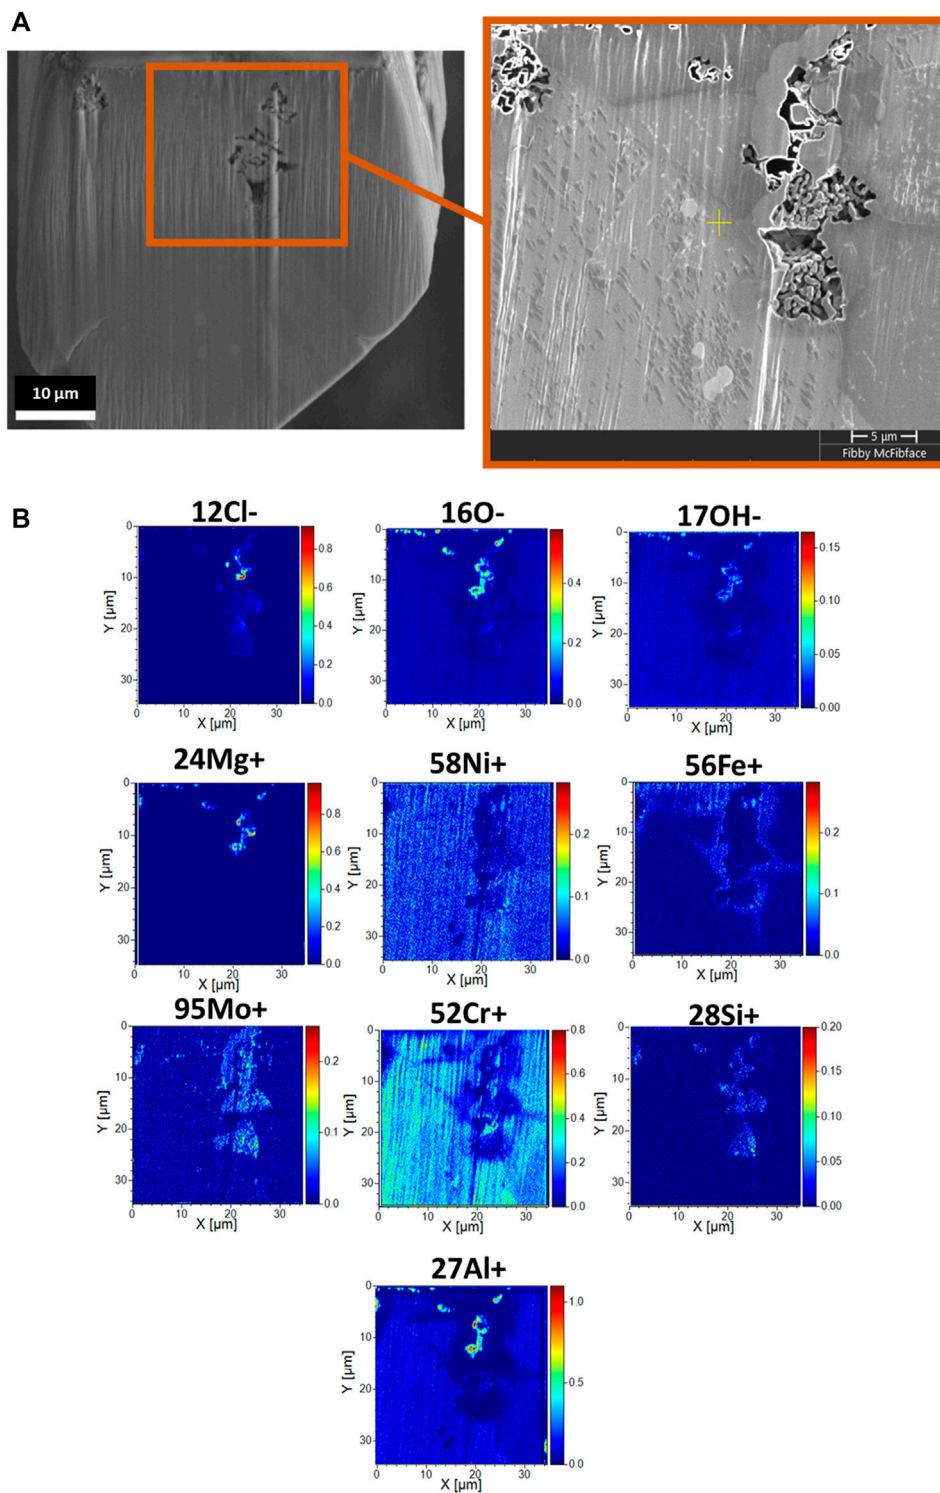
FIGURE 3 ToF-SIMS analysis acquired from (A) cross-sectioned segment captured in SEM image featuring an example of a porous network, alongside (B) two-dimensional intensity maps illustrating the distribution of ionic species originating from the salt (-Cl, -O, -OH, +Mg) and alloy (+Ni, +Fe, +Mo, +Cr, +Si, +Al).

ToF-SIMS analysis confirms the porous network corresponds to where the salt directly attacked the alloy, based on detection of Cl^- ions within the pores, Figure 3. Additionally, ToF-SIMS corroborates with EDS concerning the depletion of Ni, Cr, and Fe while enrichment of O and Si within the porous network. Enrichment of Fe around the porous network is also in agreement with SEM EDS analysis. ToF-SIMS and EDS signals corresponding to Al and Mg ions are also detected within the porous network, overlapping with the location of O. However, ToF-SIMS provides evidence of Mo enrichment within with porous network, which was not readily detected with SEM EDS analysis. The O- and OH- ion signals were captured from the residual salt within the porous network. It is highly unlikely that the rinsing procedure that removed excess salt from the surface introduced moisture sub-surface to affect the acquisition of the O- and OH- ion, given that the signal resides in pores that still contain residual salt.

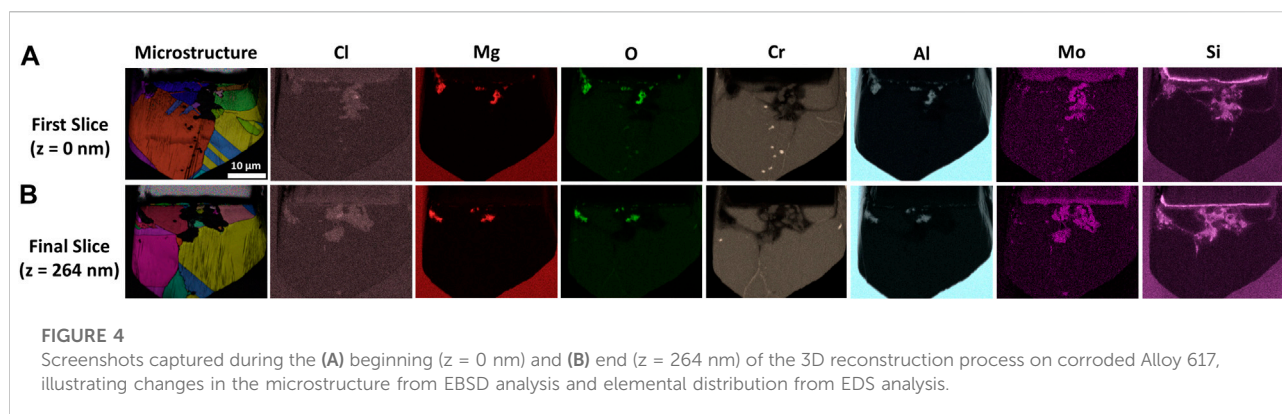
3D EDS and EBSD reconstruction of a 50 by 70 by 0.264 μm segment of corroded alloy extracted from the bulk specimen captures grain boundary phenomena traversing deeper into the material, Figure 4. 3D EDS analysis reiterates Cr, Ni, and Fe depletion within the porous network. In addition, intergranular Cr-O enrichment is observed along and in localized regions near grain boundaries that are in contact with the porous network, ahead of the corrosion front. Additional evidence of O enrichment is observed within the porous network, overlapping with signals corresponding to Al and Mg. Full animations of the 3D EDS and EBSD reconstruction are available in the data repository.

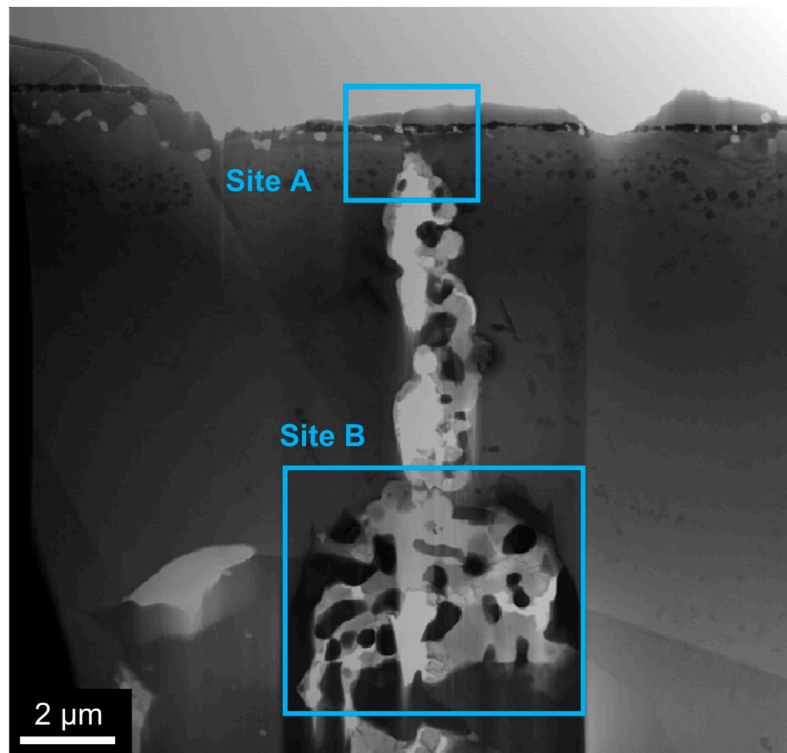
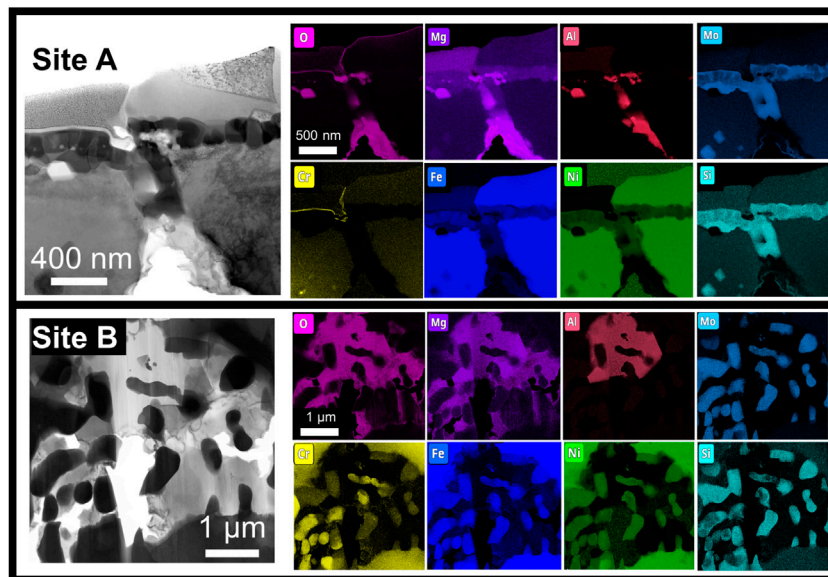
FIGURE 5
(A) Brightfield TEM image of a porous network from corroded Alloy 617, including EDS elemental analysis on two sites of interest **(B)** Site A located near the suspected origin point of the attack and **(C)** Site B deeper in the porous network.

et al., 2020). This behavior was documented in this investigation. SEM and TEM EDS analysis detected salt constituents within the porous network, Figure 5, suggesting the salt penetrated the alloy through capillary action (Grégoire et al., 2020). Furthermore, the

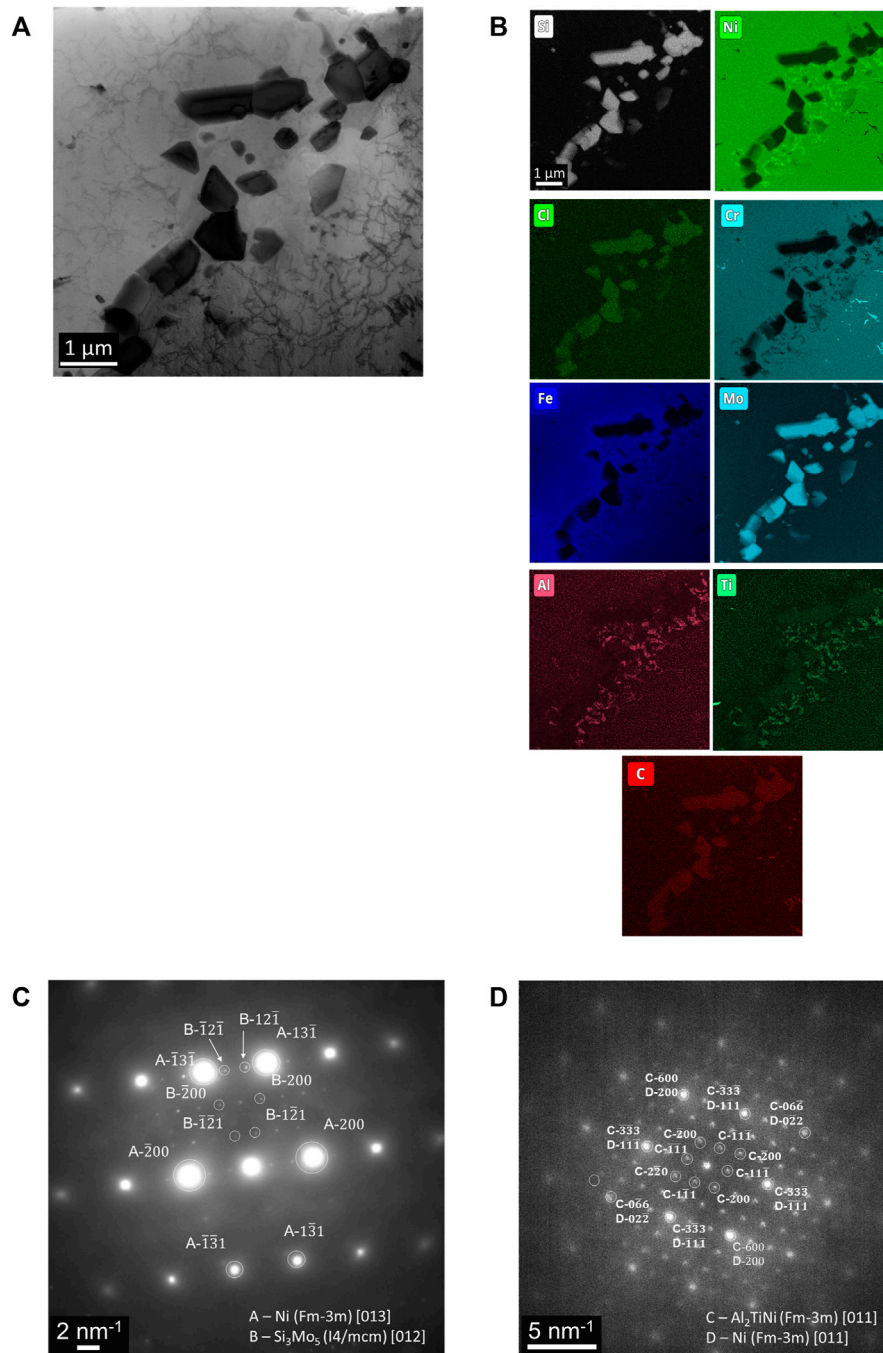
FIGURE 8 (A) Brightfield STEM image featuring Mo-Si-C and Al-Ti-Ni enriched precipitates within the alloy matrix ahead of the corrosion front, (B) elemental analysis highlighting enrichment of select elements both originating from the salt and from the alloy, and (C) indexed SAED pattern originating from Mo-Si-C and Al-Ti-Ni enriched precipitates corresponding to Mo_3Si_5 and Al_2TiNi , respectively.

The presence of Mo₃Si₅ and τ₂ precipitates correlate to precipitate strengthening in Ni-based superalloys. Mo-enriched and carbide (e.g. M₆C, M₂₃C₆, etc.) precipitates are commonly integrated into Alloy 617 to enhance mechanical properties (Ren et al., 2010). Intergranular Mo-enriched precipitates were observed in as-received Alloy 617 in this investigation, Supplementary Figure S1. Previous investigations have reported the formation of intergranular Si-Mo-enriched M₆C carbides in heat-treated Ni-Mo-Cr superalloys (Xu et al., 2015; Liu et al., 2020). Si has been reported to promote the diffusion of elements and reduce C to form carbides precipitates near grain boundaries (Liu et al., 2020). It is noteworthy to mention that TEM EDS analysis in this investigation did indicate slight C enrichment in the Mo₃Si₅ (Figure 8) and Cr-enriched precipitates (Supplementary Figure S2), but no conclusive evidence is able to discern elucidation of a corrosion-induced Si-Mo-enriched M₆C carbide or Cr-based carbide, respectively. The presence of τ₂ precipitates, a Mn₂₃Th₆ type structure, would be a novel precipitate to be associated with Alloy 617 (Raghavan, 2005; Ren et al., 2010). Al and Ti are included in Alloy 617 to form Ni₃(Al,Ti) (γ') precipitates, which enhance mechanical properties and are thermodynamically stable up to 1,000°C (Klöwer, 2017). In addition, the presence of γ' precipitates have been observed for as long as 100,000 h at 700 °C and has notably been observed to increase in concentration in thermally aged Alloy 617 at 650 and 750°C for up to 5,300 h (Benz and Richardwright, 2013; Klöwer, 2017). The lack of detection of γ' precipitates after thermal aging for 1,000 h and corrosion in NaCl-MgCl₂ eutectic salt could indicate that the corrosion mechanism has indirectly induced a phase transformation of γ' to τ₂ precipitates, but additional analysis is required to confirm.

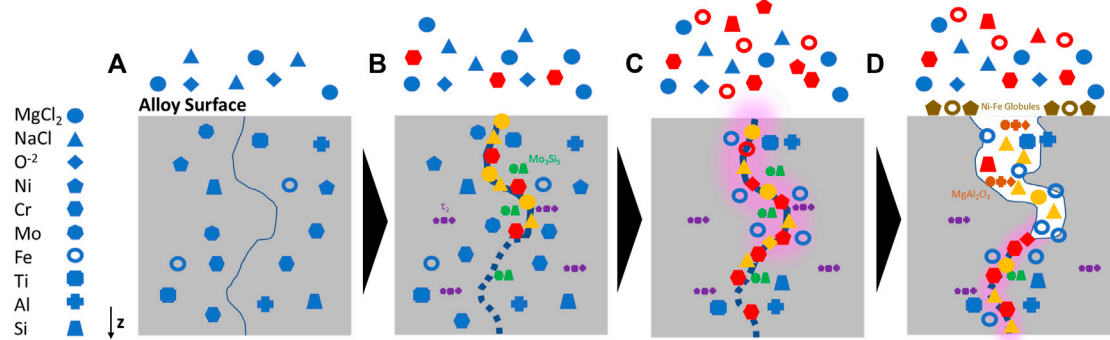
FIGURE 9

Schematic of proposed corrosion mechanism for (A) Alloy 617 exposed to NaCl-MgCl₂ eutectic salt at 700°C for 1000 h to (B) intergranular penetration of the salt constituents (yellow) and subsequent dealloying of Cr (red). During the corrosion process, Mo-enriched precipitates, primarily in proximity to grain boundaries, react with Si to form Mo₃Si₅ precipitates (green) and Ti-enriched precipitates react with Al and Ni to form τ₂. As the dealloying continued, (C) Fe atoms diffuse towards the depletion region (red) and Mo₃Si₅ and τ₂ precipitates in proximity to the corrosion regime are also dissolved as the porous network develops (highlighted in pink), (D) Finally, Mg ions react with Al and O to form MgAl₂O₄ within the porous network, alongside residual alloying elements and salt as the corrosion propagates further along the grain boundary.

corrosion of Alloy 617 by NaCl-MgCl₂ eutectic salt is comprised of three main steps, Figure 9: 1) The presence of salt moisture impurities spurs interaction of the Mg, Na, and Cl ions with select grain boundaries at the surface of the alloy. 2) After the initial breach, salt percolates along grain boundaries, O reacting with Cr and establishing a diffusion gradient that initiates Cr dealloying. Fe and Ni are affected by the Cr dealloying, also following the concentration gradient to the Cr-depleted grain and subsequently undergoing intergranular dealloying, further facilitating Cr dissolution. Ni and Fe are less soluble in the salt and phase out of solution to redeposit on the surface, forming globules near the origin point of the corrosion attack. 3) O also reacts with Mg from the salt and dealloyed Al to form MgAl₂O₄. Also, Mo₃Si₅ and τ_2 precipitates in the alloy matrix are dissolved by the salt and eventually a heterogeneous porous network forms in regions that have been significantly attacked.
